Appendix 10.1b Peat Slide Hazard and Risk Assessment -Interpretive Report

Pencloe Windfarm

Peat Slide Hazard and Risk Assessment Interpretive Report

October 2014

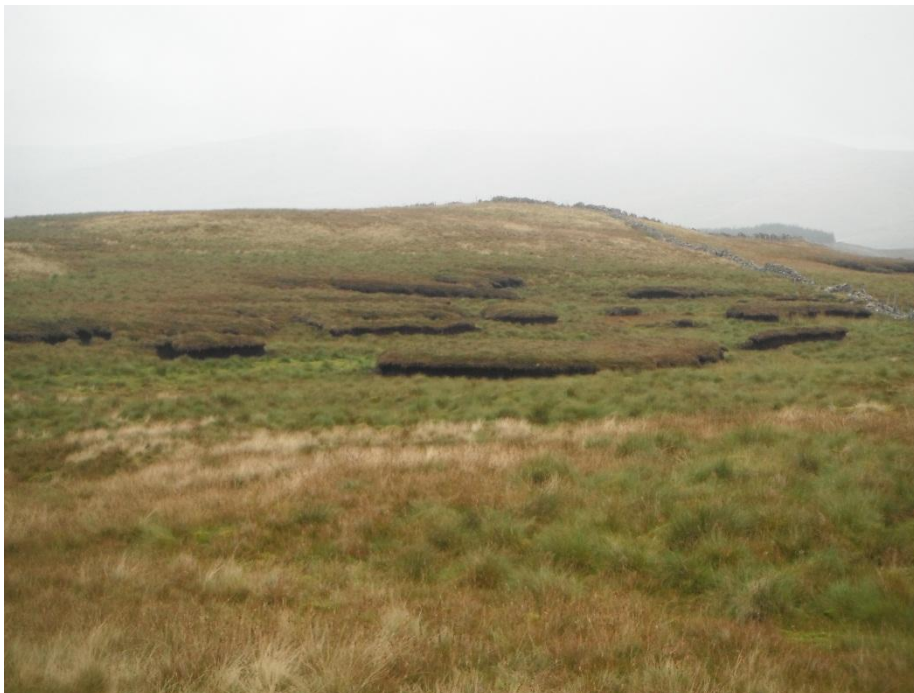
Photo 1 - Peat hagging north of Struther's Brae hill

It is evident that the peat geomorphology within this area has been considerably affected by erosion, primarily in the form of peat 'hagging' (see Plate 1 below) and the minor peat slide features encountered within this area appeared to be closely associated with natural weathering processes. Surface water run-off, wind and frost action are likely to be the most significant factors in shaping the local geomorphology.

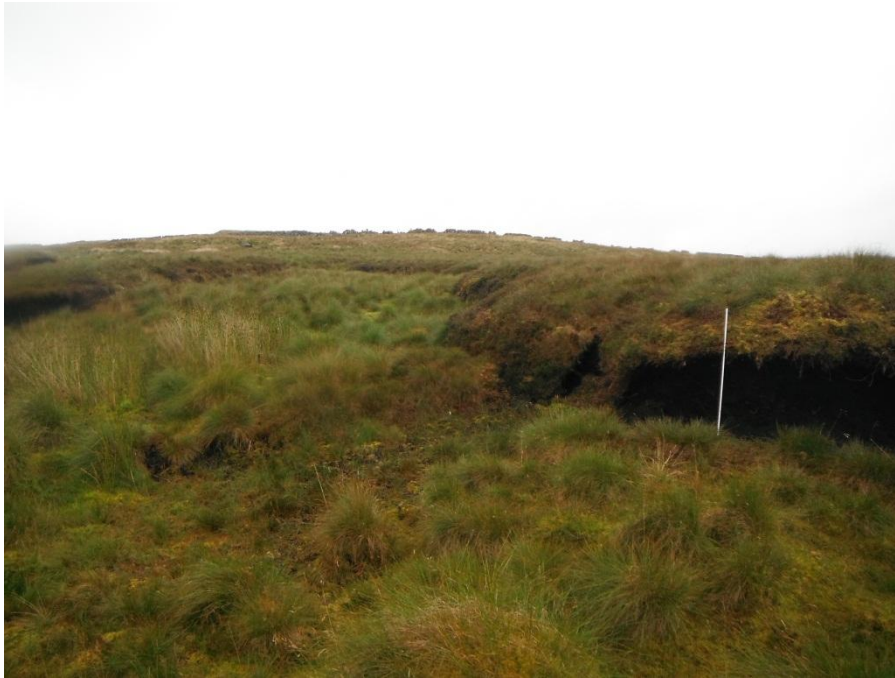
Photo 2 – Minor peat slide feature and slumping northwest of Struther's Brae hill

The observed peat slide features appeared to be relatively small scale, comprising potential relic minor translational slips which generally appeared to be associated with breaks in slope where the down gradient peat profile has been weathered away resulting in an exposed peat face or 'scar'. Such features were locally observed up to 25m in length and 10m width, with exposed faces up to approximately 1m in height and some minor slumping of the exposed peat faces was also noted (see Plate 2 below).
