PROJECT		LOCATION		LANDMARK	
Pencloe		New Cumnock, Scotland		T532	
Co-ords: X	261090	Y	608108	Ref	Grid position

GENERAL		DATE & PERSONNEL		PHOTOGRAPHS
Survey	New	Rated by:	SA	Photo looking West
Date of last survey	N/A	Date	12/09/2013

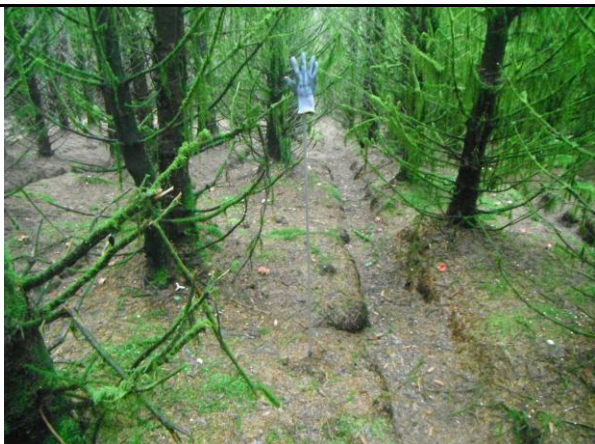
CATEGORY			SCORE
Rainfall	1870	Moderate altitude, Moderate rainfall.	100
Moisture conditions	<input checked="" type="checkbox"/> Dry <input type="checkbox"/> Patchy <input type="checkbox"/> Part saturated <input type="checkbox"/> Saturated <input type="checkbox"/> Waterlogged Ditches: <input type="checkbox"/> No ditches <input checked="" type="checkbox"/> Dry <input type="checkbox"/> Flowing <input type="checkbox"/> Ponded		3
Substrata	<input type="checkbox"/> Peat <input type="checkbox"/> Clay <input checked="" type="checkbox"/> Sand/Gravel <input type="checkbox"/> Rock Strength (kPa): <input type="checkbox"/> <10 <input type="checkbox"/> 10-20 <input type="checkbox"/> 20-30 <input type="checkbox"/> 30-40 <input checked="" type="checkbox"/> >40		5
Strata details	Peat depth = 0.6 m	Probe depth = 0.6 m	2
	Layer 1, from ground level to 0.6 mBGL at 20-30 kPa Layer 2 not applicable Layer 3 not applicable		6

Slope details	West facing Even slope of 12 degrees.		46
Morphology	<input type="checkbox"/> None <input checked="" type="checkbox"/> Few <input type="checkbox"/> Several <input type="checkbox"/> Many <input checked="" type="checkbox"/> Minor <input type="checkbox"/> Moderate <input type="checkbox"/> Major Man-made: Ditch. Natural:		5
Sub-profile drainage	<input checked="" type="checkbox"/> None <input type="checkbox"/> Seepage points Depressions: <input type="checkbox"/> Dry <input type="checkbox"/> Sink point Soil pipes: <input type="checkbox"/> Minor <input type="checkbox"/> Moderate <input type="checkbox"/> Major <input type="checkbox"/> Collapsed Sink holes: <input type="checkbox"/> Minor <input type="checkbox"/> Moderate <input type="checkbox"/> Major Grassy flush: <input type="checkbox"/> Minor <input type="checkbox"/> Major Spacing:		1
Peat slide history	<input checked="" type="checkbox"/> None <input type="checkbox"/> Few <input type="checkbox"/> Several <input type="checkbox"/> Many <input type="checkbox"/> Minor <input type="checkbox"/> Moderate <input type="checkbox"/> Major Extent if present:		1

Location sensitivity	<input checked="" type="checkbox"/> Low <input type="checkbox"/> Medium <input type="checkbox"/> High <input type="checkbox"/> Very high Reason:		3
OVERALL SCORE			172

<p><u>Vegetation</u></p> <p>Conifer: <input type="checkbox"/> Young <input type="checkbox"/> Semi-mature <input checked="" type="checkbox"/> Mature</p> <p>Deciduous: <input type="checkbox"/> Young <input type="checkbox"/> Semi-mature <input type="checkbox"/> Mature</p> <p><input checked="" type="checkbox"/> Sphagnum moss <input type="checkbox"/> Staghorn moss</p> <p><input type="checkbox"/> Other mosses <input type="checkbox"/> Cotton grass <input type="checkbox"/> Rushes</p> <p><input type="checkbox"/> Other grasses <input type="checkbox"/> Heather <input type="checkbox"/> Fern</p> <p><input type="checkbox"/> Shrubs <input checked="" type="checkbox"/> Leaf litter <input type="checkbox"/> Bracken</p> <p>Other:</p> <p>Terrain category: <input checked="" type="checkbox"/> One <input type="checkbox"/> Two <input type="checkbox"/> Three</p> <p>Notes:</p>

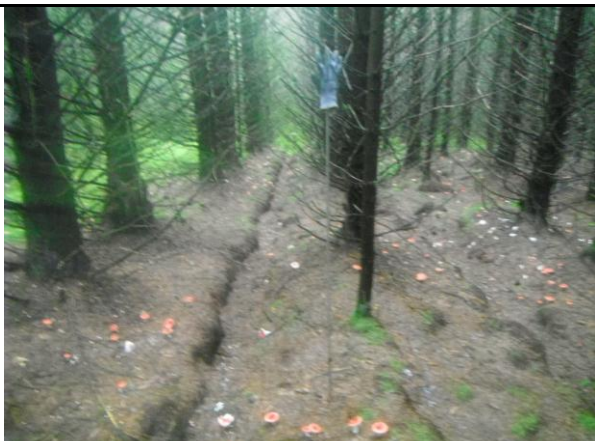
PROJECT		LOCATION		LANDMARK	
Pencloe		New Cumnock, Scotland		T533	
Co-ords: X	261190	Y	608108	Ref	Grid position

GENERAL		DATE & PERSONNEL		PHOTOGRAPHS
Survey	New	Rated by:	SA	Photo looking West
Date of last survey	N/A	Date	12/09/2013

CATEGORY			SCORE
Rainfall	1870	Moderate altitude, Moderate rainfall.	100
Moisture conditions	<input checked="" type="checkbox"/> Dry <input type="checkbox"/> Patchy <input type="checkbox"/> Part saturated <input type="checkbox"/> Saturated <input type="checkbox"/> Waterlogged Ditches: <input type="checkbox"/> No ditches <input checked="" type="checkbox"/> Dry <input type="checkbox"/> Flowing <input type="checkbox"/> Ponded		2
Substrata	<input type="checkbox"/> Peat <input type="checkbox"/> Clay <input checked="" type="checkbox"/> Sand/Gravel <input type="checkbox"/> Rock Strength (kPa): <input type="checkbox"/> <10 <input type="checkbox"/> 10-20 <input type="checkbox"/> 20-30 <input type="checkbox"/> 30-40 <input checked="" type="checkbox"/> >40		5
Strata details	Peat depth = 0.4 m		2
	Probe depth = 0.4 m		
	Layer 1, from ground level to 0.4 mBGL at 20-30 kPa Layer 2 not applicable Layer 3 not applicable		4

Slope details	West facing Even slope of 4 degrees.		7
Morphology	<input type="checkbox"/> None <input checked="" type="checkbox"/> Few <input type="checkbox"/> Several <input type="checkbox"/> Many <input checked="" type="checkbox"/> Minor <input type="checkbox"/> Moderate <input type="checkbox"/> Major Man-made: Ditch. Natural:		3
Sub-profile drainage	<input checked="" type="checkbox"/> None <input type="checkbox"/> Seepage points Depressions: <input type="checkbox"/> Dry <input type="checkbox"/> Sink point Soil pipes: <input type="checkbox"/> Minor <input type="checkbox"/> Moderate <input type="checkbox"/> Major <input type="checkbox"/> Collapsed Sink holes: <input type="checkbox"/> Minor <input type="checkbox"/> Moderate <input type="checkbox"/> Major Grassy flush: <input type="checkbox"/> Minor <input type="checkbox"/> Major Spacing:		1
Peat slide history	<input checked="" type="checkbox"/> None <input type="checkbox"/> Few <input type="checkbox"/> Several <input type="checkbox"/> Many <input type="checkbox"/> Minor <input type="checkbox"/> Moderate <input type="checkbox"/> Major Extent if present:		1

<p align="center"><u>Vegetation</u></p> <p>Conifer: <input type="checkbox"/> Young <input type="checkbox"/> Semi-mature <input checked="" type="checkbox"/> Mature</p> <p>Deciduous: <input type="checkbox"/> Young <input type="checkbox"/> Semi-mature <input type="checkbox"/> Mature</p> <p><input checked="" type="checkbox"/> Sphagnum moss <input type="checkbox"/> Staghorn moss</p> <p><input type="checkbox"/> Other mosses <input type="checkbox"/> Cotton grass <input type="checkbox"/> Rushes</p> <p><input type="checkbox"/> Other grasses <input type="checkbox"/> Heather <input type="checkbox"/> Fern</p> <p><input type="checkbox"/> Shrubs <input checked="" type="checkbox"/> Leaf litter <input type="checkbox"/> Bracken</p> <p>Other:</p>

<p>Terrain category: <input checked="" type="checkbox"/> One <input type="checkbox"/> Two <input type="checkbox"/> Three</p>	
<p>Notes:</p>

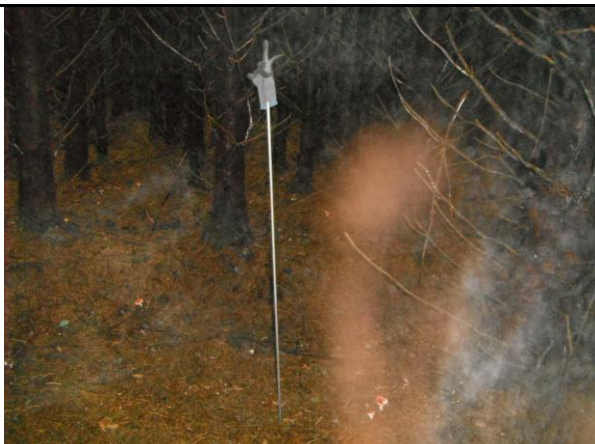
PROJECT		LOCATION		LANDMARK	
Pencloe		New Cumnock, Scotland		T534	
Co-ords: X	261290	Y	608108	Ref	Grid position

CATEGORY			SCORE
Rainfall	1870	Moderate altitude, Moderate rainfall.	100
Moisture conditions	<input checked="" type="checkbox"/> Dry <input type="checkbox"/> Patchy <input type="checkbox"/> Part saturated <input type="checkbox"/> Saturated <input type="checkbox"/> Waterlogged Ditches: <input type="checkbox"/> No ditches <input checked="" type="checkbox"/> Dry <input type="checkbox"/> Flowing <input type="checkbox"/> Ponded		2
Substrata	<input type="checkbox"/> Peat <input type="checkbox"/> Clay <input type="checkbox"/> Sand/Gravel <input checked="" type="checkbox"/> Rock Strength (kPa): <input type="checkbox"/> <10 <input type="checkbox"/> 10-20 <input type="checkbox"/> 20-30 <input type="checkbox"/> 30-40 <input checked="" type="checkbox"/> >40		8
Strata details	Peat depth = 0.3 m	Probe depth = 0.3 m	2
	Layer 1, from ground level to 0.3 mBGL at 30-40 kPa Layer 2 not applicable Layer 3 not applicable		2

<p align="center"><u>Vegetation</u></p> <p>Conifer: <input type="checkbox"/> Young <input type="checkbox"/> Semi-mature <input checked="" type="checkbox"/> Mature</p> <p>Deciduous: <input type="checkbox"/> Young <input type="checkbox"/> Semi-mature <input type="checkbox"/> Mature</p> <p><input checked="" type="checkbox"/> Sphagnum moss <input type="checkbox"/> Staghorn moss</p> <p><input type="checkbox"/> Other mosses <input type="checkbox"/> Cotton grass <input type="checkbox"/> Rushes</p> <p><input type="checkbox"/> Other grasses <input type="checkbox"/> Heather <input type="checkbox"/> Fern</p> <p><input type="checkbox"/> Shrubs <input checked="" type="checkbox"/> Leaf litter <input type="checkbox"/> Bracken</p> <p>Other:</p> <hr/> <p>Terrain category: <input checked="" type="checkbox"/> One <input type="checkbox"/> Two <input type="checkbox"/> Three</p> <hr/> <p>Notes:</p>

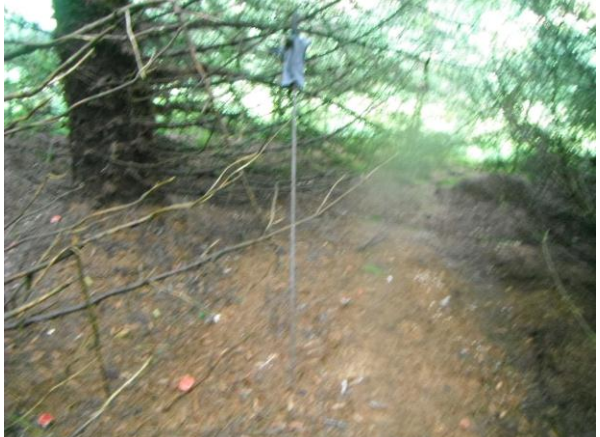
Location sensitivity	<input checked="" type="checkbox"/> Low <input type="checkbox"/> Medium <input type="checkbox"/> High <input type="checkbox"/> Very high Reason:		1
OVERALL SCORE			61

<p align="center"><u>Vegetation</u></p> <p>Conifer: <input type="checkbox"/> Young <input type="checkbox"/> Semi-mature <input checked="" type="checkbox"/> Mature</p> <p>Deciduous: <input type="checkbox"/> Young <input type="checkbox"/> Semi-mature <input type="checkbox"/> Mature</p> <p><input checked="" type="checkbox"/> Sphagnum moss <input type="checkbox"/> Staghorn moss</p> <p><input checked="" type="checkbox"/> Other mosses <input type="checkbox"/> Cotton grass <input type="checkbox"/> Rushes</p> <p><input type="checkbox"/> Other grasses <input type="checkbox"/> Heather <input type="checkbox"/> Fern</p> <p><input type="checkbox"/> Shrubs <input checked="" type="checkbox"/> Leaf litter <input type="checkbox"/> Bracken</p> <p>Other:</p>

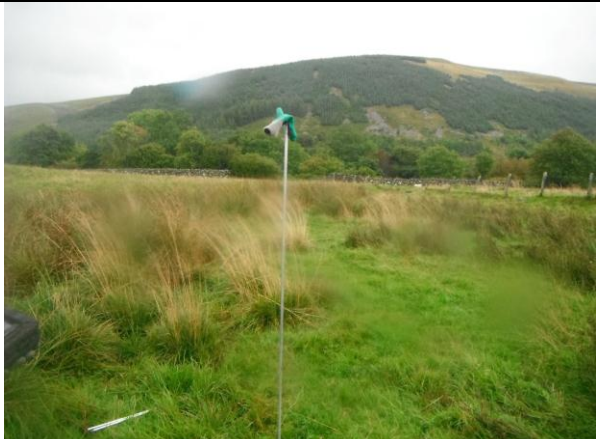
CATEGORY			SCORE
Rainfall	1870	Moderate altitude, Moderate rainfall.	100
Moisture conditions	<input type="checkbox"/> Dry <input type="checkbox"/> Patchy <input checked="" type="checkbox"/> Part saturated <input type="checkbox"/> Saturated <input type="checkbox"/> Waterlogged Ditches: <input checked="" type="checkbox"/> No ditches <input type="checkbox"/> Dry <input type="checkbox"/> Flowing <input type="checkbox"/> Ponded		10
Substrata	<input type="checkbox"/> Peat <input type="checkbox"/> Clay <input checked="" type="checkbox"/> Sand/Gravel <input type="checkbox"/> Rock Strength (kPa): <input type="checkbox"/> <10 <input type="checkbox"/> 10-20 <input type="checkbox"/> 20-30 <input type="checkbox"/> 30-40 <input checked="" type="checkbox"/> >40		3
Strata details	Peat depth = 0.0 m	Probe depth = 0.2 m	1
	Layer 1 not applicable Layer 2 not applicable Layer 3 not applicable		1
Slope details	North-east facing Undulating slope of 3 degrees.		8

Morphology	<input type="checkbox"/> None <input checked="" type="checkbox"/> Few <input type="checkbox"/> Several <input type="checkbox"/> Many <input type="checkbox"/> Minor <input checked="" type="checkbox"/> Moderate <input type="checkbox"/> Major Man-made: Track. Fence/wall. Natural: Non-peat failure.		8
Sub-profile drainage	<input type="checkbox"/> None <input type="checkbox"/> Seepage points Depressions: <input type="checkbox"/> Dry <input type="checkbox"/> Sink point Soil pipes: <input type="checkbox"/> Minor <input type="checkbox"/> Moderate <input type="checkbox"/> Major <input type="checkbox"/> Collapsed Sink holes: <input type="checkbox"/> Minor <input type="checkbox"/> Moderate <input type="checkbox"/> Major Grassy flush: <input checked="" type="checkbox"/> Minor <input type="checkbox"/> Major Spacing: Isolated		7
Peat slide history	<input checked="" type="checkbox"/> None <input type="checkbox"/> Few <input type="checkbox"/> Several <input type="checkbox"/> Many <input type="checkbox"/> Minor <input type="checkbox"/> Moderate <input type="checkbox"/> Major Extent if present:		1

<p align="center"><u>Vegetation</u></p> <p>Conifer: <input type="checkbox"/> Young <input type="checkbox"/> Semi-mature <input type="checkbox"/> Mature</p> <p>Deciduous: <input type="checkbox"/> Young <input checked="" type="checkbox"/> Semi-mature <input type="checkbox"/> Mature</p> <p><input type="checkbox"/> Sphagnum moss <input type="checkbox"/> Staghorn moss</p> <p><input type="checkbox"/> Other mosses <input type="checkbox"/> Cotton grass <input checked="" type="checkbox"/> Rushes</p> <p><input checked="" type="checkbox"/> Other grasses <input type="checkbox"/> Heather <input type="checkbox"/> Fern</p> <p><input checked="" type="checkbox"/> Shrubs <input type="checkbox"/> Leaf litter <input type="checkbox"/> Bracken</p> <p>Other:</p> <p>Terrain category: <input type="checkbox"/> One <input checked="" type="checkbox"/> Two <input type="checkbox"/> Three</p> <p>Notes:</p>

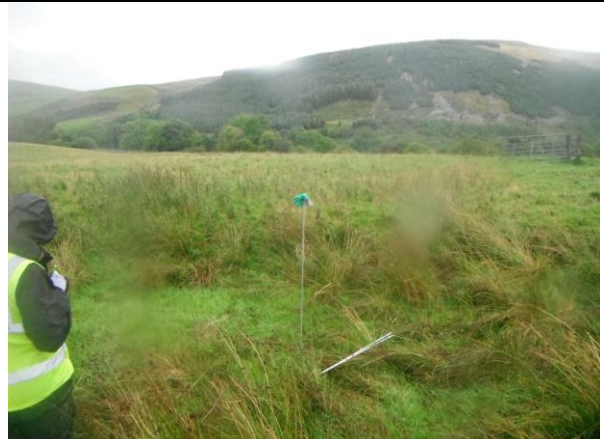
CATEGORY			SCORE
Rainfall	1870	Moderate altitude, Moderate rainfall.	100
Moisture conditions	<input type="checkbox"/> Dry <input type="checkbox"/> Patchy <input checked="" type="checkbox"/> Part saturated <input type="checkbox"/> Saturated <input type="checkbox"/> Waterlogged Ditches: <input checked="" type="checkbox"/> No ditches <input type="checkbox"/> Dry <input type="checkbox"/> Flowing <input type="checkbox"/> Ponded		10
Substrata	<input type="checkbox"/> Peat <input type="checkbox"/> Clay <input checked="" type="checkbox"/> Sand/Gravel <input type="checkbox"/> Rock Strength (kPa): <input type="checkbox"/> <10 <input type="checkbox"/> 10-20 <input type="checkbox"/> 20-30 <input type="checkbox"/> 30-40 <input checked="" type="checkbox"/> >40		3
Strata details	Peat depth = 0.0 m		1
	Probe depth = 0.6 m		
	Layer 1 not applicable Layer 2 not applicable Layer 3 not applicable		1
Slope details	North-east facing Undulating slope of 5 degrees.		12

Morphology	<input type="checkbox"/> None <input checked="" type="checkbox"/> Few <input type="checkbox"/> Several <input type="checkbox"/> Many <input type="checkbox"/> Minor <input checked="" type="checkbox"/> Moderate <input type="checkbox"/> Major Man-made: Track. Fence/wall. Natural: Non-peat failure. Exposed bedrock.		8
Sub-profile drainage	<input type="checkbox"/> None <input type="checkbox"/> Seepage points Depressions: <input type="checkbox"/> Dry <input type="checkbox"/> Sink point Soil pipes: <input type="checkbox"/> Minor <input type="checkbox"/> Moderate <input type="checkbox"/> Major <input type="checkbox"/> Collapsed Sink holes: <input type="checkbox"/> Minor <input type="checkbox"/> Moderate <input type="checkbox"/> Major Grassy flush: <input checked="" type="checkbox"/> Minor <input type="checkbox"/> Major Spacing: Isolated		7
Peat slide history	<input checked="" type="checkbox"/> None <input type="checkbox"/> Few <input type="checkbox"/> Several <input type="checkbox"/> Many <input type="checkbox"/> Minor <input type="checkbox"/> Moderate <input type="checkbox"/> Major Extent if present:		1

<p align="center"><u>Vegetation</u></p> <p>Conifer: <input type="checkbox"/> Young <input type="checkbox"/> Semi-mature <input type="checkbox"/> Mature</p> <p>Deciduous: <input type="checkbox"/> Young <input type="checkbox"/> Semi-mature <input type="checkbox"/> Mature</p> <p><input type="checkbox"/> Sphagnum moss <input type="checkbox"/> Staghorn moss</p> <p><input type="checkbox"/> Other mosses <input type="checkbox"/> Cotton grass <input checked="" type="checkbox"/> Rushes</p> <p><input checked="" type="checkbox"/> Other grasses <input type="checkbox"/> Heather <input type="checkbox"/> Fern</p> <p><input type="checkbox"/> Shrubs <input type="checkbox"/> Leaf litter <input type="checkbox"/> Bracken</p> <p>Other:</p> <hr/> <p>Terrain category: <input checked="" type="checkbox"/> One <input type="checkbox"/> Two <input type="checkbox"/> Three</p> <hr/> <p>Notes:</p>

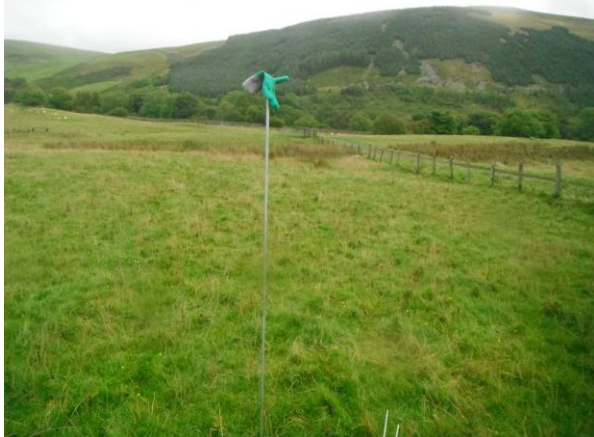
CATEGORY			SCORE
Rainfall	1870	Moderate altitude, Moderate rainfall.	100
Moisture conditions	☑ Dry ☐ Patchy ☐ Part saturated ☐ Saturated ☐ Waterlogged Ditches: ☑ No ditches ☐ Dry ☐ Flowing ☐ Ponded		3
Substrata	☐ Peat ☐ Clay ☑ Sand/Gravel ☐ Rock Strength (kPa): ☐ <10 ☐ 10-20 ☐ 20-30 ☐ 30-40 ☑ >40		3
Strata details	Peat depth = 0.0 m	Probe depth = 0.1 m	1
	Layer 1 not applicable Layer 2 not applicable Layer 3 not applicable		1
Slope details	North-east facing Undulating slope of 2 degrees.		6
Morphology	☐ None ☑ Few ☐ Several ☐ Many ☐ Minor ☑ Moderate ☐ Major Man-made: Track. Fence/wall. Natural: Non-peat failure. Exposed bedrock.		8
Sub-profile drainage	☐ None ☐ Seepage points Depressions: ☐ Dry ☐ Sink point Soil pipes: ☐ Minor ☐ Moderate ☐ Major ☐ Collapsed Sink holes: ☐ Minor ☐ Moderate ☐ Major Grassy flush: ☑ Minor ☐ Major Spacing: 10-20m		11
Peat slide history	☑ None ☐ Few ☐ Several ☐ Many ☐ Minor ☐ Moderate ☐ Major Extent if present:		1

Location sensitivity	☐ Low ☑ Medium ☐ High ☐ Very high Reason: track, fence		3
OVERALL SCORE			71

<p style="text-align: center;"><u>Vegetation</u></p> <p>Conifer: <input type="checkbox"/> Young <input type="checkbox"/> Semi-mature <input type="checkbox"/> Mature</p> <p>Deciduous: <input type="checkbox"/> Young <input type="checkbox"/> Semi-mature <input type="checkbox"/> Mature</p> <p><input type="checkbox"/> Sphagnum moss <input type="checkbox"/> Staghorn moss</p> <p><input type="checkbox"/> Other mosses <input type="checkbox"/> Cotton grass <input checked="" type="checkbox"/> Rushes</p> <p><input checked="" type="checkbox"/> Other grasses <input type="checkbox"/> Heather <input type="checkbox"/> Fern</p> <p><input type="checkbox"/> Shrubs <input type="checkbox"/> Leaf litter <input type="checkbox"/> Bracken</p> <p>Other:</p> <hr/> <p>Terrain category: <input checked="" type="checkbox"/> One <input type="checkbox"/> Two <input type="checkbox"/> Three</p> <hr/> <p>Notes:</p>

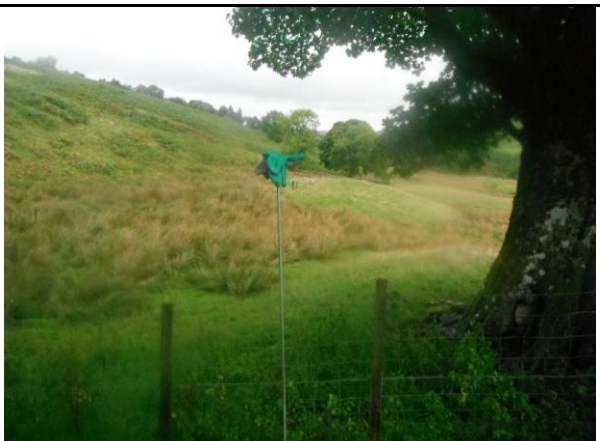
CATEGORY			SCORE
Rainfall	1870	Moderate altitude, Moderate rainfall.	100
Moisture conditions	<input checked="" type="checkbox"/> Dry <input type="checkbox"/> Patchy <input type="checkbox"/> Part saturated <input type="checkbox"/> Saturated <input type="checkbox"/> Waterlogged Ditches: <input type="checkbox"/> No ditches <input type="checkbox"/> Dry <input checked="" type="checkbox"/> Flowing <input type="checkbox"/> Ponded		5
Substrata	<input type="checkbox"/> Peat <input type="checkbox"/> Clay <input checked="" type="checkbox"/> Sand/Gravel <input type="checkbox"/> Rock Strength (kPa): <input type="checkbox"/> <10 <input type="checkbox"/> 10-20 <input type="checkbox"/> 20-30 <input type="checkbox"/> 30-40 <input checked="" type="checkbox"/> >40		3
Strata details	Peat depth = 0.0 m		1
	Probe depth = 0.1 m		
	Layer 1 not applicable Layer 2 not applicable Layer 3 not applicable		1
Slope details	North-west facing Undulating slope of 7 degrees.		18

<p style="text-align: center;"><u>Vegetation</u></p> <p>Conifer: <input type="checkbox"/> Young <input type="checkbox"/> Semi-mature <input type="checkbox"/> Mature</p> <p>Deciduous: <input type="checkbox"/> Young <input type="checkbox"/> Semi-mature <input checked="" type="checkbox"/> Mature</p> <p><input type="checkbox"/> Sphagnum moss <input type="checkbox"/> Staghorn moss</p> <p><input type="checkbox"/> Other mosses <input type="checkbox"/> Cotton grass <input checked="" type="checkbox"/> Rushes</p> <p><input checked="" type="checkbox"/> Other grasses <input type="checkbox"/> Heather <input checked="" type="checkbox"/> Fern</p> <p><input type="checkbox"/> Shrubs <input type="checkbox"/> Leaf litter <input type="checkbox"/> Bracken</p> <p>Other:</p> <p>Terrain category: <input checked="" type="checkbox"/> One <input type="checkbox"/> Two <input type="checkbox"/> Three</p> <p>Notes:</p>

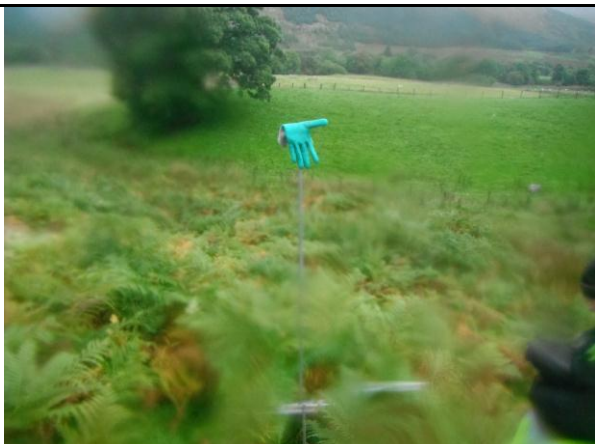
CATEGORY			SCORE
Rainfall	1870	Moderate altitude, Moderate rainfall.	100
Moisture conditions	<input type="checkbox"/> Dry <input type="checkbox"/> Patchy <input checked="" type="checkbox"/> Part saturated <input type="checkbox"/> Saturated <input type="checkbox"/> Waterlogged Ditches: <input type="checkbox"/> No ditches <input type="checkbox"/> Dry <input checked="" type="checkbox"/> Flowing <input type="checkbox"/> Ponded		9
Substrata	<input type="checkbox"/> Peat <input type="checkbox"/> Clay <input checked="" type="checkbox"/> Sand/Gravel <input type="checkbox"/> Rock Strength (kPa): <input type="checkbox"/> <10 <input type="checkbox"/> 10-20 <input type="checkbox"/> 20-30 <input type="checkbox"/> 30-40 <input checked="" type="checkbox"/> >40		3
Strata details	Peat depth = 0.0 m	Probe depth = 0.1 m	1
	Layer 1 not applicable Layer 2 not applicable Layer 3 not applicable		1
Slope details	North-east facing Uneven slope of 16 degrees.		46

Morphology	<input type="checkbox"/> None <input checked="" type="checkbox"/> Few <input type="checkbox"/> Several <input type="checkbox"/> Many <input type="checkbox"/> Minor <input type="checkbox"/> Moderate <input checked="" type="checkbox"/> Major Man-made: Fence/wall. Structure. Dwelling. Natural: Non-peat failure. Exposed bedrock.		18
Sub-profile drainage	<input type="checkbox"/> None <input type="checkbox"/> Seepage points Depressions: <input type="checkbox"/> Dry <input type="checkbox"/> Sink point Soil pipes: <input type="checkbox"/> Minor <input type="checkbox"/> Moderate <input type="checkbox"/> Major <input type="checkbox"/> Collapsed Sink holes: <input type="checkbox"/> Minor <input type="checkbox"/> Moderate <input type="checkbox"/> Major Grassy flush: <input checked="" type="checkbox"/> Minor <input type="checkbox"/> Major Spacing: 10-20m		11
Peat slide history	<input checked="" type="checkbox"/> None <input type="checkbox"/> Few <input type="checkbox"/> Several <input type="checkbox"/> Many <input type="checkbox"/> Minor <input type="checkbox"/> Moderate <input type="checkbox"/> Major Extent if present:		1

<p align="center"><u>Vegetation</u></p> <p>Conifer: <input type="checkbox"/> Young <input type="checkbox"/> Semi-mature <input type="checkbox"/> Mature</p> <p>Deciduous: <input type="checkbox"/> Young <input type="checkbox"/> Semi-mature <input type="checkbox"/> Mature</p> <p><input type="checkbox"/> Sphagnum moss <input type="checkbox"/> Staghorn moss</p> <p><input type="checkbox"/> Other mosses <input type="checkbox"/> Cotton grass <input checked="" type="checkbox"/> Rushes</p> <p><input checked="" type="checkbox"/> Other grasses <input type="checkbox"/> Heather <input checked="" type="checkbox"/> Fern</p> <p><input type="checkbox"/> Shrubs <input type="checkbox"/> Leaf litter <input type="checkbox"/> Bracken</p> <p>Other:</p>

<p>Terrain category: <input type="checkbox"/> One <input checked="" type="checkbox"/> Two <input type="checkbox"/> Three</p>	
<p>Notes:</p>

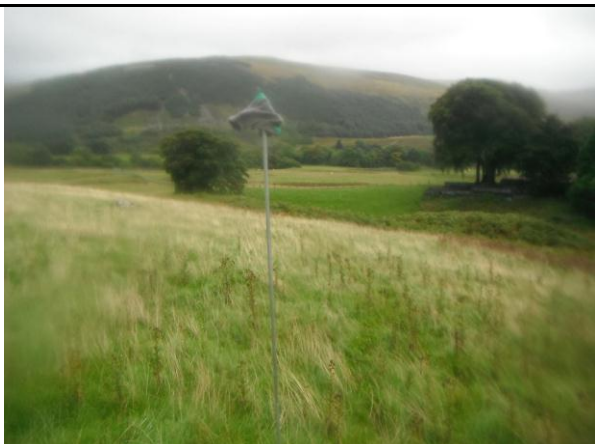
CATEGORY			SCORE
Rainfall	1870	Moderate altitude, Moderate rainfall.	100
Moisture conditions	<input checked="" type="checkbox"/> Dry <input type="checkbox"/> Patchy <input type="checkbox"/> Part saturated <input type="checkbox"/> Saturated <input type="checkbox"/> Waterlogged Ditches: <input checked="" type="checkbox"/> No ditches <input type="checkbox"/> Dry <input type="checkbox"/> Flowing <input type="checkbox"/> Ponded		3
Substrata	<input type="checkbox"/> Peat <input type="checkbox"/> Clay <input type="checkbox"/> Sand/Gravel <input checked="" type="checkbox"/> Rock Strength (kPa): <input type="checkbox"/> <10 <input type="checkbox"/> 10-20 <input type="checkbox"/> 20-30 <input type="checkbox"/> 30-40 <input checked="" type="checkbox"/> >40		8
Strata details	Peat depth = 0.0 m	Probe depth = 0.1 m	1
	Layer 1 not applicable Layer 2 not applicable Layer 3 not applicable		1
Slope details	North-east facing Undulating slope of 7 degrees.		18

Morphology	<input type="checkbox"/> None <input checked="" type="checkbox"/> Few <input type="checkbox"/> Several <input type="checkbox"/> Many <input type="checkbox"/> Minor <input type="checkbox"/> Moderate <input checked="" type="checkbox"/> Major Man-made: Fence/wall. Dwelling. Natural: Non-peat failure. Exposed bedrock.		18
Sub-profile drainage	<input type="checkbox"/> None <input type="checkbox"/> Seepage points Depressions: <input type="checkbox"/> Dry <input type="checkbox"/> Sink point Soil pipes: <input type="checkbox"/> Minor <input type="checkbox"/> Moderate <input type="checkbox"/> Major <input type="checkbox"/> Collapsed Sink holes: <input type="checkbox"/> Minor <input type="checkbox"/> Moderate <input type="checkbox"/> Major Grassy flush: <input checked="" type="checkbox"/> Minor <input type="checkbox"/> Major Spacing: 10-20m		11
Peat slide history	<input checked="" type="checkbox"/> None <input type="checkbox"/> Few <input type="checkbox"/> Several <input type="checkbox"/> Many <input type="checkbox"/> Minor <input type="checkbox"/> Moderate <input type="checkbox"/> Major Extent if present:		1

<p style="text-align: center;"><u>Vegetation</u></p> <p>Conifer: <input type="checkbox"/> Young <input type="checkbox"/> Semi-mature <input type="checkbox"/> Mature</p> <p>Deciduous: <input type="checkbox"/> Young <input type="checkbox"/> Semi-mature <input checked="" type="checkbox"/> Mature</p> <p><input type="checkbox"/> Sphagnum moss <input type="checkbox"/> Staghorn moss</p> <p><input type="checkbox"/> Other mosses <input type="checkbox"/> Cotton grass <input checked="" type="checkbox"/> Rushes</p> <p><input checked="" type="checkbox"/> Other grasses <input type="checkbox"/> Heather <input checked="" type="checkbox"/> Fern</p> <p><input type="checkbox"/> Shrubs <input type="checkbox"/> Leaf litter <input type="checkbox"/> Bracken</p> <p>Other:</p> <p>Terrain category: <input checked="" type="checkbox"/> One <input type="checkbox"/> Two <input type="checkbox"/> Three</p> <p>Notes:</p>

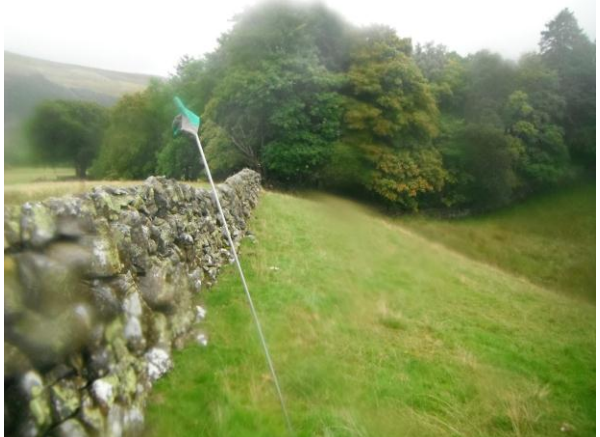
CATEGORY			SCORE
Rainfall	1870	Moderate altitude, Moderate rainfall.	100
Moisture conditions	<input checked="" type="checkbox"/> Dry <input type="checkbox"/> Patchy <input type="checkbox"/> Part saturated <input type="checkbox"/> Saturated <input type="checkbox"/> Waterlogged Ditches: <input checked="" type="checkbox"/> No ditches <input type="checkbox"/> Dry <input type="checkbox"/> Flowing <input type="checkbox"/> Ponded		3
Substrata	<input type="checkbox"/> Peat <input type="checkbox"/> Clay <input type="checkbox"/> Sand/Gravel <input checked="" type="checkbox"/> Rock Strength (kPa): <input type="checkbox"/> <10 <input type="checkbox"/> 10-20 <input type="checkbox"/> 20-30 <input type="checkbox"/> 30-40 <input checked="" type="checkbox"/> >40		8
Strata details	Peat depth = 0.0 m		1
	Probe depth = 0.1 m		
	Layer 1 not applicable Layer 2 not applicable Layer 3 not applicable		1
Slope details	South facing Gently Undulating slope of 16 degrees.		41

Location sensitivity	<input type="checkbox"/> Low <input type="checkbox"/> Medium <input checked="" type="checkbox"/> High <input type="checkbox"/> Very high Reason: house, 35 degree slope, dry stone wall		9
OVERALL SCORE			127

<p align="center"><u>Vegetation</u></p> <p>Conifer: <input type="checkbox"/> Young <input type="checkbox"/> Semi-mature <input type="checkbox"/> Mature</p> <p>Deciduous: <input type="checkbox"/> Young <input type="checkbox"/> Semi-mature <input checked="" type="checkbox"/> Mature</p> <p><input type="checkbox"/> Sphagnum moss <input type="checkbox"/> Staghorn moss</p> <p><input type="checkbox"/> Other mosses <input type="checkbox"/> Cotton grass <input checked="" type="checkbox"/> Rushes</p> <p><input checked="" type="checkbox"/> Other grasses <input type="checkbox"/> Heather <input type="checkbox"/> Fern</p> <p><input type="checkbox"/> Shrubs <input type="checkbox"/> Leaf litter <input type="checkbox"/> Bracken</p> <p>Other:</p> <hr/> <p>Terrain category: <input type="checkbox"/> One <input checked="" type="checkbox"/> Two <input type="checkbox"/> Three</p> <hr/> <p>Notes:</p>

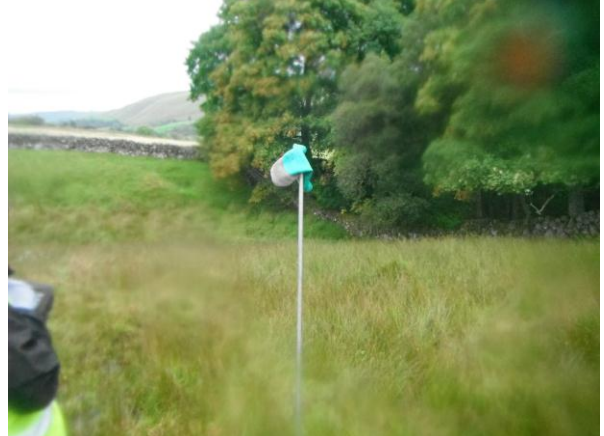
CATEGORY			SCORE
Rainfall	1870	Moderate altitude, Moderate rainfall.	100
Moisture conditions	<input type="checkbox"/> Dry <input type="checkbox"/> Patchy <input type="checkbox"/> Part saturated <input checked="" type="checkbox"/> Saturated <input type="checkbox"/> Waterlogged Ditches: <input checked="" type="checkbox"/> No ditches <input type="checkbox"/> Dry <input type="checkbox"/> Flowing <input type="checkbox"/> Ponded		15
Substrata	<input type="checkbox"/> Peat <input type="checkbox"/> Clay <input type="checkbox"/> Sand/Gravel <input checked="" type="checkbox"/> Rock Strength (kPa): <input type="checkbox"/> <10 <input type="checkbox"/> 10-20 <input type="checkbox"/> 20-30 <input type="checkbox"/> 30-40 <input checked="" type="checkbox"/> >40		8
Strata details	Peat depth = 0.0 m	Probe depth = 0.5 m	1
	Layer 1 not applicable Layer 2 not applicable Layer 3 not applicable		1
Slope details	North facing Undulating slope of 6 degrees. Nearby, 10m to the North, the slope changes to 16 degrees facing North-west.		20

Morphology	<input type="checkbox"/> None <input checked="" type="checkbox"/> Few <input type="checkbox"/> Several <input type="checkbox"/> Many <input type="checkbox"/> Minor <input type="checkbox"/> Moderate <input checked="" type="checkbox"/> Major Man-made: Fence/wall. Structure. Dwelling. Natural: Non-peat failure. Exposed bedrock.		18
Sub-profile drainage	<input type="checkbox"/> None <input checked="" type="checkbox"/> Seepage points Depressions: <input type="checkbox"/> Dry <input type="checkbox"/> Sink point Soil pipes: <input type="checkbox"/> Minor <input type="checkbox"/> Moderate <input type="checkbox"/> Major <input type="checkbox"/> Collapsed Sink holes: <input type="checkbox"/> Minor <input type="checkbox"/> Moderate <input type="checkbox"/> Major Grassy flush: <input checked="" type="checkbox"/> Minor <input type="checkbox"/> Major Spacing: 10-20m		16
Peat slide history	<input checked="" type="checkbox"/> None <input type="checkbox"/> Few <input type="checkbox"/> Several <input type="checkbox"/> Many <input type="checkbox"/> Minor <input type="checkbox"/> Moderate <input type="checkbox"/> Major Extent if present:		1

<u>Vegetation</u> Conifer: <input type="checkbox"/> Young <input type="checkbox"/> Semi-mature <input type="checkbox"/> Mature Deciduous: <input type="checkbox"/> Young <input type="checkbox"/> Semi-mature <input checked="" type="checkbox"/> Mature <input type="checkbox"/> Sphagnum moss <input type="checkbox"/> Staghorn moss <input type="checkbox"/> Other mosses <input type="checkbox"/> Cotton grass <input checked="" type="checkbox"/> Rushes <input checked="" type="checkbox"/> Other grasses <input type="checkbox"/> Heather <input type="checkbox"/> Fern <input type="checkbox"/> Shrubs <input type="checkbox"/> Leaf litter <input type="checkbox"/> Bracken Other:

Terrain category: <input type="checkbox"/> One <input checked="" type="checkbox"/> Two <input type="checkbox"/> Three	
Notes:

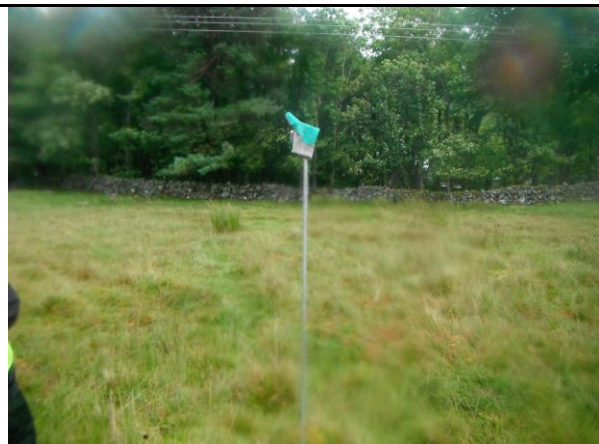
CATEGORY			SCORE
Rainfall	1870	Moderate altitude, Moderate rainfall.	100
Moisture conditions	<input type="checkbox"/> Dry <input type="checkbox"/> Patchy <input checked="" type="checkbox"/> Part saturated <input type="checkbox"/> Saturated <input type="checkbox"/> Waterlogged Ditches: <input checked="" type="checkbox"/> No ditches <input type="checkbox"/> Dry <input type="checkbox"/> Flowing <input type="checkbox"/> Ponded		10
Substrata	<input type="checkbox"/> Peat <input type="checkbox"/> Clay <input type="checkbox"/> Sand/Gravel <input checked="" type="checkbox"/> Rock Strength (kPa): <input type="checkbox"/> <10 <input type="checkbox"/> 10-20 <input type="checkbox"/> 20-30 <input type="checkbox"/> 30-40 <input checked="" type="checkbox"/> >40		8
Strata details	Peat depth = 0.0 m	Probe depth = 0.1 m	1
	Layer 1 not applicable Layer 2 not applicable Layer 3 not applicable		1
Slope details	North-east facing Gently Undulating slope of 3 degrees.		6

Morphology	<input type="checkbox"/> None <input checked="" type="checkbox"/> Few <input type="checkbox"/> Several <input type="checkbox"/> Many <input type="checkbox"/> Minor <input type="checkbox"/> Moderate <input checked="" type="checkbox"/> Major Man-made: Fence/wall. Structure. Dwelling. Natural: Non-peat failure.		18
Sub-profile drainage	<input type="checkbox"/> None <input type="checkbox"/> Seepage points Depressions: <input type="checkbox"/> Dry <input type="checkbox"/> Sink point Soil pipes: <input type="checkbox"/> Minor <input type="checkbox"/> Moderate <input type="checkbox"/> Major <input type="checkbox"/> Collapsed Sink holes: <input type="checkbox"/> Minor <input type="checkbox"/> Moderate <input type="checkbox"/> Major Grassy flush: <input checked="" type="checkbox"/> Minor <input type="checkbox"/> Major Spacing: Isolated		7
Peat slide history	<input checked="" type="checkbox"/> None <input type="checkbox"/> Few <input type="checkbox"/> Several <input type="checkbox"/> Many <input type="checkbox"/> Minor <input type="checkbox"/> Moderate <input type="checkbox"/> Major Extent if present:		1

<p><u>Vegetation</u></p> <p>Conifer: <input type="checkbox"/> Young <input type="checkbox"/> Semi-mature <input type="checkbox"/> Mature</p> <p>Deciduous: <input type="checkbox"/> Young <input type="checkbox"/> Semi-mature <input checked="" type="checkbox"/> Mature</p> <p><input type="checkbox"/> Sphagnum moss <input type="checkbox"/> Staghorn moss</p> <p><input type="checkbox"/> Other mosses <input type="checkbox"/> Cotton grass <input checked="" type="checkbox"/> Rushes</p> <p><input checked="" type="checkbox"/> Other grasses <input type="checkbox"/> Heather <input type="checkbox"/> Fern</p> <p><input type="checkbox"/> Shrubs <input type="checkbox"/> Leaf litter <input type="checkbox"/> Bracken</p> <p>Other:</p>

<p>Terrain category: <input checked="" type="checkbox"/> One <input type="checkbox"/> Two <input type="checkbox"/> Three</p>	
<p>Notes:</p>

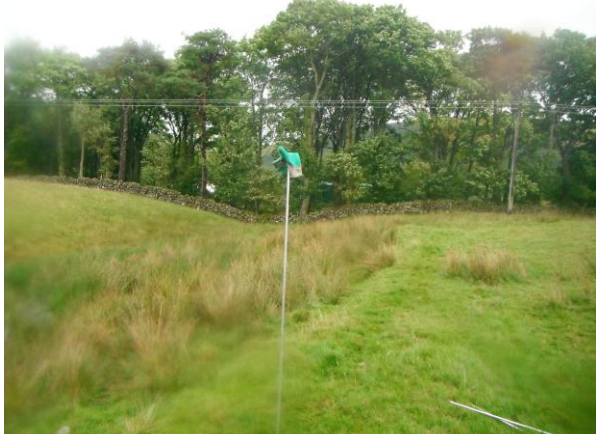
CATEGORY			SCORE
Rainfall	1870	Moderate altitude, Moderate rainfall.	100
Moisture conditions	<input type="checkbox"/> Dry <input type="checkbox"/> Patchy <input type="checkbox"/> Part saturated <input type="checkbox"/> Saturated <input checked="" type="checkbox"/> Waterlogged Ditches: <input type="checkbox"/> No ditches <input type="checkbox"/> Dry <input checked="" type="checkbox"/> Flowing <input type="checkbox"/> Ponded		23
Substrata	<input type="checkbox"/> Peat <input checked="" type="checkbox"/> Clay <input type="checkbox"/> Sand/Gravel <input type="checkbox"/> Rock Strength (kPa): <input type="checkbox"/> <10 <input type="checkbox"/> 10-20 <input type="checkbox"/> 20-30 <input type="checkbox"/> 30-40 <input checked="" type="checkbox"/> >40		10
Strata details	Peat depth = 0.0 m	Probe depth = 0.1 m	1
	Layer 1 not applicable Layer 2 not applicable Layer 3 not applicable		1
Slope details	North-east facing Uneven slope of 5 degrees.		15

Location sensitivity	<input type="checkbox"/> Low <input type="checkbox"/> Medium <input checked="" type="checkbox"/> High <input type="checkbox"/> Very high Reason: watercourse, fences , house		9
OVERALL SCORE			128

<p style="text-align: center;"><u>Vegetation</u></p> <p>Conifer: <input type="checkbox"/> Young <input type="checkbox"/> Semi-mature <input type="checkbox"/> Mature</p> <p>Deciduous: <input type="checkbox"/> Young <input type="checkbox"/> Semi-mature <input checked="" type="checkbox"/> Mature</p> <p><input type="checkbox"/> Sphagnum moss <input type="checkbox"/> Staghorn moss</p> <p><input type="checkbox"/> Other mosses <input type="checkbox"/> Cotton grass <input checked="" type="checkbox"/> Rushes</p> <p><input checked="" type="checkbox"/> Other grasses <input type="checkbox"/> Heather <input type="checkbox"/> Fern</p> <p><input type="checkbox"/> Shrubs <input type="checkbox"/> Leaf litter <input type="checkbox"/> Bracken</p> <p>Other:</p> <hr/> <p>Terrain category: <input type="checkbox"/> One <input checked="" type="checkbox"/> Two <input type="checkbox"/> Three</p> <hr/> <p>Notes:</p>

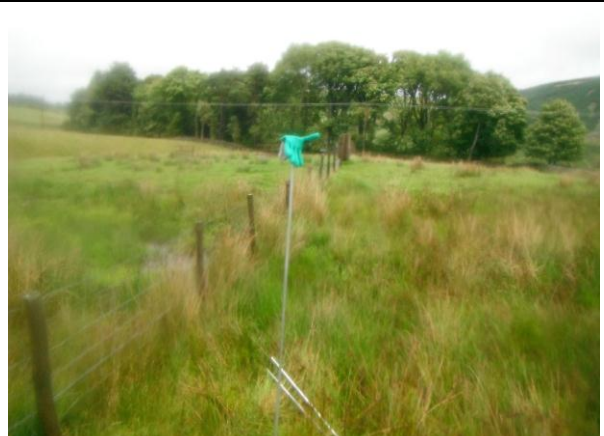
CATEGORY			SCORE
Rainfall	1870	Moderate altitude, Moderate rainfall.	100
Moisture conditions	<input type="checkbox"/> Dry <input type="checkbox"/> Patchy <input type="checkbox"/> Part saturated <input type="checkbox"/> Saturated <input checked="" type="checkbox"/> Waterlogged Ditches: <input type="checkbox"/> No ditches <input type="checkbox"/> Dry <input checked="" type="checkbox"/> Flowing <input type="checkbox"/> Ponded		45
Substrata	<input type="checkbox"/> Peat <input checked="" type="checkbox"/> Clay <input type="checkbox"/> Sand/Gravel <input type="checkbox"/> Rock Strength (kPa): <input type="checkbox"/> <10 <input type="checkbox"/> 10-20 <input type="checkbox"/> 20-30 <input type="checkbox"/> 30-40 <input checked="" type="checkbox"/> >40		20
Strata details	Peat depth = 1.6 m		5
	Probe depth = 1.6 m		
	Layer 1, from ground level to 1.6 mBGL at 20-30 kPa Layer 2 not applicable Layer 3 not applicable		15

<p align="center"><u>Vegetation</u></p> <p>Conifer: <input type="checkbox"/> Young <input type="checkbox"/> Semi-mature <input type="checkbox"/> Mature</p> <p>Deciduous: <input type="checkbox"/> Young <input type="checkbox"/> Semi-mature <input type="checkbox"/> Mature</p> <p><input type="checkbox"/> Sphagnum moss <input type="checkbox"/> Staghorn moss</p> <p><input type="checkbox"/> Other mosses <input type="checkbox"/> Cotton grass <input checked="" type="checkbox"/> Rushes</p> <p><input checked="" type="checkbox"/> Other grasses <input type="checkbox"/> Heather <input type="checkbox"/> Fern</p> <p><input type="checkbox"/> Shrubs <input type="checkbox"/> Leaf litter <input type="checkbox"/> Bracken</p> <p>Other:</p> <hr/> <p>Terrain category: <input type="checkbox"/> One <input checked="" type="checkbox"/> Two <input type="checkbox"/> Three</p> <hr/> <p>Notes:</p>

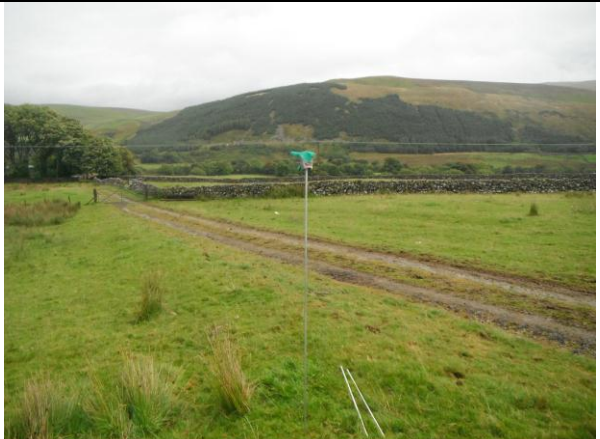
CATEGORY			SCORE
Rainfall	1870	Moderate altitude, Moderate rainfall.	100
Moisture conditions	<input type="checkbox"/> Dry <input type="checkbox"/> Patchy <input checked="" type="checkbox"/> Part saturated <input type="checkbox"/> Saturated <input type="checkbox"/> Waterlogged Ditches: <input type="checkbox"/> No ditches <input type="checkbox"/> Dry <input checked="" type="checkbox"/> Flowing <input type="checkbox"/> Ponded		9
Substrata	<input type="checkbox"/> Peat <input type="checkbox"/> Clay <input type="checkbox"/> Sand/Gravel <input checked="" type="checkbox"/> Rock Strength (kPa): <input type="checkbox"/> <10 <input type="checkbox"/> 10-20 <input type="checkbox"/> 20-30 <input type="checkbox"/> 30-40 <input checked="" type="checkbox"/> >40		8
Strata details	Peat depth = 0.0 m	Probe depth = 0.1 m	1
	Layer 1 not applicable Layer 2 not applicable Layer 3 not applicable		1
Slope details	North facing Even slope of 4 degrees.		7

Morphology	<input type="checkbox"/> None <input checked="" type="checkbox"/> Few <input type="checkbox"/> Several <input type="checkbox"/> Many <input type="checkbox"/> Minor <input checked="" type="checkbox"/> Moderate <input type="checkbox"/> Major Man-made: Track. Fence/wall. Natural: Non-peat failure. Exposed bedrock.		8
Sub-profile drainage	<input type="checkbox"/> None <input type="checkbox"/> Seepage points Depressions: <input type="checkbox"/> Dry <input type="checkbox"/> Sink point Soil pipes: <input type="checkbox"/> Minor <input type="checkbox"/> Moderate <input type="checkbox"/> Major <input type="checkbox"/> Collapsed Sink holes: <input type="checkbox"/> Minor <input type="checkbox"/> Moderate <input type="checkbox"/> Major Grassy flush: <input checked="" type="checkbox"/> Minor <input type="checkbox"/> Major Spacing: 10-20m		11
Peat slide history	<input checked="" type="checkbox"/> None <input type="checkbox"/> Few <input type="checkbox"/> Several <input type="checkbox"/> Many <input type="checkbox"/> Minor <input type="checkbox"/> Moderate <input type="checkbox"/> Major Extent if present:		1

<p align="center"><u>Vegetation</u></p> <p>Conifer: <input type="checkbox"/> Young <input type="checkbox"/> Semi-mature <input type="checkbox"/> Mature</p> <p>Deciduous: <input type="checkbox"/> Young <input type="checkbox"/> Semi-mature <input type="checkbox"/> Mature</p> <p><input type="checkbox"/> Sphagnum moss <input type="checkbox"/> Staghorn moss</p> <p><input type="checkbox"/> Other mosses <input type="checkbox"/> Cotton grass <input checked="" type="checkbox"/> Rushes</p> <p><input checked="" type="checkbox"/> Other grasses <input type="checkbox"/> Heather <input type="checkbox"/> Fern</p> <p><input type="checkbox"/> Shrubs <input type="checkbox"/> Leaf litter <input type="checkbox"/> Bracken</p> <p>Other:</p> <hr/> <p>Terrain category: <input checked="" type="checkbox"/> One <input type="checkbox"/> Two <input type="checkbox"/> Three</p> <hr/> <p>Notes:</p>

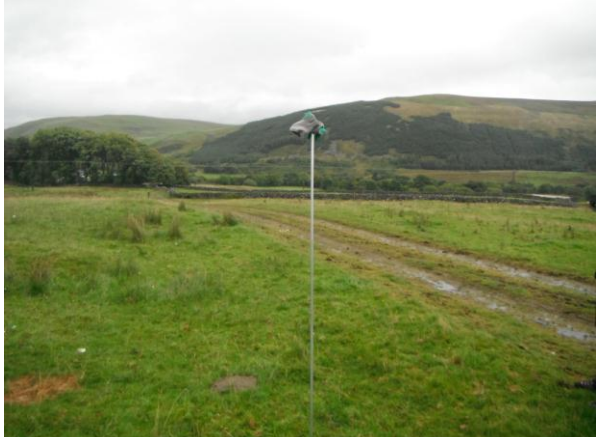
CATEGORY			SCORE
Rainfall	1870	Moderate altitude, Moderate rainfall.	100
Moisture conditions	<input checked="" type="checkbox"/> Dry <input type="checkbox"/> Patchy <input type="checkbox"/> Part saturated <input type="checkbox"/> Saturated <input type="checkbox"/> Waterlogged Ditches: <input checked="" type="checkbox"/> No ditches <input type="checkbox"/> Dry <input type="checkbox"/> Flowing <input type="checkbox"/> Ponded		3
Substrata	<input type="checkbox"/> Peat <input type="checkbox"/> Clay <input type="checkbox"/> Sand/Gravel <input checked="" type="checkbox"/> Rock Strength (kPa): <input type="checkbox"/> <10 <input type="checkbox"/> 10-20 <input type="checkbox"/> 20-30 <input type="checkbox"/> 30-40 <input checked="" type="checkbox"/> >40		8
Strata details	Peat depth = 0.1 m		1
	Probe depth = 0.1 m		
	Layer 1, from ground level to 0.1 mBGL at 20-30 kPa Layer 2 not applicable Layer 3 not applicable		2

Slope details	North-east facing Undulating slope of 4 degrees.		10
Morphology	<input type="checkbox"/> None <input checked="" type="checkbox"/> Few <input type="checkbox"/> Several <input type="checkbox"/> Many <input type="checkbox"/> Minor <input checked="" type="checkbox"/> Moderate <input type="checkbox"/> Major Man-made: Track. Fence/wall. Natural: Non-peat failure. Exposed bedrock.		8
Sub-profile drainage	<input type="checkbox"/> None <input type="checkbox"/> Seepage points Depressions: <input type="checkbox"/> Dry <input type="checkbox"/> Sink point Soil pipes: <input type="checkbox"/> Minor <input type="checkbox"/> Moderate <input type="checkbox"/> Major <input type="checkbox"/> Collapsed Sink holes: <input type="checkbox"/> Minor <input type="checkbox"/> Moderate <input type="checkbox"/> Major Grassy flush: <input checked="" type="checkbox"/> Minor <input type="checkbox"/> Major Spacing: 10-20m		11

Peat slide history	<input checked="" type="checkbox"/> None <input type="checkbox"/> Few <input type="checkbox"/> Several <input type="checkbox"/> Many <input type="checkbox"/> Minor <input type="checkbox"/> Moderate <input type="checkbox"/> Major Extent if present:		1
Location sensitivity	<input type="checkbox"/> Low <input checked="" type="checkbox"/> Medium <input type="checkbox"/> High <input type="checkbox"/> Very high Reason: track		3
OVERALL SCORE			81

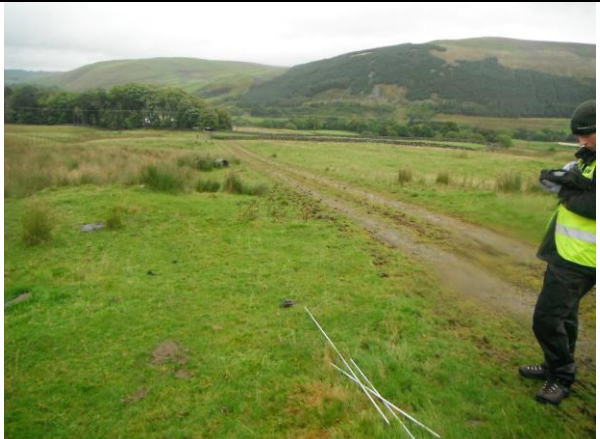
CATEGORY			SCORE
Rainfall	1870	Moderate altitude, Moderate rainfall.	100
Moisture conditions	☑ Dry ☐ Patchy ☐ Part saturated ☐ Saturated ☐ Waterlogged Ditches: ☑ No ditches ☐ Dry ☐ Flowing ☐ Ponded		3
Substrata	☐ Peat ☐ Clay ☐ Sand/Gravel ☑ Rock Strength (kPa): ☐ <10 ☐ 10-20 ☐ 20-30 ☐ 30-40 ☑ >40		8
Strata details	Peat depth = 0.0 m	Probe depth = 0.1 m	1
	Layer 1 not applicable Layer 2 not applicable Layer 3 not applicable		1
Slope details	North-east facing Uneven slope of 7 degrees.		21
Morphology	☐ None ☑ Few ☐ Several ☐ Many ☐ Minor ☑ Moderate ☐ Major Man-made: Track. Fence/wall. Natural: Non-peat failure. Exposed bedrock.		8
Sub-profile drainage	☐ None ☐ Seepage points Depressions: ☐ Dry ☐ Sink point Soil pipes: ☐ Minor ☐ Moderate ☐ Major ☐ Collapsed Sink holes: ☐ Minor ☐ Moderate ☐ Major Grassy flush: ☑ Minor ☐ Major Spacing: 10-20m		11
Peat slide history	☑ None ☐ Few ☐ Several ☐ Many ☐ Minor ☐ Moderate ☐ Major Extent if present:		1

<p align="center"><u>Vegetation</u></p> <p>Conifer: <input type="checkbox"/> Young <input type="checkbox"/> Semi-mature <input type="checkbox"/> Mature</p> <p>Deciduous: <input type="checkbox"/> Young <input type="checkbox"/> Semi-mature <input type="checkbox"/> Mature</p> <p><input type="checkbox"/> Sphagnum moss <input type="checkbox"/> Staghorn moss</p> <p><input type="checkbox"/> Other mosses <input type="checkbox"/> Cotton grass <input checked="" type="checkbox"/> Rushes</p> <p><input checked="" type="checkbox"/> Other grasses <input type="checkbox"/> Heather <input type="checkbox"/> Fern</p> <p><input type="checkbox"/> Shrubs <input type="checkbox"/> Leaf litter <input type="checkbox"/> Bracken</p> <p>Other:</p> <p>Terrain category: <input checked="" type="checkbox"/> One <input type="checkbox"/> Two <input type="checkbox"/> Three</p> <p>Notes:</p>

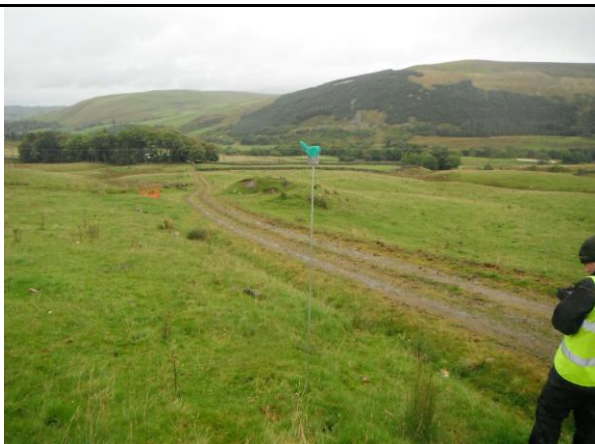
CATEGORY			SCORE
Rainfall	1870	Moderate altitude, Moderate rainfall.	100
Moisture conditions	<input checked="" type="checkbox"/> Dry <input type="checkbox"/> Patchy <input type="checkbox"/> Part saturated <input type="checkbox"/> Saturated <input type="checkbox"/> Waterlogged Ditches: <input type="checkbox"/> No ditches <input checked="" type="checkbox"/> Dry <input type="checkbox"/> Flowing <input type="checkbox"/> Ponded		2
Substrata	<input type="checkbox"/> Peat <input type="checkbox"/> Clay <input type="checkbox"/> Sand/Gravel <input checked="" type="checkbox"/> Rock Strength (kPa): <input type="checkbox"/> <10 <input type="checkbox"/> 10-20 <input type="checkbox"/> 20-30 <input type="checkbox"/> 30-40 <input checked="" type="checkbox"/> >40		8
Strata details	Peat depth = 0.0 m	Probe depth = 0.1 m	1
	Layer 1 not applicable Layer 2 not applicable Layer 3 not applicable		1
Slope details	North-east facing Uneven slope of 10 degrees.		36

Morphology	<input type="checkbox"/> None <input checked="" type="checkbox"/> Few <input type="checkbox"/> Several <input type="checkbox"/> Many <input type="checkbox"/> Minor <input checked="" type="checkbox"/> Moderate <input type="checkbox"/> Major Man-made: Track. Fence/wall. Natural: Non-peat failure. Exposed bedrock.		8
Sub-profile drainage	<input type="checkbox"/> None <input type="checkbox"/> Seepage points Depressions: <input type="checkbox"/> Dry <input type="checkbox"/> Sink point Soil pipes: <input type="checkbox"/> Minor <input type="checkbox"/> Moderate <input type="checkbox"/> Major <input type="checkbox"/> Collapsed Sink holes: <input type="checkbox"/> Minor <input type="checkbox"/> Moderate <input type="checkbox"/> Major Grassy flush: <input checked="" type="checkbox"/> Minor <input type="checkbox"/> Major Spacing: 10-20m		11
Peat slide history	<input checked="" type="checkbox"/> None <input type="checkbox"/> Few <input type="checkbox"/> Several <input type="checkbox"/> Many <input type="checkbox"/> Minor <input type="checkbox"/> Moderate <input type="checkbox"/> Major Extent if present:		1

<p style="text-align: center;"><u>Vegetation</u></p> <p>Conifer: <input type="checkbox"/> Young <input type="checkbox"/> Semi-mature <input type="checkbox"/> Mature</p> <p>Deciduous: <input type="checkbox"/> Young <input type="checkbox"/> Semi-mature <input type="checkbox"/> Mature</p> <p><input type="checkbox"/> Sphagnum moss <input type="checkbox"/> Staghorn moss</p> <p><input type="checkbox"/> Other mosses <input type="checkbox"/> Cotton grass <input checked="" type="checkbox"/> Rushes</p> <p><input checked="" type="checkbox"/> Other grasses <input type="checkbox"/> Heather <input type="checkbox"/> Fern</p> <p><input type="checkbox"/> Shrubs <input type="checkbox"/> Leaf litter <input type="checkbox"/> Bracken</p> <p>Other:</p> <hr/> <p>Terrain category: <input type="checkbox"/> One <input checked="" type="checkbox"/> Two <input type="checkbox"/> Three</p> <hr/> <p>Notes:</p>

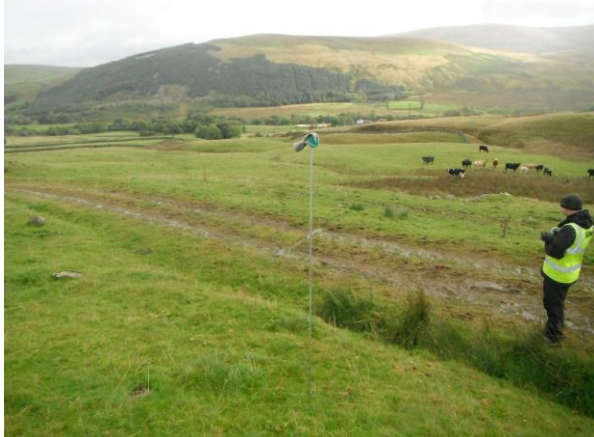
Location sensitivity	<input type="checkbox"/> Low <input checked="" type="checkbox"/> Medium <input type="checkbox"/> High <input type="checkbox"/> Very high Reason: dry stone wall, track		3
OVERALL SCORE			90

<p align="center"><u>Vegetation</u></p> <p>Conifer: <input type="checkbox"/> Young <input type="checkbox"/> Semi-mature <input type="checkbox"/> Mature</p> <p>Deciduous: <input type="checkbox"/> Young <input type="checkbox"/> Semi-mature <input type="checkbox"/> Mature</p> <p><input checked="" type="checkbox"/> Sphagnum moss <input type="checkbox"/> Staghorn moss</p> <p><input type="checkbox"/> Other mosses <input type="checkbox"/> Cotton grass <input checked="" type="checkbox"/> Rushes</p> <p><input checked="" type="checkbox"/> Other grasses <input type="checkbox"/> Heather <input type="checkbox"/> Fern</p> <p><input type="checkbox"/> Shrubs <input type="checkbox"/> Leaf litter <input type="checkbox"/> Bracken</p> <p>Other:</p> <hr/> <p>Terrain category: <input type="checkbox"/> One <input checked="" type="checkbox"/> Two <input type="checkbox"/> Three</p> <hr/> <p>Notes:</p>

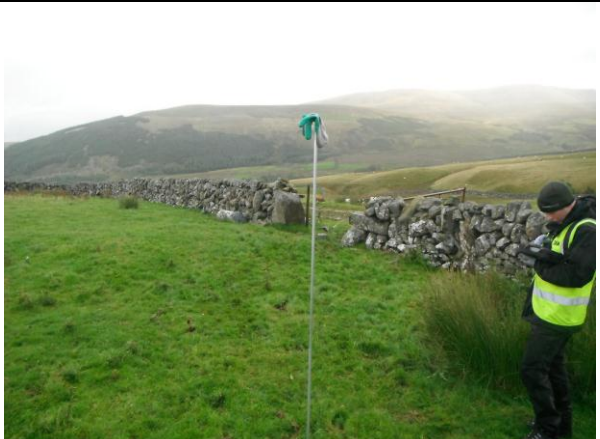
CATEGORY			SCORE
Rainfall	1870	Moderate altitude, Moderate rainfall.	100
Moisture conditions	<input checked="" type="checkbox"/> Dry <input type="checkbox"/> Patchy <input type="checkbox"/> Part saturated <input type="checkbox"/> Saturated <input type="checkbox"/> Waterlogged Ditches: <input type="checkbox"/> No ditches <input checked="" type="checkbox"/> Dry <input type="checkbox"/> Flowing <input type="checkbox"/> Ponded		2
Substrata	<input type="checkbox"/> Peat <input type="checkbox"/> Clay <input type="checkbox"/> Sand/Gravel <input checked="" type="checkbox"/> Rock Strength (kPa): <input type="checkbox"/> <10 <input type="checkbox"/> 10-20 <input type="checkbox"/> 20-30 <input type="checkbox"/> 30-40 <input checked="" type="checkbox"/> >40		8
Strata details	Peat depth = 0.0 m	Probe depth = 0.1 m	1
	Layer 1 not applicable Layer 2 not applicable Layer 3 not applicable		1
Slope details	North-east facing Uneven slope of 8 degrees.		25

<p style="text-align: center;"><u>Vegetation</u></p> <p>Conifer: <input type="checkbox"/> Young <input type="checkbox"/> Semi-mature <input type="checkbox"/> Mature</p> <p>Deciduous: <input type="checkbox"/> Young <input type="checkbox"/> Semi-mature <input type="checkbox"/> Mature</p> <p><input checked="" type="checkbox"/> Sphagnum moss <input type="checkbox"/> Staghorn moss</p> <p><input type="checkbox"/> Other mosses <input type="checkbox"/> Cotton grass <input checked="" type="checkbox"/> Rushes</p> <p><input checked="" type="checkbox"/> Other grasses <input type="checkbox"/> Heather <input type="checkbox"/> Fern</p> <p><input type="checkbox"/> Shrubs <input type="checkbox"/> Leaf litter <input type="checkbox"/> Bracken</p> <p>Other:</p> <p>Terrain category: <input checked="" type="checkbox"/> One <input type="checkbox"/> Two <input type="checkbox"/> Three</p> <p>Notes:</p>

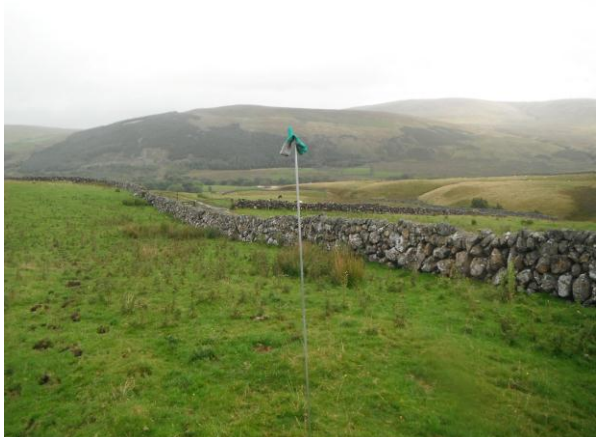
Location sensitivity	<input type="checkbox"/> Low <input checked="" type="checkbox"/> Medium <input type="checkbox"/> High <input type="checkbox"/> Very high Reason: track, dry stone wall		3
OVERALL SCORE			77

<p style="text-align: center;"><u>Vegetation</u></p> <p>Conifer: <input type="checkbox"/> Young <input type="checkbox"/> Semi-mature <input type="checkbox"/> Mature</p> <p>Deciduous: <input type="checkbox"/> Young <input type="checkbox"/> Semi-mature <input type="checkbox"/> Mature</p> <p><input checked="" type="checkbox"/> Sphagnum moss <input type="checkbox"/> Staghorn moss</p> <p><input type="checkbox"/> Other mosses <input type="checkbox"/> Cotton grass <input checked="" type="checkbox"/> Rushes</p> <p><input checked="" type="checkbox"/> Other grasses <input type="checkbox"/> Heather <input type="checkbox"/> Fern</p> <p><input type="checkbox"/> Shrubs <input type="checkbox"/> Leaf litter <input type="checkbox"/> Bracken</p> <p>Other:</p> <p>Terrain category: <input checked="" type="checkbox"/> One <input type="checkbox"/> Two <input type="checkbox"/> Three</p> <p>Notes:</p>

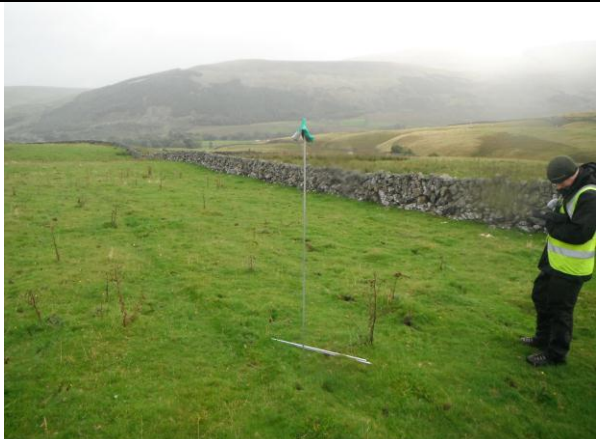
Location sensitivity	☐ Low ☑ Medium ☐ High ☐ Very high Reason: track, dry stone wall		3
OVERALL SCORE			75

<p align="center"><u>Vegetation</u></p> <p>Conifer: <input type="checkbox"/> Young <input type="checkbox"/> Semi-mature <input type="checkbox"/> Mature</p> <p>Deciduous: <input type="checkbox"/> Young <input type="checkbox"/> Semi-mature <input type="checkbox"/> Mature</p> <p><input checked="" type="checkbox"/> Sphagnum moss <input type="checkbox"/> Staghorn moss</p> <p><input type="checkbox"/> Other mosses <input type="checkbox"/> Cotton grass <input checked="" type="checkbox"/> Rushes</p> <p><input checked="" type="checkbox"/> Other grasses <input type="checkbox"/> Heather <input type="checkbox"/> Fern</p> <p><input type="checkbox"/> Shrubs <input type="checkbox"/> Leaf litter <input type="checkbox"/> Bracken</p> <p>Other:</p> <hr/> <p>Terrain category: <input checked="" type="checkbox"/> One <input type="checkbox"/> Two <input type="checkbox"/> Three</p> <hr/> <p>Notes:</p>

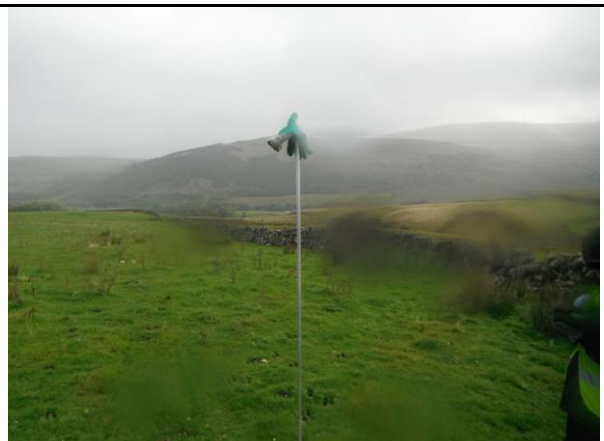
Location sensitivity	<input type="checkbox"/> Low <input checked="" type="checkbox"/> Medium <input type="checkbox"/> High <input type="checkbox"/> Very high Reason: track, dry stone wall		3
OVERALL SCORE			71

<p align="center"><u>Vegetation</u></p> <p>Conifer: <input type="checkbox"/> Young <input type="checkbox"/> Semi-mature <input type="checkbox"/> Mature</p> <p>Deciduous: <input type="checkbox"/> Young <input type="checkbox"/> Semi-mature <input type="checkbox"/> Mature</p> <p><input type="checkbox"/> Sphagnum moss <input type="checkbox"/> Staghorn moss</p> <p><input checked="" type="checkbox"/> Other mosses <input type="checkbox"/> Cotton grass <input checked="" type="checkbox"/> Rushes</p> <p><input checked="" type="checkbox"/> Other grasses <input type="checkbox"/> Heather <input type="checkbox"/> Fern</p> <p><input type="checkbox"/> Shrubs <input type="checkbox"/> Leaf litter <input type="checkbox"/> Bracken</p> <p>Other:</p>
