PROJECT		LOCATION		LANDMARK	
Pencloe		New Cumnock, Scotland		T532	
Co-ords: X	261090	Y	608108	Ref	Grid position

GENERAL		DATE & PERSONNEL		PHOTOGRAPHS
Survey	New	Rated by:	SA	Photo looking West
Date of last survey	N/A	Date	12/09/2013

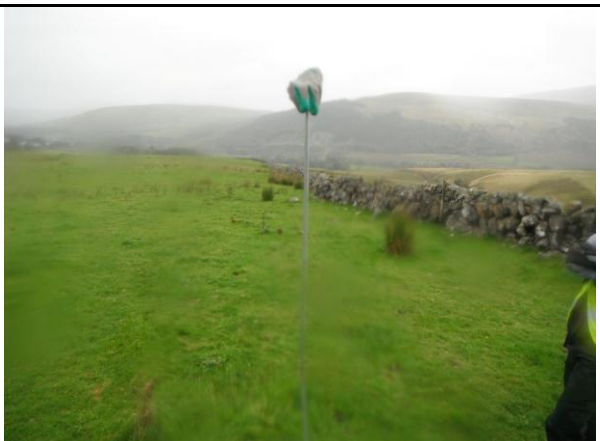
Location sensitivity	<input type="checkbox"/> Low <input checked="" type="checkbox"/> Medium <input type="checkbox"/> High <input type="checkbox"/> Very high Reason: track, dry stone wall		3
OVERALL SCORE			63

<p align="center"><u>Vegetation</u></p> <p>Conifer: <input type="checkbox"/> Young <input type="checkbox"/> Semi-mature <input type="checkbox"/> Mature</p> <p>Deciduous: <input type="checkbox"/> Young <input type="checkbox"/> Semi-mature <input type="checkbox"/> Mature</p> <p><input type="checkbox"/> Sphagnum moss <input type="checkbox"/> Staghorn moss</p> <p><input checked="" type="checkbox"/> Other mosses <input type="checkbox"/> Cotton grass <input checked="" type="checkbox"/> Rushes</p> <p><input checked="" type="checkbox"/> Other grasses <input type="checkbox"/> Heather <input type="checkbox"/> Fern</p> <p><input type="checkbox"/> Shrubs <input type="checkbox"/> Leaf litter <input type="checkbox"/> Bracken</p> <p>Other:</p> <p>Terrain category: <input checked="" type="checkbox"/> One <input type="checkbox"/> Two <input type="checkbox"/> Three</p> <p>Notes:</p>

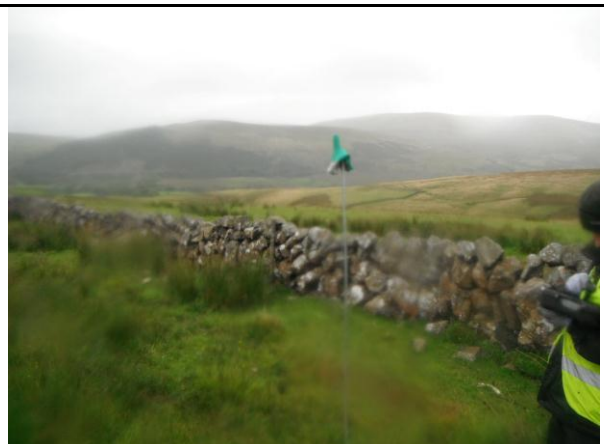
<p align="center"><u>Vegetation</u></p> <p>Conifer: <input type="checkbox"/> Young <input type="checkbox"/> Semi-mature <input type="checkbox"/> Mature</p> <p>Deciduous: <input type="checkbox"/> Young <input type="checkbox"/> Semi-mature <input type="checkbox"/> Mature</p> <p><input type="checkbox"/> Sphagnum moss <input type="checkbox"/> Staghorn moss</p> <p><input checked="" type="checkbox"/> Other mosses <input type="checkbox"/> Cotton grass <input checked="" type="checkbox"/> Rushes</p> <p><input checked="" type="checkbox"/> Other grasses <input type="checkbox"/> Heather <input type="checkbox"/> Fern</p> <p><input type="checkbox"/> Shrubs <input type="checkbox"/> Leaf litter <input type="checkbox"/> Bracken</p> <p>Other:</p> <hr/> <p>Terrain category: <input checked="" type="checkbox"/> One <input type="checkbox"/> Two <input type="checkbox"/> Three</p> <hr/> <p>Notes: exposed soil profile at gate</p>

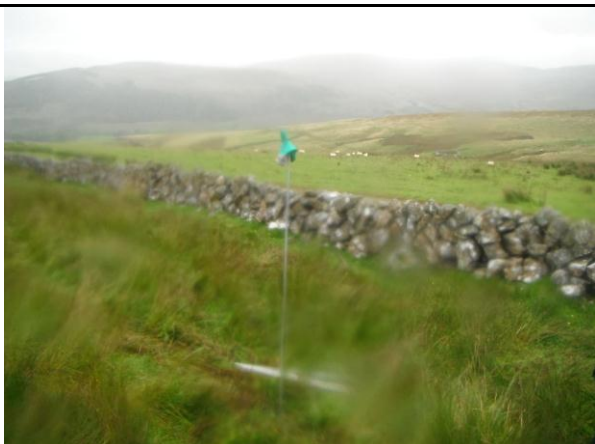
Location sensitivity	<input type="checkbox"/> Low <input checked="" type="checkbox"/> Medium <input type="checkbox"/> High <input type="checkbox"/> Very high Reason: track , dry stone wall		3
OVERALL SCORE			74

<p align="center"><u>Vegetation</u></p> <p>Conifer: <input type="checkbox"/> Young <input type="checkbox"/> Semi-mature <input type="checkbox"/> Mature</p> <p>Deciduous: <input type="checkbox"/> Young <input type="checkbox"/> Semi-mature <input type="checkbox"/> Mature</p> <p><input type="checkbox"/> Sphagnum moss <input type="checkbox"/> Staghorn moss</p> <p><input checked="" type="checkbox"/> Other mosses <input type="checkbox"/> Cotton grass <input checked="" type="checkbox"/> Rushes</p> <p><input checked="" type="checkbox"/> Other grasses <input type="checkbox"/> Heather <input type="checkbox"/> Fern</p> <p><input type="checkbox"/> Shrubs <input type="checkbox"/> Leaf litter <input type="checkbox"/> Bracken</p> <p>Other:</p> <hr/> <p>Terrain category: <input checked="" type="checkbox"/> One <input type="checkbox"/> Two <input type="checkbox"/> Three</p> <hr/> <p>Notes:</p>

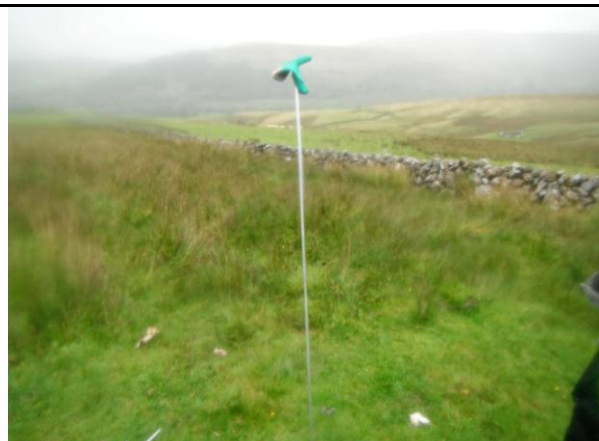
Location sensitivity	<input type="checkbox"/> Low <input checked="" type="checkbox"/> Medium <input type="checkbox"/> High <input type="checkbox"/> Very high Reason: track, dry stone wall		3
OVERALL SCORE			73

<p align="center"><u>Vegetation</u></p> <p>Conifer: <input type="checkbox"/> Young <input checked="" type="checkbox"/> Semi-mature <input type="checkbox"/> Mature</p> <p>Deciduous: <input type="checkbox"/> Young <input type="checkbox"/> Semi-mature <input type="checkbox"/> Mature</p> <p><input type="checkbox"/> Sphagnum moss <input type="checkbox"/> Staghorn moss</p> <p><input checked="" type="checkbox"/> Other mosses <input type="checkbox"/> Cotton grass <input checked="" type="checkbox"/> Rushes</p> <p><input checked="" type="checkbox"/> Other grasses <input type="checkbox"/> Heather <input type="checkbox"/> Fern</p> <p><input type="checkbox"/> Shrubs <input type="checkbox"/> Leaf litter <input type="checkbox"/> Bracken</p> <p>Other:</p> <hr/> <p>Terrain category: <input checked="" type="checkbox"/> One <input type="checkbox"/> Two <input type="checkbox"/> Three</p> <hr/> <p>Notes:</p>

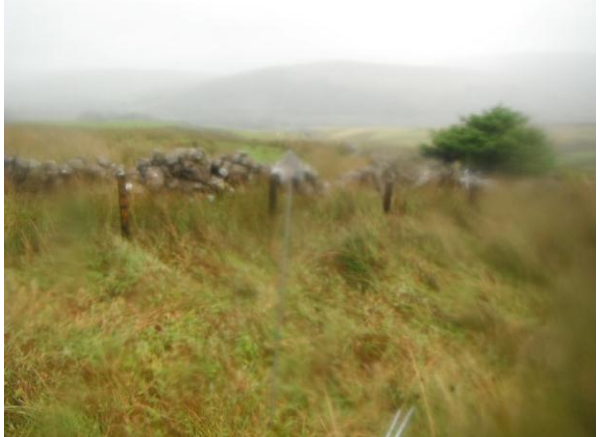
Location sensitivity	<input type="checkbox"/> Low <input checked="" type="checkbox"/> Medium <input type="checkbox"/> High <input type="checkbox"/> Very high Reason: track , dry stone wall		3
OVERALL SCORE			91

<p align="center"><u>Vegetation</u></p> <p>Conifer: <input type="checkbox"/> Young <input checked="" type="checkbox"/> Semi-mature <input type="checkbox"/> Mature</p> <p>Deciduous: <input type="checkbox"/> Young <input type="checkbox"/> Semi-mature <input type="checkbox"/> Mature</p> <p><input type="checkbox"/> Sphagnum moss <input type="checkbox"/> Staghorn moss</p> <p><input checked="" type="checkbox"/> Other mosses <input type="checkbox"/> Cotton grass <input checked="" type="checkbox"/> Rushes</p> <p><input checked="" type="checkbox"/> Other grasses <input type="checkbox"/> Heather <input type="checkbox"/> Fern</p> <p><input type="checkbox"/> Shrubs <input type="checkbox"/> Leaf litter <input type="checkbox"/> Bracken</p> <p>Other:</p> <hr/> <p>Terrain category: <input checked="" type="checkbox"/> One <input type="checkbox"/> Two <input type="checkbox"/> Three</p> <hr/> <p>Notes:</p>

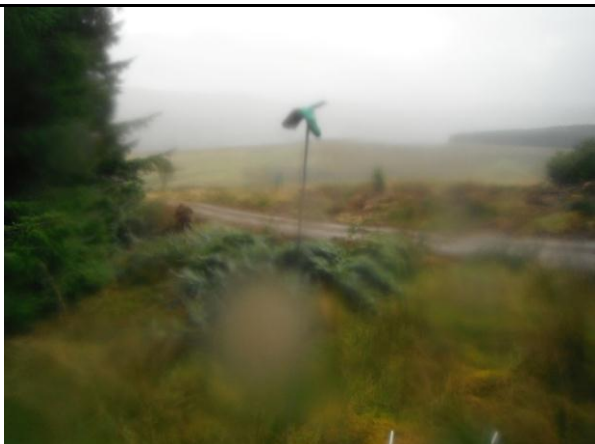
Location sensitivity	<input type="checkbox"/> Low <input checked="" type="checkbox"/> Medium <input type="checkbox"/> High <input type="checkbox"/> Very high Reason: track		3
OVERALL SCORE			91

<p style="text-align: center;"><u>Vegetation</u></p> <p>Conifer: <input type="checkbox"/> Young <input type="checkbox"/> Semi-mature <input checked="" type="checkbox"/> Mature</p> <p>Deciduous: <input type="checkbox"/> Young <input type="checkbox"/> Semi-mature <input type="checkbox"/> Mature</p> <p><input checked="" type="checkbox"/> Sphagnum moss <input type="checkbox"/> Staghorn moss</p> <p><input type="checkbox"/> Other mosses <input type="checkbox"/> Cotton grass <input checked="" type="checkbox"/> Rushes</p> <p><input checked="" type="checkbox"/> Other grasses <input type="checkbox"/> Heather <input type="checkbox"/> Fern</p> <p><input type="checkbox"/> Shrubs <input checked="" type="checkbox"/> Leaf litter <input type="checkbox"/> Bracken</p> <p>Other:</p> <p>Terrain category: <input checked="" type="checkbox"/> One <input type="checkbox"/> Two <input type="checkbox"/> Three</p> <p>Notes:</p>

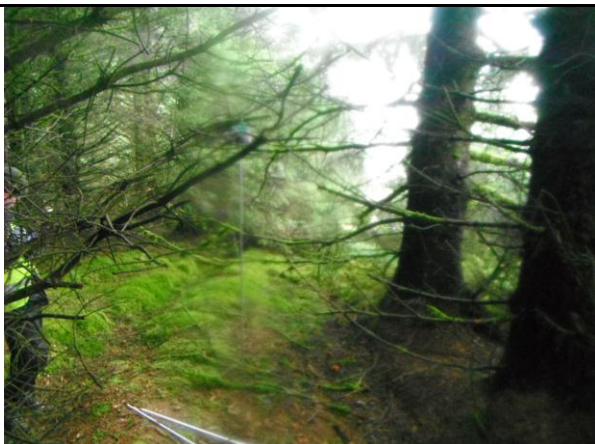
Location sensitivity	<input type="checkbox"/> Low <input checked="" type="checkbox"/> Medium <input type="checkbox"/> High <input type="checkbox"/> Very high Reason:		3
OVERALL SCORE			80

<p style="text-align: center;"><u>Vegetation</u></p> <p>Conifer: <input type="checkbox"/> Young <input type="checkbox"/> Semi-mature <input checked="" type="checkbox"/> Mature</p> <p>Deciduous: <input type="checkbox"/> Young <input type="checkbox"/> Semi-mature <input type="checkbox"/> Mature</p> <p><input checked="" type="checkbox"/> Sphagnum moss <input type="checkbox"/> Staghorn moss</p> <p><input checked="" type="checkbox"/> Other mosses <input type="checkbox"/> Cotton grass <input type="checkbox"/> Rushes</p> <p><input checked="" type="checkbox"/> Other grasses <input type="checkbox"/> Heather <input type="checkbox"/> Fern</p> <p><input type="checkbox"/> Shrubs <input checked="" type="checkbox"/> Leaf litter <input type="checkbox"/> Bracken</p> <p>Other:</p> <hr/> <p>Terrain category: <input checked="" type="checkbox"/> One <input type="checkbox"/> Two <input type="checkbox"/> Three</p> <hr/> <p>Notes:</p>

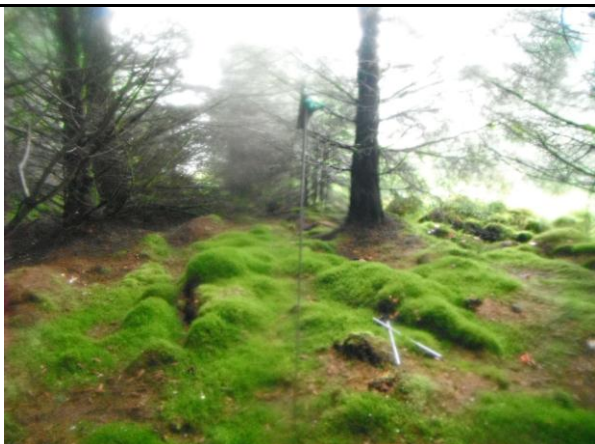
Location sensitivity	<input type="checkbox"/> Low <input checked="" type="checkbox"/> Medium <input type="checkbox"/> High <input type="checkbox"/> Very high Reason: track		3
OVERALL SCORE			60

<p align="center"><u>Vegetation</u></p> <p>Conifer: <input type="checkbox"/> Young <input type="checkbox"/> Semi-mature <input checked="" type="checkbox"/> Mature</p> <p>Deciduous: <input type="checkbox"/> Young <input type="checkbox"/> Semi-mature <input type="checkbox"/> Mature</p> <p><input checked="" type="checkbox"/> Sphagnum moss <input type="checkbox"/> Staghorn moss</p> <p><input checked="" type="checkbox"/> Other mosses <input type="checkbox"/> Cotton grass <input type="checkbox"/> Rushes</p> <p><input checked="" type="checkbox"/> Other grasses <input type="checkbox"/> Heather <input type="checkbox"/> Fern</p> <p><input checked="" type="checkbox"/> Shrubs <input checked="" type="checkbox"/> Leaf litter <input type="checkbox"/> Bracken</p> <p>Other:</p> <hr/> <p>Terrain category: <input checked="" type="checkbox"/> One <input type="checkbox"/> Two <input type="checkbox"/> Three</p> <hr/> <p>Notes:</p>

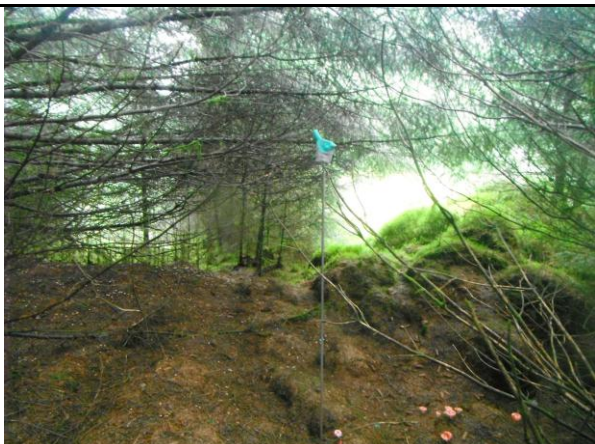
Location sensitivity	<input type="checkbox"/> Low <input checked="" type="checkbox"/> Medium <input type="checkbox"/> High <input type="checkbox"/> Very high Reason: track		3
OVERALL SCORE			134

<p style="text-align: center;"><u>Vegetation</u></p> <p>Conifer: <input type="checkbox"/> Young <input type="checkbox"/> Semi-mature <input checked="" type="checkbox"/> Mature Deciduous: <input type="checkbox"/> Young <input type="checkbox"/> Semi-mature <input type="checkbox"/> Mature <input checked="" type="checkbox"/> Sphagnum moss <input type="checkbox"/> Staghorn moss <input checked="" type="checkbox"/> Other mosses <input type="checkbox"/> Cotton grass <input checked="" type="checkbox"/> Rushes <input checked="" type="checkbox"/> Other grasses <input type="checkbox"/> Heather <input type="checkbox"/> Fern <input type="checkbox"/> Shrubs <input checked="" type="checkbox"/> Leaf litter <input type="checkbox"/> Bracken Other:</p> <p>Terrain category: <input checked="" type="checkbox"/> One <input type="checkbox"/> Two <input type="checkbox"/> Three</p> <p>Notes:</p>

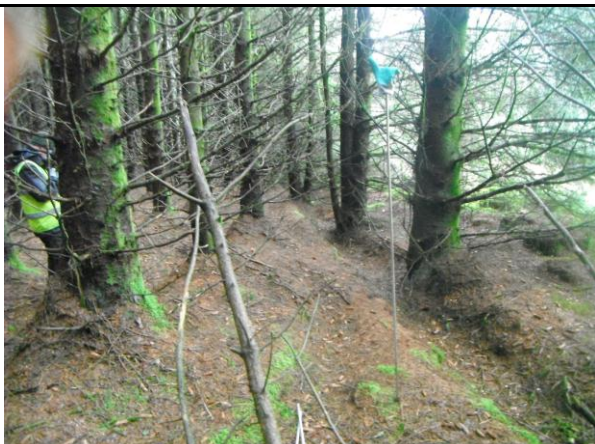
Location sensitivity	<input type="checkbox"/> Low <input checked="" type="checkbox"/> Medium <input type="checkbox"/> High <input type="checkbox"/> Very high Reason: track		3
OVERALL SCORE			68

<p align="center"><u>Vegetation</u></p> <p>Conifer: <input type="checkbox"/> Young <input type="checkbox"/> Semi-mature <input checked="" type="checkbox"/> Mature</p> <p>Deciduous: <input type="checkbox"/> Young <input type="checkbox"/> Semi-mature <input type="checkbox"/> Mature</p> <p><input checked="" type="checkbox"/> Sphagnum moss <input type="checkbox"/> Staghorn moss</p> <p><input type="checkbox"/> Other mosses <input type="checkbox"/> Cotton grass <input type="checkbox"/> Rushes</p> <p><input checked="" type="checkbox"/> Other grasses <input type="checkbox"/> Heather <input type="checkbox"/> Fern</p> <p><input checked="" type="checkbox"/> Shrubs <input checked="" type="checkbox"/> Leaf litter <input type="checkbox"/> Bracken</p> <p>Other:</p> <p>Terrain category: <input checked="" type="checkbox"/> One <input type="checkbox"/> Two <input type="checkbox"/> Three</p> <p>Notes:</p>

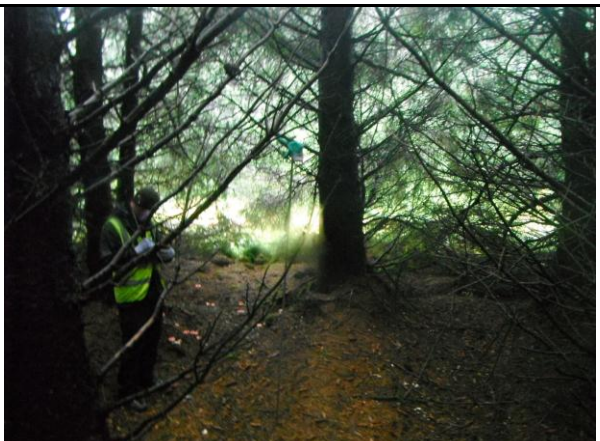
CATEGORY			SCORE
Rainfall	1870	Moderate altitude, Moderate rainfall.	100
Moisture conditions	<input checked="" type="checkbox"/> Dry <input type="checkbox"/> Patchy <input type="checkbox"/> Part saturated <input type="checkbox"/> Saturated <input type="checkbox"/> Waterlogged Ditches: <input type="checkbox"/> No ditches <input checked="" type="checkbox"/> Dry <input type="checkbox"/> Flowing <input type="checkbox"/> Ponded		2
Substrata	<input type="checkbox"/> Peat <input type="checkbox"/> Clay <input checked="" type="checkbox"/> Sand/Gravel <input type="checkbox"/> Rock Strength (kPa): <input type="checkbox"/> <10 <input type="checkbox"/> 10-20 <input type="checkbox"/> 20-30 <input type="checkbox"/> 30-40 <input checked="" type="checkbox"/> >40		3
Strata details	Peat depth = 0.2 m		1
	Probe depth = 0.2 m		
	Layer 1, from ground level to 0.2 mBGL at 30-40 kPa Layer 2 not applicable Layer 3 not applicable		2

Location sensitivity	<input type="checkbox"/> Low <input checked="" type="checkbox"/> Medium <input type="checkbox"/> High <input type="checkbox"/> Very high Reason: track		3
OVERALL SCORE			58

<p><u>Vegetation</u></p> <p>Conifer: <input type="checkbox"/> Young <input type="checkbox"/> Semi-mature <input checked="" type="checkbox"/> Mature</p> <p>Deciduous: <input type="checkbox"/> Young <input type="checkbox"/> Semi-mature <input type="checkbox"/> Mature</p> <p><input checked="" type="checkbox"/> Sphagnum moss <input type="checkbox"/> Staghorn moss</p> <p><input type="checkbox"/> Other mosses <input type="checkbox"/> Cotton grass <input type="checkbox"/> Rushes</p> <p><input checked="" type="checkbox"/> Other grasses <input type="checkbox"/> Heather <input type="checkbox"/> Fern</p> <p><input type="checkbox"/> Shrubs <input checked="" type="checkbox"/> Leaf litter <input type="checkbox"/> Bracken</p> <p>Other:</p> <p>Terrain category: <input checked="" type="checkbox"/> One <input type="checkbox"/> Two <input type="checkbox"/> Three</p> <p>Notes:</p>

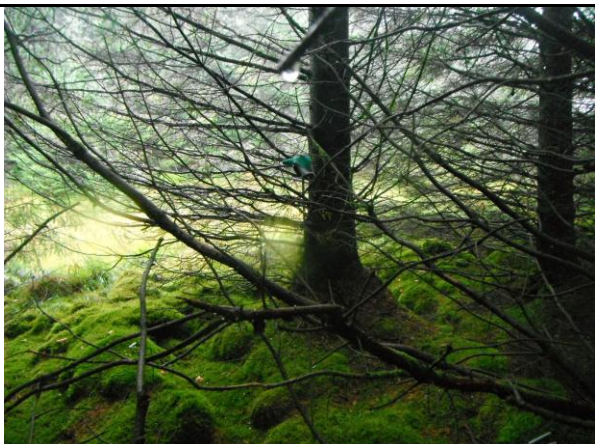
PROJECT		LOCATION		LANDMARK	
Pencloe		New Cumnock, Scotland		TR33	
Co-ords: X	261467	Y	608362	Ref	Grid position

CATEGORY			SCORE
Rainfall	1870	Moderate altitude, Moderate rainfall.	100
Moisture conditions	<input checked="" type="checkbox"/> Dry <input type="checkbox"/> Patchy <input type="checkbox"/> Part saturated <input type="checkbox"/> Saturated <input type="checkbox"/> Waterlogged Ditches: <input type="checkbox"/> No ditches <input checked="" type="checkbox"/> Dry <input type="checkbox"/> Flowing <input type="checkbox"/> Ponded		2
Substrata	<input type="checkbox"/> Peat <input type="checkbox"/> Clay <input type="checkbox"/> Sand/Gravel <input checked="" type="checkbox"/> Rock Strength (kPa): <input type="checkbox"/> <10 <input type="checkbox"/> 10-20 <input type="checkbox"/> 20-30 <input type="checkbox"/> 30-40 <input checked="" type="checkbox"/> >40		8
Strata details	Peat depth = 0.3 m	Probe depth = 0.3 m	2
	Layer 1, from ground level to 0.3 mBGL at 30-40 kPa Layer 2 not applicable Layer 3 not applicable		2

Location sensitivity	<input type="checkbox"/> Low <input checked="" type="checkbox"/> Medium <input type="checkbox"/> High <input type="checkbox"/> Very high Reason:		3
OVERALL SCORE			130

<p align="center"><u>Vegetation</u></p> <p>Conifer: <input type="checkbox"/> Young <input type="checkbox"/> Semi-mature <input checked="" type="checkbox"/> Mature</p> <p>Deciduous: <input type="checkbox"/> Young <input type="checkbox"/> Semi-mature <input type="checkbox"/> Mature</p> <p><input checked="" type="checkbox"/> Sphagnum moss <input type="checkbox"/> Staghorn moss</p> <p><input type="checkbox"/> Other mosses <input type="checkbox"/> Cotton grass <input type="checkbox"/> Rushes</p> <p><input checked="" type="checkbox"/> Other grasses <input type="checkbox"/> Heather <input type="checkbox"/> Fern</p> <p><input type="checkbox"/> Shrubs <input checked="" type="checkbox"/> Leaf litter <input type="checkbox"/> Bracken</p> <p>Other:</p> <hr/> <p>Terrain category: <input checked="" type="checkbox"/> One <input type="checkbox"/> Two <input type="checkbox"/> Three</p> <hr/> <p>Notes:</p>

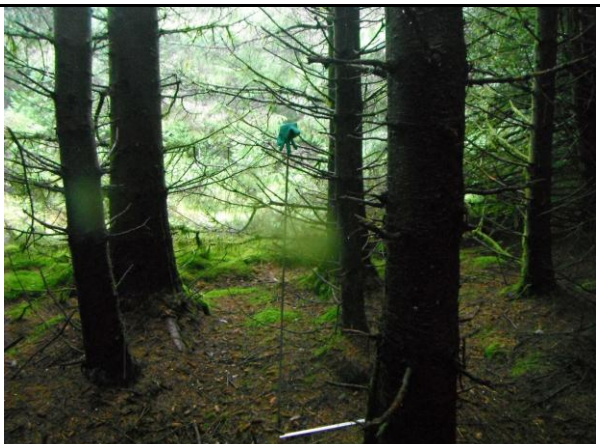
PROJECT		LOCATION		LANDMARK	
Pencloe		New Cumnock, Scotland		TR34	
Co-ords: X	261448	Y	608316	Ref	Grid position

CATEGORY			SCORE
Rainfall	1870	Moderate altitude, Moderate rainfall.	100
Moisture conditions	<input checked="" type="checkbox"/> Dry <input type="checkbox"/> Patchy <input type="checkbox"/> Part saturated <input type="checkbox"/> Saturated <input type="checkbox"/> Waterlogged Ditches: <input type="checkbox"/> No ditches <input checked="" type="checkbox"/> Dry <input type="checkbox"/> Flowing <input type="checkbox"/> Ponded		2
Substrata	<input type="checkbox"/> Peat <input type="checkbox"/> Clay <input type="checkbox"/> Sand/Gravel <input checked="" type="checkbox"/> Rock Strength (kPa): <input type="checkbox"/> <10 <input type="checkbox"/> 10-20 <input type="checkbox"/> 20-30 <input type="checkbox"/> 30-40 <input checked="" type="checkbox"/> >40		8
Strata details	Peat depth = 0.2 m		1
	Probe depth = 0.2 m		
	Layer 1, from ground level to 0.2 mBGL at 20-30 kPa Layer 2 not applicable Layer 3 not applicable		3

Location sensitivity	<input type="checkbox"/> Low <input checked="" type="checkbox"/> Medium <input type="checkbox"/> High <input type="checkbox"/> Very high Reason: track		3
OVERALL SCORE			64

<p><u>Vegetation</u></p> <p>Conifer: <input type="checkbox"/> Young <input type="checkbox"/> Semi-mature <input checked="" type="checkbox"/> Mature</p> <p>Deciduous: <input type="checkbox"/> Young <input type="checkbox"/> Semi-mature <input type="checkbox"/> Mature</p> <p><input checked="" type="checkbox"/> Sphagnum moss <input type="checkbox"/> Staghorn moss</p> <p><input type="checkbox"/> Other mosses <input type="checkbox"/> Cotton grass <input type="checkbox"/> Rushes</p> <p><input type="checkbox"/> Other grasses <input type="checkbox"/> Heather <input type="checkbox"/> Fern</p> <p><input checked="" type="checkbox"/> Shrubs <input checked="" type="checkbox"/> Leaf litter <input type="checkbox"/> Bracken</p> <p>Other:</p>

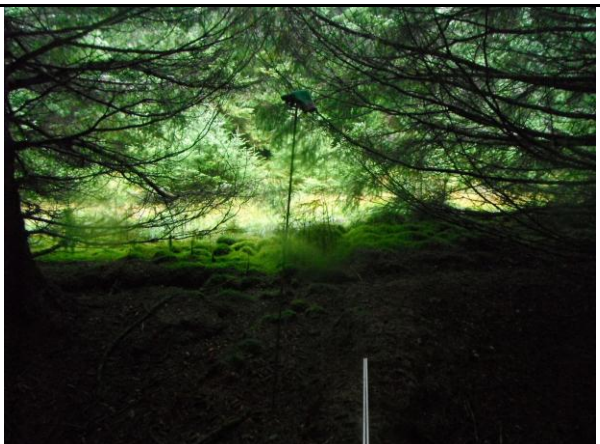
PROJECT		LOCATION		LANDMARK	
Pencloe		New Cumnock, Scotland		TR35	
Co-ords: X	261435	Y	608268	Ref	Grid position

CATEGORY			SCORE
Rainfall	1870	Moderate altitude, Moderate rainfall.	100
Moisture conditions	<input checked="" type="checkbox"/> Dry <input type="checkbox"/> Patchy <input type="checkbox"/> Part saturated <input type="checkbox"/> Saturated <input type="checkbox"/> Waterlogged Ditches: <input type="checkbox"/> No ditches <input checked="" type="checkbox"/> Dry <input type="checkbox"/> Flowing <input type="checkbox"/> Ponded		2
Substrata	<input type="checkbox"/> Peat <input type="checkbox"/> Clay <input type="checkbox"/> Sand/Gravel <input checked="" type="checkbox"/> Rock Strength (kPa): <input type="checkbox"/> <10 <input type="checkbox"/> 10-20 <input type="checkbox"/> 20-30 <input type="checkbox"/> 30-40 <input checked="" type="checkbox"/> >40		8
Strata details	Peat depth = 0.1 m		1
	Probe depth = 0.1 m		
	Layer 1, from ground level to 0.1 mBGL at 10-20 kPa Layer 2 not applicable Layer 3 not applicable		3

Location sensitivity	<input type="checkbox"/> Low <input checked="" type="checkbox"/> Medium <input type="checkbox"/> High <input type="checkbox"/> Very high Reason: track		3
OVERALL SCORE			64

<p style="text-align: center;"><u>Vegetation</u></p> <p>Conifer: <input type="checkbox"/> Young <input type="checkbox"/> Semi-mature <input checked="" type="checkbox"/> Mature</p> <p>Deciduous: <input type="checkbox"/> Young <input type="checkbox"/> Semi-mature <input type="checkbox"/> Mature</p> <p><input checked="" type="checkbox"/> Sphagnum moss <input type="checkbox"/> Staghorn moss</p> <p><input type="checkbox"/> Other mosses <input type="checkbox"/> Cotton grass <input type="checkbox"/> Rushes</p> <p><input checked="" type="checkbox"/> Other grasses <input type="checkbox"/> Heather <input type="checkbox"/> Fern</p> <p><input checked="" type="checkbox"/> Shrubs <input checked="" type="checkbox"/> Leaf litter <input type="checkbox"/> Bracken</p> <p>Other:</p> <hr/> <p>Terrain category: <input checked="" type="checkbox"/> One <input type="checkbox"/> Two <input type="checkbox"/> Three</p> <hr/> <p>Notes:</p>

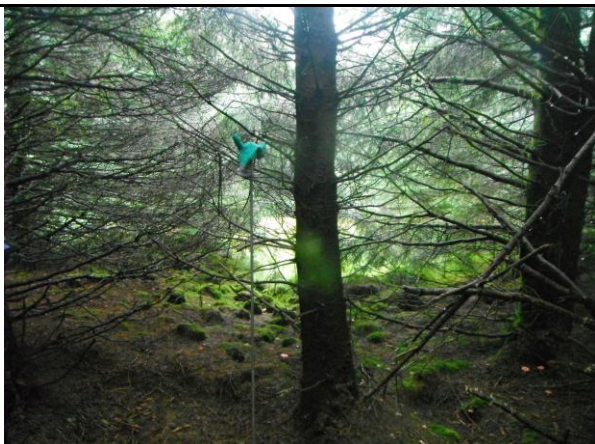
PROJECT		LOCATION		LANDMARK	
Pencloe		New Cumnock, Scotland		TR37	
Co-ords: X	261410	Y	608171	Ref	Grid position

CATEGORY			SCORE
Rainfall	1870	Moderate altitude, Moderate rainfall.	100
Moisture conditions	<input checked="" type="checkbox"/> Dry <input type="checkbox"/> Patchy <input type="checkbox"/> Part saturated <input type="checkbox"/> Saturated <input type="checkbox"/> Waterlogged Ditches: <input type="checkbox"/> No ditches <input checked="" type="checkbox"/> Dry <input type="checkbox"/> Flowing <input type="checkbox"/> Ponded		2
Substrata	<input type="checkbox"/> Peat <input type="checkbox"/> Clay <input checked="" type="checkbox"/> Sand/Gravel <input type="checkbox"/> Rock Strength (kPa): <input type="checkbox"/> <10 <input type="checkbox"/> 10-20 <input type="checkbox"/> 20-30 <input type="checkbox"/> 30-40 <input checked="" type="checkbox"/> >40		3
Strata details	Peat depth = 0.1 m		1
	Probe depth = 0.1 m		
	Layer 1, from ground level to 0.1 mBGL at 20-30 kPa Layer 2 not applicable Layer 3 not applicable		2

Location sensitivity	<input type="checkbox"/> Low <input checked="" type="checkbox"/> Medium <input type="checkbox"/> High <input type="checkbox"/> Very high Reason: track		3
OVERALL SCORE			60

<p style="text-align: center;"><u>Vegetation</u></p> <p>Conifer: <input type="checkbox"/> Young <input type="checkbox"/> Semi-mature <input checked="" type="checkbox"/> Mature</p> <p>Deciduous: <input type="checkbox"/> Young <input type="checkbox"/> Semi-mature <input type="checkbox"/> Mature</p> <p><input checked="" type="checkbox"/> Sphagnum moss <input type="checkbox"/> Staghorn moss</p> <p><input type="checkbox"/> Other mosses <input type="checkbox"/> Cotton grass <input type="checkbox"/> Rushes</p> <p><input type="checkbox"/> Other grasses <input type="checkbox"/> Heather <input type="checkbox"/> Fern</p> <p><input type="checkbox"/> Shrubs <input checked="" type="checkbox"/> Leaf litter <input type="checkbox"/> Bracken</p> <p>Other:</p> <hr/> <p>Terrain category: <input checked="" type="checkbox"/> One <input type="checkbox"/> Two <input type="checkbox"/> Three</p> <hr/> <p>Notes:</p>

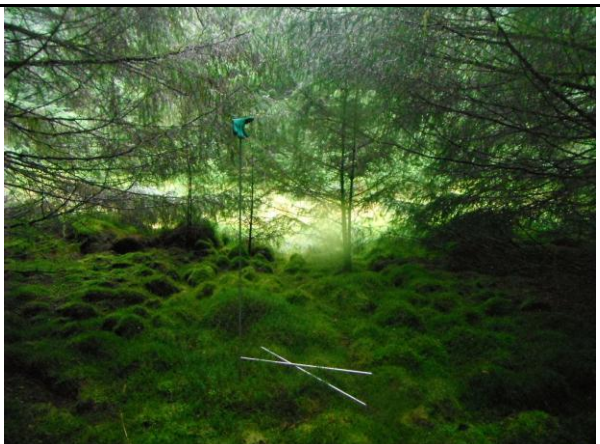
PROJECT		LOCATION		LANDMARK	
Pencloe		New Cumnock, Scotland		TR38	
Co-ords: X	261413	Y	608228	Ref	Grid position

CATEGORY			SCORE
Rainfall	1870	Moderate altitude, Moderate rainfall.	100
Moisture conditions	<input type="checkbox"/> Dry <input checked="" type="checkbox"/> Patchy <input type="checkbox"/> Part saturated <input type="checkbox"/> Saturated <input type="checkbox"/> Waterlogged Ditches: <input type="checkbox"/> No ditches <input checked="" type="checkbox"/> Dry <input type="checkbox"/> Flowing <input type="checkbox"/> Ponded		5
Substrata	<input type="checkbox"/> Peat <input type="checkbox"/> Clay <input checked="" type="checkbox"/> Sand/Gravel <input type="checkbox"/> Rock Strength (kPa): <input type="checkbox"/> <10 <input type="checkbox"/> 10-20 <input type="checkbox"/> 20-30 <input type="checkbox"/> 30-40 <input checked="" type="checkbox"/> >40		3
Strata details	Peat depth = 0.2 m	Probe depth = 0.2 m	1
	Layer 1, from ground level to 0.2 mBGL at 20-30 kPa Layer 2 not applicable Layer 3 not applicable		3

Location sensitivity	<input type="checkbox"/> Low <input checked="" type="checkbox"/> Medium <input type="checkbox"/> High <input type="checkbox"/> Very high Reason: track		3
OVERALL SCORE			62

<p><u>Vegetation</u></p> <p>Conifer: <input type="checkbox"/> Young <input type="checkbox"/> Semi-mature <input checked="" type="checkbox"/> Mature</p> <p>Deciduous: <input type="checkbox"/> Young <input type="checkbox"/> Semi-mature <input type="checkbox"/> Mature</p> <p><input checked="" type="checkbox"/> Sphagnum moss <input type="checkbox"/> Staghorn moss</p> <p><input type="checkbox"/> Other mosses <input type="checkbox"/> Cotton grass <input type="checkbox"/> Rushes</p> <p><input checked="" type="checkbox"/> Other grasses <input type="checkbox"/> Heather <input type="checkbox"/> Fern</p> <p><input checked="" type="checkbox"/> Shrubs <input checked="" type="checkbox"/> Leaf litter <input type="checkbox"/> Bracken</p> <p>Other:</p> <p>Terrain category: <input checked="" type="checkbox"/> One <input type="checkbox"/> Two <input type="checkbox"/> Three</p> <p>Notes:</p>

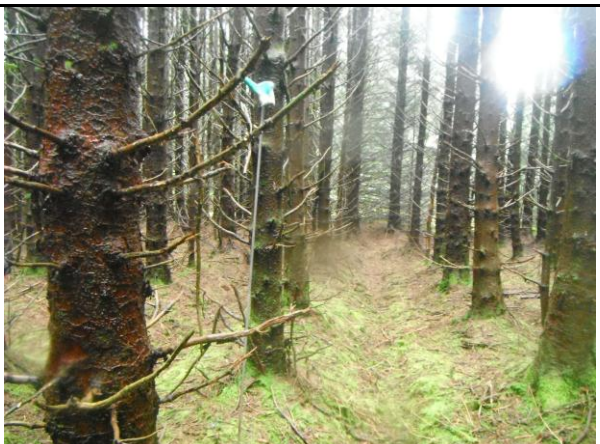
PROJECT		LOCATION		LANDMARK	
Pencloe		New Cumnock, Scotland		TR39	
Co-ords: X	261382	Y	608188	Ref	Grid position

CATEGORY			SCORE
Rainfall	1870	Moderate altitude, Moderate rainfall.	100
Moisture conditions	<input checked="" type="checkbox"/> Dry <input type="checkbox"/> Patchy <input type="checkbox"/> Part saturated <input type="checkbox"/> Saturated <input type="checkbox"/> Waterlogged Ditches: <input type="checkbox"/> No ditches <input checked="" type="checkbox"/> Dry <input type="checkbox"/> Flowing <input type="checkbox"/> Ponded		2
Substrata	<input type="checkbox"/> Peat <input type="checkbox"/> Clay <input checked="" type="checkbox"/> Sand/Gravel <input type="checkbox"/> Rock Strength (kPa): <input type="checkbox"/> <10 <input type="checkbox"/> 10-20 <input type="checkbox"/> 20-30 <input type="checkbox"/> 30-40 <input checked="" type="checkbox"/> >40		3
Strata details	Peat depth = 0.1 m	Probe depth = 0.1 m	1
	Layer 1, from ground level to 0.1 mBGL at 10-20 kPa Layer 2 not applicable Layer 3 not applicable		3

Location sensitivity	<input checked="" type="checkbox"/> Low <input type="checkbox"/> Medium <input type="checkbox"/> High <input type="checkbox"/> Very high Reason:		1
OVERALL SCORE			54

<p align="center"><u>Vegetation</u></p> <p>Conifer: <input type="checkbox"/> Young <input type="checkbox"/> Semi-mature <input checked="" type="checkbox"/> Mature</p> <p>Deciduous: <input type="checkbox"/> Young <input type="checkbox"/> Semi-mature <input type="checkbox"/> Mature</p> <p><input checked="" type="checkbox"/> Sphagnum moss <input type="checkbox"/> Staghorn moss</p> <p><input type="checkbox"/> Other mosses <input type="checkbox"/> Cotton grass <input type="checkbox"/> Rushes</p> <p><input type="checkbox"/> Other grasses <input type="checkbox"/> Heather <input type="checkbox"/> Fern</p> <p><input type="checkbox"/> Shrubs <input checked="" type="checkbox"/> Leaf litter <input type="checkbox"/> Bracken</p> <p>Other:</p> <hr/> <p>Terrain category: <input checked="" type="checkbox"/> One <input type="checkbox"/> Two <input type="checkbox"/> Three</p> <hr/> <p>Notes:</p>

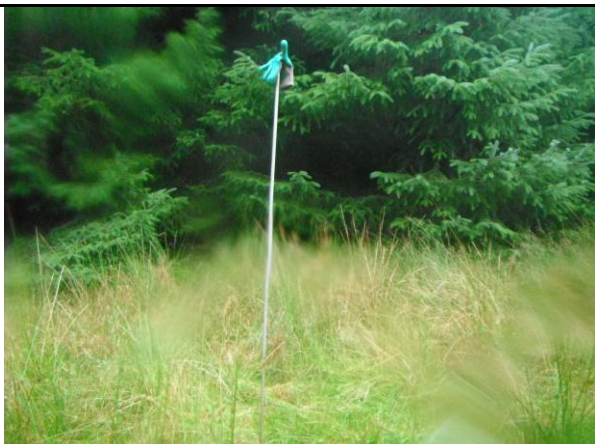
PROJECT		LOCATION		LANDMARK	
Pencloe		New Cumnock, Scotland		TR40	
Co-ords: X	260856	Y	607367	Ref	Grid position

CATEGORY			SCORE
Rainfall	1870	Moderate altitude, Moderate rainfall.	100
Moisture conditions	<input type="checkbox"/> Dry <input type="checkbox"/> Patchy <input checked="" type="checkbox"/> Part saturated <input type="checkbox"/> Saturated <input type="checkbox"/> Waterlogged Ditches: <input type="checkbox"/> No ditches <input type="checkbox"/> Dry <input checked="" type="checkbox"/> Flowing <input type="checkbox"/> Ponded		9
Substrata	<input type="checkbox"/> Peat <input type="checkbox"/> Clay <input checked="" type="checkbox"/> Sand/Gravel <input type="checkbox"/> Rock Strength (kPa): <input type="checkbox"/> <10 <input type="checkbox"/> 10-20 <input type="checkbox"/> 20-30 <input type="checkbox"/> 30-40 <input checked="" type="checkbox"/> >40		3
Strata details	Peat depth = 0.1 m		1
	Probe depth = 0.8 m		
	Layer 1, from ground level to 0.1 mBGL at 20-30 kPa Layer 2 not applicable Layer 3 not applicable		2

Peat slide history	<input checked="" type="checkbox"/> None <input type="checkbox"/> Few <input type="checkbox"/> Several <input type="checkbox"/> Many <input type="checkbox"/> Minor <input type="checkbox"/> Moderate <input type="checkbox"/> Major Extent if present:		1
Location sensitivity	<input type="checkbox"/> Low <input type="checkbox"/> Medium <input type="checkbox"/> High <input checked="" type="checkbox"/> Very high Reason: os stream, track		27
OVERALL SCORE			119

<p align="center"><u>Vegetation</u></p> <p>Conifer: <input checked="" type="checkbox"/> Young <input type="checkbox"/> Semi-mature <input checked="" type="checkbox"/> Mature Deciduous: <input type="checkbox"/> Young <input type="checkbox"/> Semi-mature <input type="checkbox"/> Mature <input checked="" type="checkbox"/> Sphagnum moss <input type="checkbox"/> Staghorn moss <input type="checkbox"/> Other mosses <input type="checkbox"/> Cotton grass <input checked="" type="checkbox"/> Rushes <input checked="" type="checkbox"/> Other grasses <input type="checkbox"/> Heather <input type="checkbox"/> Fern <input type="checkbox"/> Shrubs <input checked="" type="checkbox"/> Leaf litter <input type="checkbox"/> Bracken Other:</p> <p>Terrain category: <input type="checkbox"/> One <input checked="" type="checkbox"/> Two <input type="checkbox"/> Three</p> <p>Notes:</p>

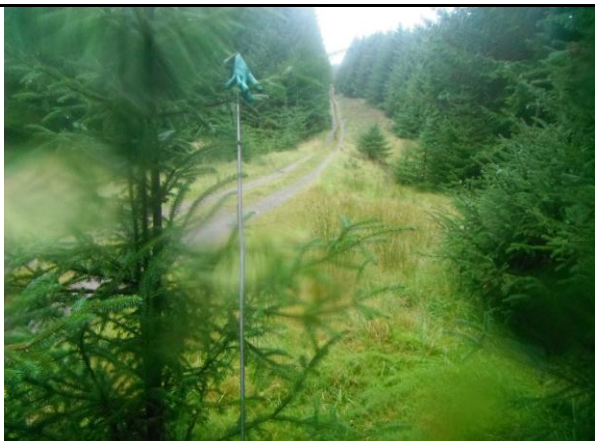
PROJECT		LOCATION		LANDMARK	
Pencloe		New Cumnock, Scotland		TR41	
Co-ords: X	260895	Y	607336	Ref	Grid position

CATEGORY			SCORE
Rainfall	1870	Moderate altitude, Moderate rainfall.	100
Moisture conditions	<input type="checkbox"/> Dry <input type="checkbox"/> Patchy <input checked="" type="checkbox"/> Part saturated <input type="checkbox"/> Saturated <input type="checkbox"/> Waterlogged Ditches: <input type="checkbox"/> No ditches <input type="checkbox"/> Dry <input checked="" type="checkbox"/> Flowing <input type="checkbox"/> Ponded		9
Substrata	<input type="checkbox"/> Peat <input type="checkbox"/> Clay <input type="checkbox"/> Sand/Gravel <input checked="" type="checkbox"/> Rock Strength (kPa): <input type="checkbox"/> <10 <input type="checkbox"/> 10-20 <input type="checkbox"/> 20-30 <input type="checkbox"/> 30-40 <input checked="" type="checkbox"/> >40		8
Strata details	Peat depth = 0.1 m		1
	Probe depth = 0.1 m		
	Layer 1, from ground level to 0.1 mBGL at 10-20 kPa Layer 2 not applicable Layer 3 not applicable		3

Location sensitivity	<input type="checkbox"/> Low <input type="checkbox"/> Medium <input checked="" type="checkbox"/> High <input type="checkbox"/> Very high Reason: track, os stream		9
OVERALL SCORE			80

<p style="text-align: center;"><u>Vegetation</u></p> <p>Conifer: <input checked="" type="checkbox"/> Young <input checked="" type="checkbox"/> Semi-mature <input type="checkbox"/> Mature</p> <p>Deciduous: <input type="checkbox"/> Young <input type="checkbox"/> Semi-mature <input type="checkbox"/> Mature</p> <p><input checked="" type="checkbox"/> Sphagnum moss <input type="checkbox"/> Staghorn moss</p> <p><input type="checkbox"/> Other mosses <input type="checkbox"/> Cotton grass <input checked="" type="checkbox"/> Rushes</p> <p><input checked="" type="checkbox"/> Other grasses <input type="checkbox"/> Heather <input type="checkbox"/> Fern</p> <p><input type="checkbox"/> Shrubs <input checked="" type="checkbox"/> Leaf litter <input type="checkbox"/> Bracken</p> <p>Other:</p> <hr/> <p>Terrain category: <input type="checkbox"/> One <input checked="" type="checkbox"/> Two <input type="checkbox"/> Three</p> <hr/> <p>Notes:</p>

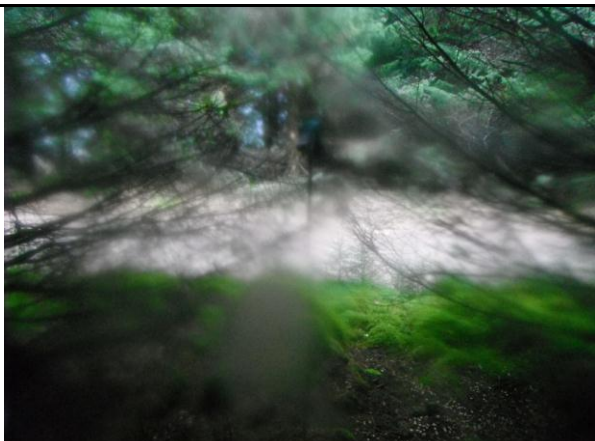
PROJECT		LOCATION		LANDMARK	
Pencloe		New Cumnock, Scotland		TR42	
Co-ords: X	261561	Y	608670	Ref	Grid position

CATEGORY			SCORE
Rainfall	1870	Moderate altitude, Moderate rainfall.	100
Moisture conditions	<input checked="" type="checkbox"/> Dry <input type="checkbox"/> Patchy <input type="checkbox"/> Part saturated <input type="checkbox"/> Saturated <input type="checkbox"/> Waterlogged Ditches: <input type="checkbox"/> No ditches <input type="checkbox"/> Dry <input checked="" type="checkbox"/> Flowing <input type="checkbox"/> Ponded		5
Substrata	<input type="checkbox"/> Peat <input type="checkbox"/> Clay <input type="checkbox"/> Sand/Gravel <input checked="" type="checkbox"/> Rock Strength (kPa): <input type="checkbox"/> <10 <input type="checkbox"/> 10-20 <input type="checkbox"/> 20-30 <input type="checkbox"/> 30-40 <input checked="" type="checkbox"/> >40		8
Strata details	Peat depth = 0.1 m	Probe depth = 0.1 m	1
	Layer 1, from ground level to 0.1 mBGL at 10-20 kPa Layer 2 not applicable Layer 3 not applicable		3

Location sensitivity	<input type="checkbox"/> Low <input checked="" type="checkbox"/> Medium <input type="checkbox"/> High <input type="checkbox"/> Very high Reason: track		3
OVERALL SCORE			76

<p align="center"><u>Vegetation</u></p> <p>Conifer: <input type="checkbox"/> Young <input type="checkbox"/> Semi-mature <input checked="" type="checkbox"/> Mature</p> <p>Deciduous: <input type="checkbox"/> Young <input type="checkbox"/> Semi-mature <input type="checkbox"/> Mature</p> <p><input checked="" type="checkbox"/> Sphagnum moss <input type="checkbox"/> Staghorn moss</p> <p><input type="checkbox"/> Other mosses <input type="checkbox"/> Cotton grass <input type="checkbox"/> Rushes</p> <p><input type="checkbox"/> Other grasses <input type="checkbox"/> Heather <input type="checkbox"/> Fern</p> <p><input type="checkbox"/> Shrubs <input checked="" type="checkbox"/> Leaf litter <input type="checkbox"/> Bracken</p> <p>Other:</p> <p>Terrain category: <input checked="" type="checkbox"/> One <input type="checkbox"/> Two <input type="checkbox"/> Three</p> <p>Notes:</p>

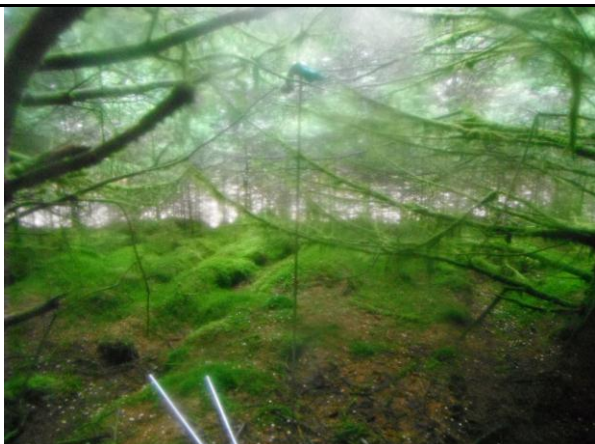
PROJECT		LOCATION		LANDMARK	
Pencloe		New Cumnock, Scotland		TR43	
Co-ords: X	261516	Y	608692	Ref	Grid position

CATEGORY			SCORE
Rainfall	1870	Moderate altitude, Moderate rainfall.	100
Moisture conditions	<input checked="" type="checkbox"/> Dry <input type="checkbox"/> Patchy <input type="checkbox"/> Part saturated <input type="checkbox"/> Saturated <input type="checkbox"/> Waterlogged Ditches: <input type="checkbox"/> No ditches <input checked="" type="checkbox"/> Dry <input type="checkbox"/> Flowing <input type="checkbox"/> Ponded		2
Substrata	<input type="checkbox"/> Peat <input type="checkbox"/> Clay <input type="checkbox"/> Sand/Gravel <input checked="" type="checkbox"/> Rock Strength (kPa): <input type="checkbox"/> <10 <input type="checkbox"/> 10-20 <input type="checkbox"/> 20-30 <input type="checkbox"/> 30-40 <input checked="" type="checkbox"/> >40		8
Strata details	Peat depth = 0.2 m	Probe depth = 0.2 m	1
	Layer 1, from ground level to 0.2 mBGL at 20-30 kPa Layer 2 not applicable Layer 3 not applicable		3

Location sensitivity	<input type="checkbox"/> Low <input checked="" type="checkbox"/> Medium <input type="checkbox"/> High <input type="checkbox"/> Very high Reason:		3
OVERALL SCORE			64

<p align="center"><u>Vegetation</u></p> <p>Conifer: <input type="checkbox"/> Young <input type="checkbox"/> Semi-mature <input checked="" type="checkbox"/> Mature</p> <p>Deciduous: <input type="checkbox"/> Young <input type="checkbox"/> Semi-mature <input type="checkbox"/> Mature</p> <p><input checked="" type="checkbox"/> Sphagnum moss <input type="checkbox"/> Staghorn moss</p> <p><input type="checkbox"/> Other mosses <input type="checkbox"/> Cotton grass <input type="checkbox"/> Rushes</p> <p><input type="checkbox"/> Other grasses <input type="checkbox"/> Heather <input type="checkbox"/> Fern</p> <p><input type="checkbox"/> Shrubs <input checked="" type="checkbox"/> Leaf litter <input type="checkbox"/> Bracken</p> <p>Other:</p>

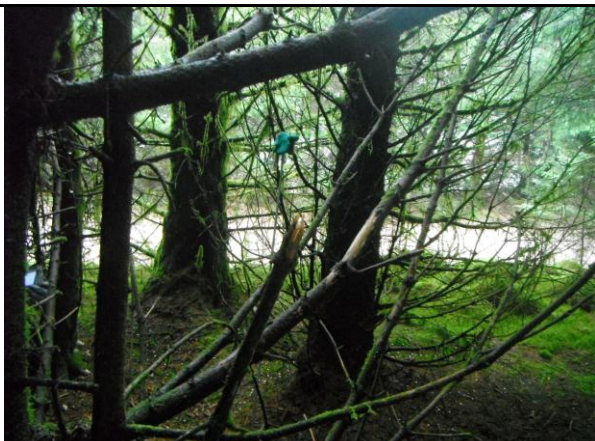
PROJECT		LOCATION		LANDMARK	
Pencloe		New Cumnock, Scotland		TR44	
Co-ords: X	261466	Y	608698	Ref	Grid position

CATEGORY			SCORE
Rainfall	1870	Moderate altitude, Moderate rainfall.	100
Moisture conditions	<input checked="" type="checkbox"/> Dry <input type="checkbox"/> Patchy <input type="checkbox"/> Part saturated <input type="checkbox"/> Saturated <input type="checkbox"/> Waterlogged Ditches: <input type="checkbox"/> No ditches <input checked="" type="checkbox"/> Dry <input type="checkbox"/> Flowing <input type="checkbox"/> Ponded		2
Substrata	<input type="checkbox"/> Peat <input type="checkbox"/> Clay <input type="checkbox"/> Sand/Gravel <input checked="" type="checkbox"/> Rock Strength (kPa): <input type="checkbox"/> <10 <input type="checkbox"/> 10-20 <input type="checkbox"/> 20-30 <input type="checkbox"/> 30-40 <input checked="" type="checkbox"/> >40		8
Strata details	Peat depth = 0.1 m		1
	Probe depth = 0.1 m		
	Layer 1, from ground level to 0.1 mBGL at 10-20 kPa Layer 2 not applicable Layer 3 not applicable		3

Location sensitivity	<input type="checkbox"/> Low <input checked="" type="checkbox"/> Medium <input type="checkbox"/> High <input type="checkbox"/> Very high Reason: track		3
OVERALL SCORE			68

<p align="center"><u>Vegetation</u></p> <p>Conifer: <input type="checkbox"/> Young <input type="checkbox"/> Semi-mature <input checked="" type="checkbox"/> Mature</p> <p>Deciduous: <input type="checkbox"/> Young <input type="checkbox"/> Semi-mature <input type="checkbox"/> Mature</p> <p><input checked="" type="checkbox"/> Sphagnum moss <input type="checkbox"/> Staghorn moss</p> <p><input type="checkbox"/> Other mosses <input type="checkbox"/> Cotton grass <input type="checkbox"/> Rushes</p> <p><input type="checkbox"/> Other grasses <input type="checkbox"/> Heather <input type="checkbox"/> Fern</p> <p><input type="checkbox"/> Shrubs <input checked="" type="checkbox"/> Leaf litter <input type="checkbox"/> Bracken</p> <p>Other:</p>

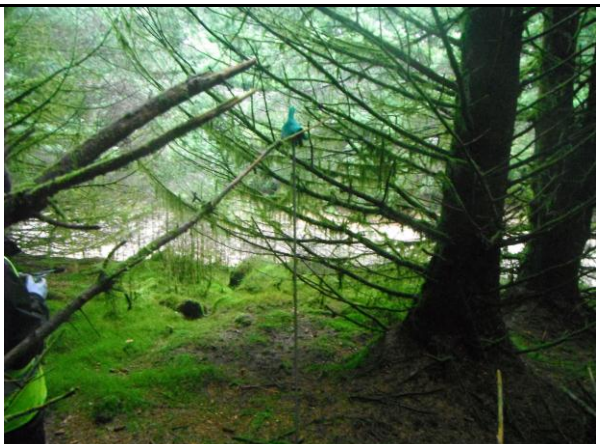
PROJECT		LOCATION		LANDMARK	
Pencloe		New Cumnock, Scotland		TR45	
Co-ords: X	261417	Y	608704	Ref	Grid position

CATEGORY			SCORE
Rainfall	1870	Moderate altitude, Moderate rainfall.	100
Moisture conditions	<input checked="" type="checkbox"/> Dry <input type="checkbox"/> Patchy <input type="checkbox"/> Part saturated <input type="checkbox"/> Saturated <input type="checkbox"/> Waterlogged Ditches: <input type="checkbox"/> No ditches <input checked="" type="checkbox"/> Dry <input type="checkbox"/> Flowing <input type="checkbox"/> Ponded		2
Substrata	<input type="checkbox"/> Peat <input type="checkbox"/> Clay <input checked="" type="checkbox"/> Sand/Gravel <input type="checkbox"/> Rock Strength (kPa): <input type="checkbox"/> <10 <input type="checkbox"/> 10-20 <input type="checkbox"/> 20-30 <input type="checkbox"/> 30-40 <input checked="" type="checkbox"/> >40		3
Strata details	Peat depth = 0.2 m		1
	Probe depth = 0.2 m		
	Layer 1, from ground level to 0.2 mBGL at 10-20 kPa Layer 2 not applicable Layer 3 not applicable		5

Location sensitivity	<input type="checkbox"/> Low <input checked="" type="checkbox"/> Medium <input type="checkbox"/> High <input type="checkbox"/> Very high Reason: track		3
OVERALL SCORE			65

<p><u>Vegetation</u></p> <p>Conifer: <input type="checkbox"/> Young <input type="checkbox"/> Semi-mature <input checked="" type="checkbox"/> Mature</p> <p>Deciduous: <input type="checkbox"/> Young <input type="checkbox"/> Semi-mature <input type="checkbox"/> Mature</p> <p><input checked="" type="checkbox"/> Sphagnum moss <input type="checkbox"/> Staghorn moss</p> <p><input type="checkbox"/> Other mosses <input type="checkbox"/> Cotton grass <input type="checkbox"/> Rushes</p> <p><input type="checkbox"/> Other grasses <input type="checkbox"/> Heather <input type="checkbox"/> Fern</p> <p><input type="checkbox"/> Shrubs <input checked="" type="checkbox"/> Leaf litter <input type="checkbox"/> Bracken</p> <p>Other:</p> <p>Terrain category: <input checked="" type="checkbox"/> One <input type="checkbox"/> Two <input type="checkbox"/> Three</p> <p>Notes:</p>

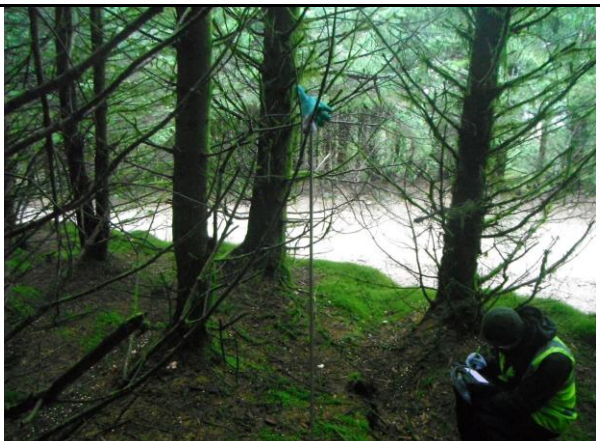
PROJECT		LOCATION		LANDMARK	
Pencloe		New Cumnock, Scotland		TR46	
Co-ords: X	261367	Y	608709	Ref	Grid position

CATEGORY			SCORE
Rainfall	1870	Moderate altitude, Moderate rainfall.	100
Moisture conditions	<input checked="" type="checkbox"/> Dry <input type="checkbox"/> Patchy <input type="checkbox"/> Part saturated <input type="checkbox"/> Saturated <input type="checkbox"/> Waterlogged Ditches: <input type="checkbox"/> No ditches <input checked="" type="checkbox"/> Dry <input type="checkbox"/> Flowing <input type="checkbox"/> Ponded		2
Substrata	<input type="checkbox"/> Peat <input type="checkbox"/> Clay <input type="checkbox"/> Sand/Gravel <input checked="" type="checkbox"/> Rock Strength (kPa): <input type="checkbox"/> <10 <input type="checkbox"/> 10-20 <input type="checkbox"/> 20-30 <input type="checkbox"/> 30-40 <input checked="" type="checkbox"/> >40		8
Strata details	Peat depth = 0.1 m		1
	Probe depth = 0.1 m		
	Layer 1, from ground level to 0.1 mBGL at 10-20 kPa Layer 2 not applicable Layer 3 not applicable		3

Location sensitivity	<input type="checkbox"/> Low <input checked="" type="checkbox"/> Medium <input type="checkbox"/> High <input type="checkbox"/> Very high Reason: track		3
OVERALL SCORE			66

<p><u>Vegetation</u></p> <p>Conifer: <input type="checkbox"/> Young <input type="checkbox"/> Semi-mature <input checked="" type="checkbox"/> Mature</p> <p>Deciduous: <input type="checkbox"/> Young <input type="checkbox"/> Semi-mature <input type="checkbox"/> Mature</p> <p><input checked="" type="checkbox"/> Sphagnum moss <input type="checkbox"/> Staghorn moss</p> <p><input type="checkbox"/> Other mosses <input type="checkbox"/> Cotton grass <input type="checkbox"/> Rushes</p> <p><input type="checkbox"/> Other grasses <input type="checkbox"/> Heather <input type="checkbox"/> Fern</p> <p><input type="checkbox"/> Shrubs <input checked="" type="checkbox"/> Leaf litter <input type="checkbox"/> Bracken</p> <p>Other:</p> <p>Terrain category: <input checked="" type="checkbox"/> One <input type="checkbox"/> Two <input type="checkbox"/> Three</p> <p>Notes:</p>

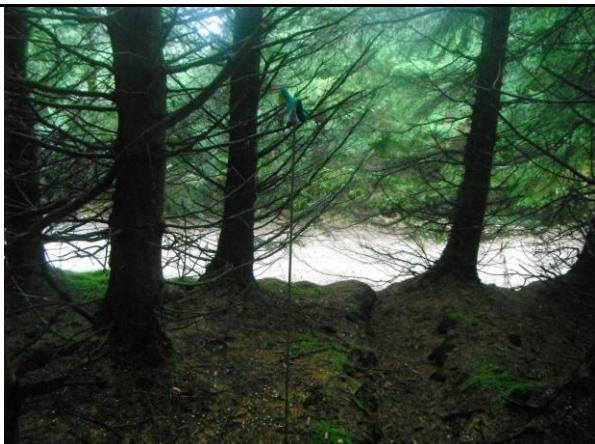
PROJECT		LOCATION		LANDMARK	
Pencloe		New Cumnock, Scotland		TR47	
Co-ords: X	261320	Y	608694	Ref	Grid position

CATEGORY			SCORE
Rainfall	1870	Moderate altitude, Moderate rainfall.	100
Moisture conditions	<input checked="" type="checkbox"/> Dry <input type="checkbox"/> Patchy <input type="checkbox"/> Part saturated <input type="checkbox"/> Saturated <input type="checkbox"/> Waterlogged Ditches: <input type="checkbox"/> No ditches <input checked="" type="checkbox"/> Dry <input type="checkbox"/> Flowing <input type="checkbox"/> Ponded		2
Substrata	<input type="checkbox"/> Peat <input type="checkbox"/> Clay <input checked="" type="checkbox"/> Sand/Gravel <input type="checkbox"/> Rock Strength (kPa): <input type="checkbox"/> <10 <input type="checkbox"/> 10-20 <input type="checkbox"/> 20-30 <input type="checkbox"/> 30-40 <input checked="" type="checkbox"/> >40		3
Strata details	Peat depth = 0.3 m		2
	Probe depth = 0.3 m		
	Layer 1, from ground level to 0.3 mBGL at 30-40 kPa Layer 2 not applicable Layer 3 not applicable		2

Location sensitivity	<input type="checkbox"/> Low <input checked="" type="checkbox"/> Medium <input type="checkbox"/> High <input type="checkbox"/> Very high Reason: track		3
OVERALL SCORE			134

<p style="text-align: center;"><u>Vegetation</u></p> <p>Conifer: <input type="checkbox"/> Young <input type="checkbox"/> Semi-mature <input checked="" type="checkbox"/> Mature</p> <p>Deciduous: <input type="checkbox"/> Young <input type="checkbox"/> Semi-mature <input type="checkbox"/> Mature</p> <p><input checked="" type="checkbox"/> Sphagnum moss <input type="checkbox"/> Staghorn moss</p> <p><input type="checkbox"/> Other mosses <input type="checkbox"/> Cotton grass <input type="checkbox"/> Rushes</p> <p><input type="checkbox"/> Other grasses <input type="checkbox"/> Heather <input type="checkbox"/> Fern</p> <p><input type="checkbox"/> Shrubs <input checked="" type="checkbox"/> Leaf litter <input type="checkbox"/> Bracken</p> <p>Other:</p> <p>Terrain category: <input checked="" type="checkbox"/> One <input type="checkbox"/> Two <input type="checkbox"/> Three</p> <p>Notes:</p>

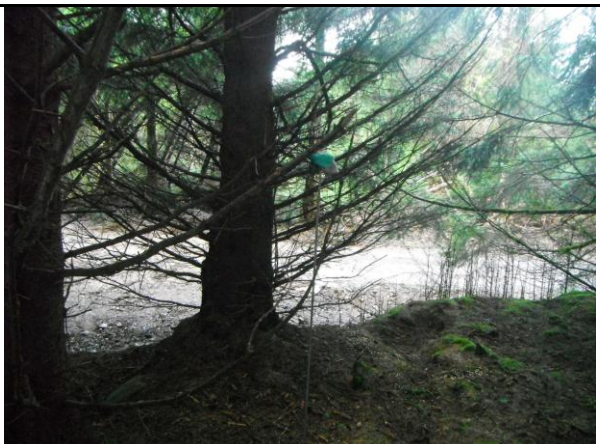
PROJECT		LOCATION		LANDMARK	
Pencloe		New Cumnock, Scotland		TR48	
Co-ords: X	261284	Y	608660	Ref	Grid position

CATEGORY			SCORE
Rainfall	1870	Moderate altitude, Moderate rainfall.	100
Moisture conditions	<input checked="" type="checkbox"/> Dry <input type="checkbox"/> Patchy <input type="checkbox"/> Part saturated <input type="checkbox"/> Saturated <input type="checkbox"/> Waterlogged Ditches: <input type="checkbox"/> No ditches <input type="checkbox"/> Dry <input type="checkbox"/> Flowing <input checked="" type="checkbox"/> Ponded		10
Substrata	<input type="checkbox"/> Peat <input type="checkbox"/> Clay <input type="checkbox"/> Sand/Gravel <input checked="" type="checkbox"/> Rock Strength (kPa): <input type="checkbox"/> <10 <input type="checkbox"/> 10-20 <input type="checkbox"/> 20-30 <input type="checkbox"/> 30-40 <input checked="" type="checkbox"/> >40		8
Strata details	Peat depth = 0.1 m	Probe depth = 0.1 m	1
	Layer 1, from ground level to 0.1 mBGL at 10-20 kPa Layer 2 not applicable Layer 3 not applicable		3

Location sensitivity	<input type="checkbox"/> Low <input checked="" type="checkbox"/> Medium <input type="checkbox"/> High <input type="checkbox"/> Very high Reason: track		3
OVERALL SCORE			76

<p><u>Vegetation</u></p> <p>Conifer: <input type="checkbox"/> Young <input type="checkbox"/> Semi-mature <input checked="" type="checkbox"/> Mature</p> <p>Deciduous: <input type="checkbox"/> Young <input type="checkbox"/> Semi-mature <input type="checkbox"/> Mature</p> <p><input checked="" type="checkbox"/> Sphagnum moss <input type="checkbox"/> Staghorn moss</p> <p><input type="checkbox"/> Other mosses <input type="checkbox"/> Cotton grass <input type="checkbox"/> Rushes</p> <p><input type="checkbox"/> Other grasses <input type="checkbox"/> Heather <input type="checkbox"/> Fern</p> <p><input type="checkbox"/> Shrubs <input checked="" type="checkbox"/> Leaf litter <input type="checkbox"/> Bracken</p> <p>Other:</p> <p>Terrain category: <input checked="" type="checkbox"/> One <input type="checkbox"/> Two <input type="checkbox"/> Three</p> <p>Notes:</p>

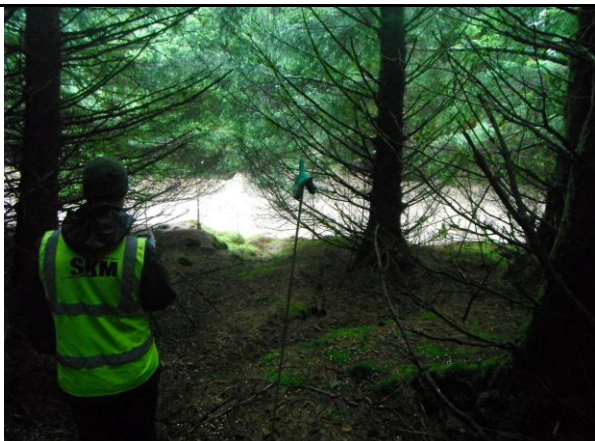
PROJECT		LOCATION		LANDMARK	
Pencloe		New Cumnock, Scotland		TR49	
Co-ords: X	261246	Y	608627	Ref	Grid position

CATEGORY			SCORE
Rainfall	1870	Moderate altitude, Moderate rainfall.	100
Moisture conditions	<input checked="" type="checkbox"/> Dry <input type="checkbox"/> Patchy <input type="checkbox"/> Part saturated <input type="checkbox"/> Saturated <input type="checkbox"/> Waterlogged Ditches: <input type="checkbox"/> No ditches <input type="checkbox"/> Dry <input checked="" type="checkbox"/> Flowing <input type="checkbox"/> Ponded		5
Substrata	<input type="checkbox"/> Peat <input type="checkbox"/> Clay <input type="checkbox"/> Sand/Gravel <input checked="" type="checkbox"/> Rock Strength (kPa): <input type="checkbox"/> <10 <input type="checkbox"/> 10-20 <input type="checkbox"/> 20-30 <input type="checkbox"/> 30-40 <input checked="" type="checkbox"/> >40		15
Strata details	Peat depth = 0.5 m		2
	Probe depth = 0.5 m		
	Layer 1, from ground level to 0.5 mBGL at 20-30 kPa Layer 2 not applicable Layer 3 not applicable		5

Peat slide history	<input checked="" type="checkbox"/> None <input type="checkbox"/> Few <input type="checkbox"/> Several <input type="checkbox"/> Many <input type="checkbox"/> Minor <input type="checkbox"/> Moderate <input type="checkbox"/> Major Extent if present:		1
Location sensitivity	<input type="checkbox"/> Low <input type="checkbox"/> Medium <input checked="" type="checkbox"/> High <input type="checkbox"/> Very high Reason: watercourse 10m west and track		27
OVERALL SCORE			198

<p align="center"><u>Vegetation</u></p> <p>Conifer: <input type="checkbox"/> Young <input type="checkbox"/> Semi-mature <input checked="" type="checkbox"/> Mature</p> <p>Deciduous: <input type="checkbox"/> Young <input type="checkbox"/> Semi-mature <input type="checkbox"/> Mature</p> <p><input checked="" type="checkbox"/> Sphagnum moss <input type="checkbox"/> Staghorn moss</p> <p><input type="checkbox"/> Other mosses <input type="checkbox"/> Cotton grass <input type="checkbox"/> Rushes</p> <p><input type="checkbox"/> Other grasses <input type="checkbox"/> Heather <input type="checkbox"/> Fern</p> <p><input type="checkbox"/> Shrubs <input checked="" type="checkbox"/> Leaf litter <input type="checkbox"/> Bracken</p> <p>Other:</p> <p>Terrain category: <input checked="" type="checkbox"/> One <input type="checkbox"/> Two <input type="checkbox"/> Three</p> <p>Notes:</p>

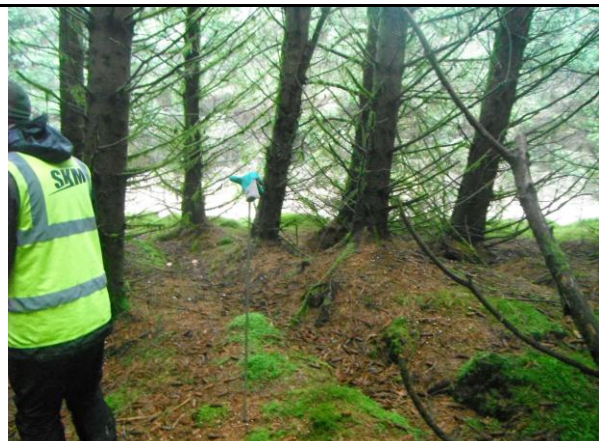
CATEGORY			SCORE
Rainfall	1870	Moderate altitude, Moderate rainfall.	100
Moisture conditions	<input checked="" type="checkbox"/> Dry <input type="checkbox"/> Patchy <input type="checkbox"/> Part saturated <input type="checkbox"/> Saturated <input type="checkbox"/> Waterlogged Ditches: <input type="checkbox"/> No ditches <input type="checkbox"/> Dry <input checked="" type="checkbox"/> Flowing <input type="checkbox"/> Ponded		10
Substrata	<input type="checkbox"/> Peat <input type="checkbox"/> Clay <input checked="" type="checkbox"/> Sand/Gravel <input type="checkbox"/> Rock Strength (kPa): <input type="checkbox"/> <10 <input type="checkbox"/> 10-20 <input type="checkbox"/> 20-30 <input type="checkbox"/> 30-40 <input checked="" type="checkbox"/> >40		5
Strata details	Peat depth = 0.7 m		2
	Probe depth = 0.7 m		
	Layer 1, from ground level to 0.7 mBGL at 20-30 kPa Layer 2 not applicable Layer 3 not applicable		7

Peat slide history	<input checked="" type="checkbox"/> None <input type="checkbox"/> Few <input type="checkbox"/> Several <input type="checkbox"/> Many <input type="checkbox"/> Minor <input type="checkbox"/> Moderate <input type="checkbox"/> Major Extent if present:		1
Location sensitivity	<input type="checkbox"/> Low <input checked="" type="checkbox"/> Medium <input type="checkbox"/> High <input type="checkbox"/> Very high Reason: track		9
OVERALL SCORE			177

<p style="text-align: center;"><u>Vegetation</u></p> <p>Conifer: <input type="checkbox"/> Young <input type="checkbox"/> Semi-mature <input checked="" type="checkbox"/> Mature</p> <p>Deciduous: <input type="checkbox"/> Young <input type="checkbox"/> Semi-mature <input type="checkbox"/> Mature</p> <p><input checked="" type="checkbox"/> Sphagnum moss <input type="checkbox"/> Staghorn moss</p> <p><input type="checkbox"/> Other mosses <input type="checkbox"/> Cotton grass <input type="checkbox"/> Rushes</p> <p><input type="checkbox"/> Other grasses <input type="checkbox"/> Heather <input type="checkbox"/> Fern</p> <p><input type="checkbox"/> Shrubs <input checked="" type="checkbox"/> Leaf litter <input type="checkbox"/> Bracken</p> <p>Other:</p> <hr/> <p>Terrain category: <input checked="" type="checkbox"/> One <input type="checkbox"/> Two <input type="checkbox"/> Three</p> <hr/> <p>Notes:</p>
