PROJECT		LOCATION		LANDMARK	
Pencloe		New Cumnock, Scotland		T532	
Co-ords: X	261090	Y	608108	Ref	Grid position

GENERAL		DATE & PERSONNEL		PHOTOGRAPHS
Survey	New	Rated by:	SA	Photo looking West
Date of last survey	N/A	Date	12/09/2013

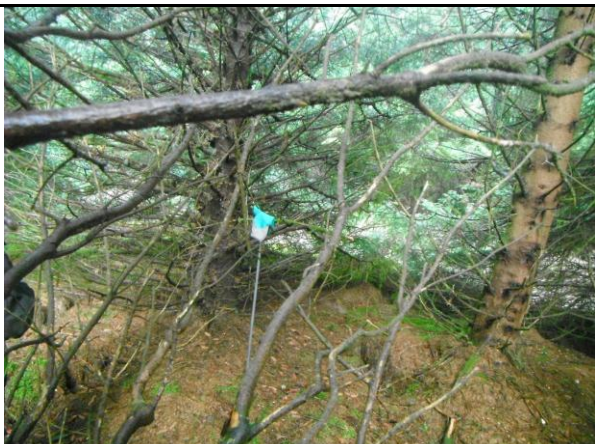
PROJECT		LOCATION		LANDMARK	
Pencloe		New Cumnock, Scotland		TR51	
Co-ords: X	261154	Y	608589	Ref	Grid position

CATEGORY			SCORE
Rainfall	1870	Moderate altitude, Moderate rainfall.	100
Moisture conditions	<input checked="" type="checkbox"/> Dry <input type="checkbox"/> Patchy <input type="checkbox"/> Part saturated <input type="checkbox"/> Saturated <input type="checkbox"/> Waterlogged Ditches: <input type="checkbox"/> No ditches <input checked="" type="checkbox"/> Dry <input type="checkbox"/> Flowing <input type="checkbox"/> Ponded		3
Substrata	<input type="checkbox"/> Peat <input type="checkbox"/> Clay <input type="checkbox"/> Sand/Gravel <input checked="" type="checkbox"/> Rock Strength (kPa): <input type="checkbox"/> <10 <input type="checkbox"/> 10-20 <input type="checkbox"/> 20-30 <input type="checkbox"/> 30-40 <input checked="" type="checkbox"/> >40		15
Strata details	Peat depth = 0.6 m		2
	Probe depth = 0.6 m		
	Layer 1, from ground level to 0.6 mBGL at 30-40 kPa Layer 2 not applicable Layer 3 not applicable		3

Location sensitivity	<input type="checkbox"/> Low <input checked="" type="checkbox"/> Medium <input type="checkbox"/> High <input type="checkbox"/> Very high Reason: track		9
OVERALL SCORE			156

<p><u>Vegetation</u></p> <p>Conifer: <input type="checkbox"/> Young <input type="checkbox"/> Semi-mature <input checked="" type="checkbox"/> Mature</p> <p>Deciduous: <input type="checkbox"/> Young <input type="checkbox"/> Semi-mature <input type="checkbox"/> Mature</p> <p><input checked="" type="checkbox"/> Sphagnum moss <input type="checkbox"/> Staghorn moss</p> <p><input checked="" type="checkbox"/> Other mosses <input type="checkbox"/> Cotton grass <input type="checkbox"/> Rushes</p> <p><input type="checkbox"/> Other grasses <input type="checkbox"/> Heather <input type="checkbox"/> Fern</p> <p><input type="checkbox"/> Shrubs <input checked="" type="checkbox"/> Leaf litter <input type="checkbox"/> Bracken</p> <p>Other:</p> <p>Terrain category: <input checked="" type="checkbox"/> One <input type="checkbox"/> Two <input type="checkbox"/> Three</p> <p>Notes:</p>

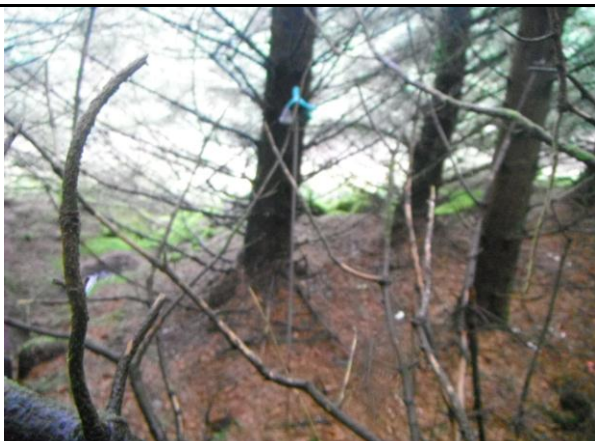
PROJECT		LOCATION		LANDMARK	
Pencloe		New Cumnock, Scotland		TR52	
Co-ords: X	261109	Y	608567	Ref	Grid position

CATEGORY			SCORE
Rainfall	1870	Moderate altitude, Moderate rainfall.	100
Moisture conditions	<input checked="" type="checkbox"/> Dry <input type="checkbox"/> Patchy <input type="checkbox"/> Part saturated <input type="checkbox"/> Saturated <input type="checkbox"/> Waterlogged Ditches: <input type="checkbox"/> No ditches <input type="checkbox"/> Dry <input type="checkbox"/> Flowing <input checked="" type="checkbox"/> Ponded		10
Substrata	<input type="checkbox"/> Peat <input type="checkbox"/> Clay <input type="checkbox"/> Sand/Gravel <input checked="" type="checkbox"/> Rock Strength (kPa): <input type="checkbox"/> <10 <input type="checkbox"/> 10-20 <input type="checkbox"/> 20-30 <input type="checkbox"/> 30-40 <input checked="" type="checkbox"/> >40		8
Strata details	Peat depth = 0.2 m		1
	Probe depth = 0.2 m		
	Layer 1, from ground level to 0.2 mBGL at 20-30 kPa Layer 2 not applicable Layer 3 not applicable		3

Location sensitivity	<input type="checkbox"/> Low <input checked="" type="checkbox"/> Medium <input type="checkbox"/> High <input type="checkbox"/> Very high Reason: track		3
OVERALL SCORE			76

<p align="center"><u>Vegetation</u></p> <p>Conifer: <input type="checkbox"/> Young <input type="checkbox"/> Semi-mature <input checked="" type="checkbox"/> Mature</p> <p>Deciduous: <input type="checkbox"/> Young <input type="checkbox"/> Semi-mature <input type="checkbox"/> Mature</p> <p><input checked="" type="checkbox"/> Sphagnum moss <input type="checkbox"/> Staghorn moss</p> <p><input checked="" type="checkbox"/> Other mosses <input type="checkbox"/> Cotton grass <input type="checkbox"/> Rushes</p> <p><input type="checkbox"/> Other grasses <input type="checkbox"/> Heather <input type="checkbox"/> Fern</p> <p><input type="checkbox"/> Shrubs <input checked="" type="checkbox"/> Leaf litter <input type="checkbox"/> Bracken</p> <p>Other:</p>

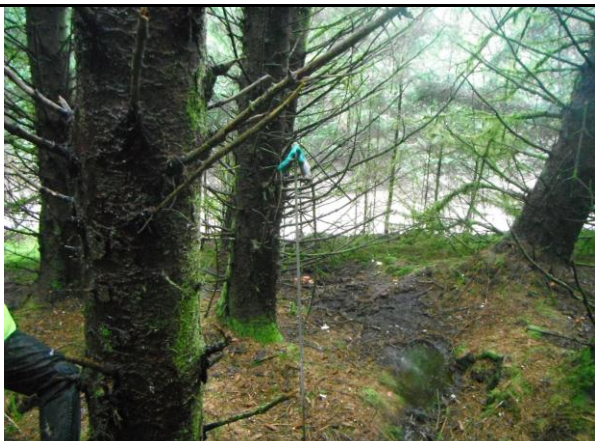
PROJECT		LOCATION		LANDMARK	
Pencloe		New Cumnock, Scotland		TR53	
Co-ords: X	261068	Y	608538	Ref	Grid position

CATEGORY			SCORE
Rainfall	1870	Moderate altitude, Moderate rainfall.	100
Moisture conditions	<input checked="" type="checkbox"/> Dry <input type="checkbox"/> Patchy <input type="checkbox"/> Part saturated <input type="checkbox"/> Saturated <input type="checkbox"/> Waterlogged Ditches: <input type="checkbox"/> No ditches <input type="checkbox"/> Dry <input type="checkbox"/> Flowing <input checked="" type="checkbox"/> Ponded		10
Substrata	<input type="checkbox"/> Peat <input type="checkbox"/> Clay <input checked="" type="checkbox"/> Sand/Gravel <input type="checkbox"/> Rock Strength (kPa): <input type="checkbox"/> <10 <input type="checkbox"/> 10-20 <input type="checkbox"/> 20-30 <input type="checkbox"/> 30-40 <input checked="" type="checkbox"/> >40		5
Strata details	Peat depth = 0.4 m		2
	Probe depth = 0.4 m		
	Layer 1, from ground level to 0.4 mBGL at 20-30 kPa Layer 2 not applicable Layer 3 not applicable		4

Location sensitivity	<input type="checkbox"/> Low <input checked="" type="checkbox"/> Medium <input type="checkbox"/> High <input type="checkbox"/> Very high Reason: track		9
OVERALL SCORE			147

<p><u>Vegetation</u></p> Conifer: <input type="checkbox"/> Young <input type="checkbox"/> Semi-mature <input checked="" type="checkbox"/> Mature Deciduous: <input type="checkbox"/> Young <input type="checkbox"/> Semi-mature <input type="checkbox"/> Mature <input checked="" type="checkbox"/> Sphagnum moss <input type="checkbox"/> Staghorn moss <input checked="" type="checkbox"/> Other mosses <input type="checkbox"/> Cotton grass <input type="checkbox"/> Rushes <input type="checkbox"/> Other grasses <input type="checkbox"/> Heather <input type="checkbox"/> Fern <input type="checkbox"/> Shrubs <input checked="" type="checkbox"/> Leaf litter <input type="checkbox"/> Bracken Other:

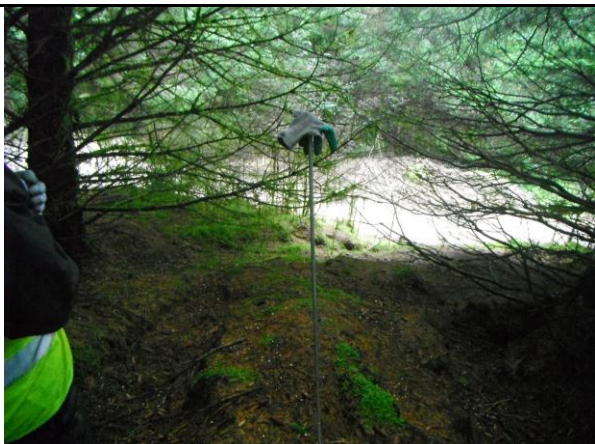
PROJECT		LOCATION		LANDMARK	
Pencloe		New Cumnock, Scotland		TR54	
Co-ords: X	261033	Y	608503	Ref	Grid position

CATEGORY			SCORE
Rainfall	1870	Moderate altitude, Moderate rainfall.	100
Moisture conditions	<input checked="" type="checkbox"/> Dry <input type="checkbox"/> Patchy <input type="checkbox"/> Part saturated <input type="checkbox"/> Saturated <input type="checkbox"/> Waterlogged Ditches: <input type="checkbox"/> No ditches <input type="checkbox"/> Dry <input type="checkbox"/> Flowing <input checked="" type="checkbox"/> Ponded		10
Substrata	<input type="checkbox"/> Peat <input type="checkbox"/> Clay <input type="checkbox"/> Sand/Gravel <input checked="" type="checkbox"/> Rock Strength (kPa): <input type="checkbox"/> <10 <input type="checkbox"/> 10-20 <input type="checkbox"/> 20-30 <input type="checkbox"/> 30-40 <input checked="" type="checkbox"/> >40		15
Strata details	Peat depth = 0.5 m	Probe depth = 0.5 m	2
	Layer 1, from ground level to 0.5 mBGL at 10-20 kPa Layer 2 not applicable Layer 3 not applicable		11

Location sensitivity	<input type="checkbox"/> Low <input checked="" type="checkbox"/> Medium <input type="checkbox"/> High <input type="checkbox"/> Very high Reason: track		9
OVERALL SCORE			173

<p align="center"><u>Vegetation</u></p> <p>Conifer: <input type="checkbox"/> Young <input type="checkbox"/> Semi-mature <input checked="" type="checkbox"/> Mature</p> <p>Deciduous: <input type="checkbox"/> Young <input type="checkbox"/> Semi-mature <input type="checkbox"/> Mature</p> <p><input checked="" type="checkbox"/> Sphagnum moss <input type="checkbox"/> Staghorn moss</p> <p><input checked="" type="checkbox"/> Other mosses <input type="checkbox"/> Cotton grass <input type="checkbox"/> Rushes</p> <p><input type="checkbox"/> Other grasses <input type="checkbox"/> Heather <input type="checkbox"/> Fern</p> <p><input type="checkbox"/> Shrubs <input checked="" type="checkbox"/> Leaf litter <input type="checkbox"/> Bracken</p> <p>Other:</p> <p>Terrain category: <input checked="" type="checkbox"/> One <input type="checkbox"/> Two <input type="checkbox"/> Three</p> <p>Notes:</p>

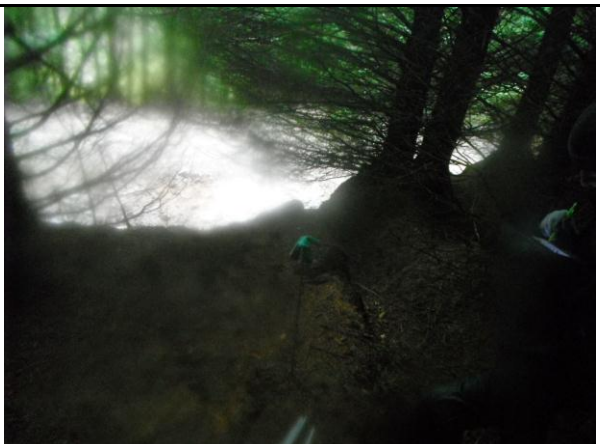
PROJECT		LOCATION		LANDMARK	
Pencloe		New Cumnock, Scotland		TR64	
Co-ords: X	260936	Y	608022	Ref	Grid position

CATEGORY			SCORE
Rainfall	1870	Moderate altitude, Moderate rainfall.	100
Moisture conditions	<input checked="" type="checkbox"/> Dry <input type="checkbox"/> Patchy <input type="checkbox"/> Part saturated <input type="checkbox"/> Saturated <input type="checkbox"/> Waterlogged Ditches: <input type="checkbox"/> No ditches <input type="checkbox"/> Dry <input checked="" type="checkbox"/> Flowing <input type="checkbox"/> Ponded		5
Substrata	<input type="checkbox"/> Peat <input type="checkbox"/> Clay <input type="checkbox"/> Sand/Gravel <input checked="" type="checkbox"/> Rock Strength (kPa): <input type="checkbox"/> <10 <input type="checkbox"/> 10-20 <input type="checkbox"/> 20-30 <input type="checkbox"/> 30-40 <input checked="" type="checkbox"/> >40		8
Strata details	Peat depth = 0.1 m	Probe depth = 0.1 m	1
	Layer 1, from ground level to 0.1 mBGL at 20-30 kPa Layer 2 not applicable Layer 3 not applicable		2

Peat slide history	<input checked="" type="checkbox"/> None <input type="checkbox"/> Few <input type="checkbox"/> Several <input type="checkbox"/> Many <input type="checkbox"/> Minor <input type="checkbox"/> Moderate <input type="checkbox"/> Major Extent if present:		1
Location sensitivity	<input type="checkbox"/> Low <input checked="" type="checkbox"/> Medium <input type="checkbox"/> High <input type="checkbox"/> Very high Reason: track 20 degree slope		3
OVERALL SCORE			111

<p align="center"><u>Vegetation</u></p> <p>Conifer: <input type="checkbox"/> Young <input type="checkbox"/> Semi-mature <input checked="" type="checkbox"/> Mature</p> <p>Deciduous: <input type="checkbox"/> Young <input type="checkbox"/> Semi-mature <input type="checkbox"/> Mature</p> <p><input checked="" type="checkbox"/> Sphagnum moss <input type="checkbox"/> Staghorn moss</p> <p><input type="checkbox"/> Other mosses <input type="checkbox"/> Cotton grass <input type="checkbox"/> Rushes</p> <p><input type="checkbox"/> Other grasses <input type="checkbox"/> Heather <input type="checkbox"/> Fern</p> <p><input type="checkbox"/> Shrubs <input checked="" type="checkbox"/> Leaf litter <input type="checkbox"/> Bracken</p> <p>Other:</p> <hr/> <p>Terrain category: <input type="checkbox"/> One <input checked="" type="checkbox"/> Two <input type="checkbox"/> Three</p> <hr/> <p>Notes:</p>

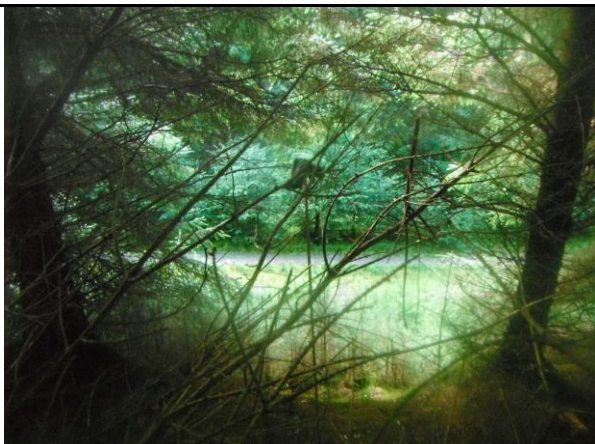
PROJECT		LOCATION		LANDMARK	
Pencloe		New Cumnock, Scotland		TR65	
Co-ords: X	260939	Y	607972	Ref	Grid position

CATEGORY			SCORE
Rainfall	1870	Moderate altitude, Moderate rainfall.	100
Moisture conditions	<input checked="" type="checkbox"/> Dry <input type="checkbox"/> Patchy <input type="checkbox"/> Part saturated <input type="checkbox"/> Saturated <input type="checkbox"/> Waterlogged Ditches: <input type="checkbox"/> No ditches <input type="checkbox"/> Dry <input checked="" type="checkbox"/> Flowing <input type="checkbox"/> Ponded		5
Substrata	<input type="checkbox"/> Peat <input type="checkbox"/> Clay <input type="checkbox"/> Sand/Gravel <input checked="" type="checkbox"/> Rock Strength (kPa): <input type="checkbox"/> <10 <input type="checkbox"/> 10-20 <input type="checkbox"/> 20-30 <input type="checkbox"/> 30-40 <input checked="" type="checkbox"/> >40		8
Strata details	Peat depth = 0.1 m		1
	Probe depth = 0.1 m		
	Layer 1, from ground level to 0.1 mBGL at 20-30 kPa Layer 2 not applicable Layer 3 not applicable		2

Location sensitivity	<input type="checkbox"/> Low <input checked="" type="checkbox"/> Medium <input type="checkbox"/> High <input type="checkbox"/> Very high Reason: track, 35 degree slope		3
OVERALL SCORE			106

<p style="text-align: center;"><u>Vegetation</u></p> <p>Conifer: <input checked="" type="checkbox"/> Young <input type="checkbox"/> Semi-mature <input checked="" type="checkbox"/> Mature Deciduous: <input type="checkbox"/> Young <input type="checkbox"/> Semi-mature <input type="checkbox"/> Mature <input checked="" type="checkbox"/> Sphagnum moss <input type="checkbox"/> Staghorn moss <input type="checkbox"/> Other mosses <input type="checkbox"/> Cotton grass <input type="checkbox"/> Rushes <input checked="" type="checkbox"/> Other grasses <input type="checkbox"/> Heather <input type="checkbox"/> Fern <input checked="" type="checkbox"/> Shrubs <input checked="" type="checkbox"/> Leaf litter <input type="checkbox"/> Bracken Other:</p> <p>Terrain category: <input type="checkbox"/> One <input checked="" type="checkbox"/> Two <input type="checkbox"/> Three</p> <p>Notes:</p>

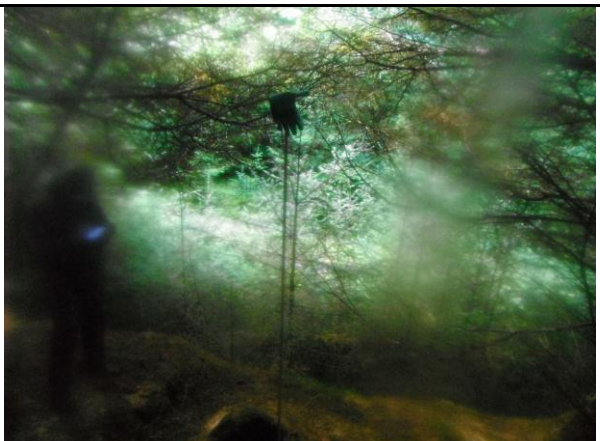
Location sensitivity	<input type="checkbox"/> Low <input checked="" type="checkbox"/> Medium <input type="checkbox"/> High <input type="checkbox"/> Very high Reason: track , 35 degree slope		3
OVERALL SCORE			103

<p><u>Vegetation</u></p> <p>Conifer: <input checked="" type="checkbox"/> Young <input type="checkbox"/> Semi-mature <input checked="" type="checkbox"/> Mature Deciduous: <input type="checkbox"/> Young <input type="checkbox"/> Semi-mature <input type="checkbox"/> Mature <input checked="" type="checkbox"/> Sphagnum moss <input type="checkbox"/> Staghorn moss <input type="checkbox"/> Other mosses <input type="checkbox"/> Cotton grass <input type="checkbox"/> Rushes <input checked="" type="checkbox"/> Other grasses <input type="checkbox"/> Heather <input type="checkbox"/> Fern <input checked="" type="checkbox"/> Shrubs <input checked="" type="checkbox"/> Leaf litter <input type="checkbox"/> Bracken Other:</p> <p>Terrain category: <input type="checkbox"/> One <input checked="" type="checkbox"/> Two <input type="checkbox"/> Three</p> <p>Notes:</p>

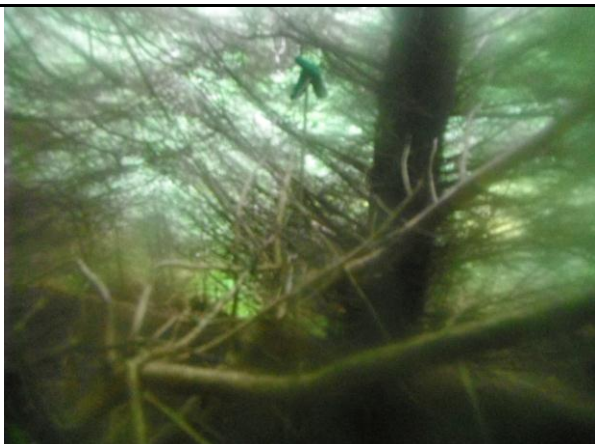
PROJECT		LOCATION		LANDMARK	
Pencloe		New Cumnock, Scotland		TR67	
Co-ords: X	260945	Y	607873	Ref	Grid position

CATEGORY			SCORE
Rainfall	1870	Moderate altitude, Moderate rainfall.	100
Moisture conditions	<input checked="" type="checkbox"/> Dry <input type="checkbox"/> Patchy <input type="checkbox"/> Part saturated <input type="checkbox"/> Saturated <input type="checkbox"/> Waterlogged Ditches: <input type="checkbox"/> No ditches <input checked="" type="checkbox"/> Dry <input type="checkbox"/> Flowing <input type="checkbox"/> Ponded		2
Substrata	<input type="checkbox"/> Peat <input type="checkbox"/> Clay <input type="checkbox"/> Sand/Gravel <input checked="" type="checkbox"/> Rock Strength (kPa): <input type="checkbox"/> <10 <input type="checkbox"/> 10-20 <input type="checkbox"/> 20-30 <input type="checkbox"/> 30-40 <input checked="" type="checkbox"/> >40		8
Strata details	Peat depth = 0.1 m	Probe depth = 0.1 m	1
	Layer 1, from ground level to 0.1 mBGL at 10-20 kPa Layer 2 not applicable Layer 3 not applicable		3

Location sensitivity	<input type="checkbox"/> Low <input checked="" type="checkbox"/> Medium <input type="checkbox"/> High <input type="checkbox"/> Very high Reason: track , 35 degree slope		3
OVERALL SCORE			102

<p align="center"><u>Vegetation</u></p> <p>Conifer: <input checked="" type="checkbox"/> Young <input type="checkbox"/> Semi-mature <input checked="" type="checkbox"/> Mature Deciduous: <input type="checkbox"/> Young <input type="checkbox"/> Semi-mature <input type="checkbox"/> Mature <input checked="" type="checkbox"/> Sphagnum moss <input type="checkbox"/> Staghorn moss <input type="checkbox"/> Other mosses <input type="checkbox"/> Cotton grass <input type="checkbox"/> Rushes <input checked="" type="checkbox"/> Other grasses <input type="checkbox"/> Heather <input type="checkbox"/> Fern <input type="checkbox"/> Shrubs <input checked="" type="checkbox"/> Leaf litter <input type="checkbox"/> Bracken Other:</p> <p>Terrain category: <input type="checkbox"/> One <input checked="" type="checkbox"/> Two <input type="checkbox"/> Three</p> <p>Notes:</p>

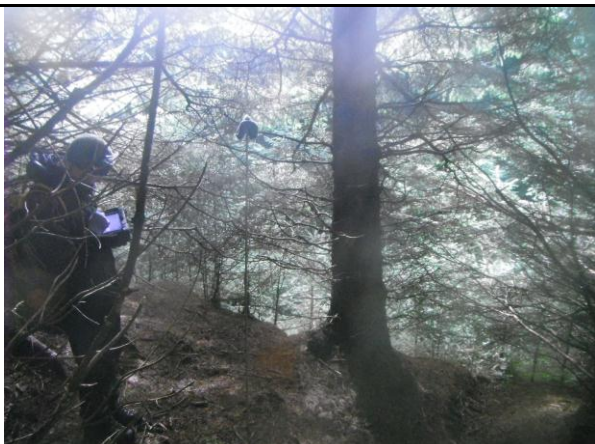
PROJECT		LOCATION		LANDMARK	
Pencloe		New Cumnock, Scotland		TR68	
Co-ords: X	260949	Y	607823	Ref	Grid position

CATEGORY			SCORE
Rainfall	1870	Moderate altitude, Moderate rainfall.	100
Moisture conditions	<input checked="" type="checkbox"/> Dry <input type="checkbox"/> Patchy <input type="checkbox"/> Part saturated <input type="checkbox"/> Saturated <input type="checkbox"/> Waterlogged Ditches: <input type="checkbox"/> No ditches <input checked="" type="checkbox"/> Dry <input type="checkbox"/> Flowing <input type="checkbox"/> Ponded		2
Substrata	<input type="checkbox"/> Peat <input type="checkbox"/> Clay <input type="checkbox"/> Sand/Gravel <input checked="" type="checkbox"/> Rock Strength (kPa): <input type="checkbox"/> <10 <input type="checkbox"/> 10-20 <input type="checkbox"/> 20-30 <input type="checkbox"/> 30-40 <input checked="" type="checkbox"/> >40		8
Strata details	Peat depth = 0.1 m		1
	Probe depth = 0.1 m		
	Layer 1, from ground level to 0.1 mBGL at 10-20 kPa Layer 2 not applicable Layer 3 not applicable		3

Location sensitivity	<input type="checkbox"/> Low <input checked="" type="checkbox"/> Medium <input type="checkbox"/> High <input type="checkbox"/> Very high Reason: track, 25 degree slope		3
OVERALL SCORE			102

<p align="center"><u>Vegetation</u></p> <p>Conifer: <input checked="" type="checkbox"/> Young <input type="checkbox"/> Semi-mature <input checked="" type="checkbox"/> Mature Deciduous: <input type="checkbox"/> Young <input type="checkbox"/> Semi-mature <input type="checkbox"/> Mature <input checked="" type="checkbox"/> Sphagnum moss <input type="checkbox"/> Staghorn moss <input type="checkbox"/> Other mosses <input type="checkbox"/> Cotton grass <input type="checkbox"/> Rushes <input checked="" type="checkbox"/> Other grasses <input type="checkbox"/> Heather <input type="checkbox"/> Fern <input checked="" type="checkbox"/> Shrubs <input checked="" type="checkbox"/> Leaf litter <input type="checkbox"/> Bracken Other:</p> <p>Terrain category: <input type="checkbox"/> One <input checked="" type="checkbox"/> Two <input type="checkbox"/> Three</p> <p>Notes:</p>

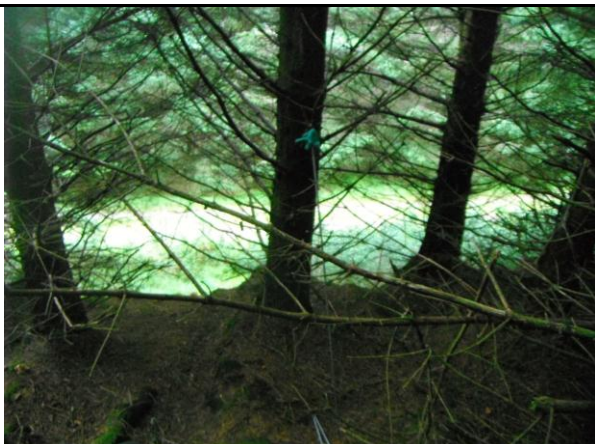
CATEGORY			SCORE
Rainfall	1870	Moderate altitude, Moderate rainfall.	100
Moisture conditions	<input checked="" type="checkbox"/> Dry <input type="checkbox"/> Patchy <input type="checkbox"/> Part saturated <input type="checkbox"/> Saturated <input type="checkbox"/> Waterlogged Ditches: <input type="checkbox"/> No ditches <input checked="" type="checkbox"/> Dry <input type="checkbox"/> Flowing <input type="checkbox"/> Ponded		2
Substrata	<input type="checkbox"/> Peat <input type="checkbox"/> Clay <input type="checkbox"/> Sand/Gravel <input checked="" type="checkbox"/> Rock Strength (kPa): <input type="checkbox"/> <10 <input type="checkbox"/> 10-20 <input type="checkbox"/> 20-30 <input type="checkbox"/> 30-40 <input checked="" type="checkbox"/> >40		8
Strata details	Peat depth = 0.1 m	Probe depth = 0.1 m	1
	Layer 1, from ground level to 0.1 mBGL at 10-20 kPa Layer 2 not applicable Layer 3 not applicable		3

Location sensitivity	<input type="checkbox"/> Low <input checked="" type="checkbox"/> Medium <input type="checkbox"/> High <input type="checkbox"/> Very high Reason: track, 50 degree slope		3
OVERALL SCORE			104

<p align="center"><u>Vegetation</u></p> <p>Conifer: <input checked="" type="checkbox"/> Young <input type="checkbox"/> Semi-mature <input checked="" type="checkbox"/> Mature</p> <p>Deciduous: <input type="checkbox"/> Young <input type="checkbox"/> Semi-mature <input type="checkbox"/> Mature</p> <p><input checked="" type="checkbox"/> Sphagnum moss <input type="checkbox"/> Staghorn moss</p> <p><input type="checkbox"/> Other mosses <input type="checkbox"/> Cotton grass <input type="checkbox"/> Rushes</p> <p><input checked="" type="checkbox"/> Other grasses <input type="checkbox"/> Heather <input type="checkbox"/> Fern</p> <p><input checked="" type="checkbox"/> Shrubs <input checked="" type="checkbox"/> Leaf litter <input type="checkbox"/> Bracken</p> <p>Other:</p> <hr/> <p>Terrain category: <input type="checkbox"/> One <input checked="" type="checkbox"/> Two <input type="checkbox"/> Three</p> <hr/> <p>Notes:</p>

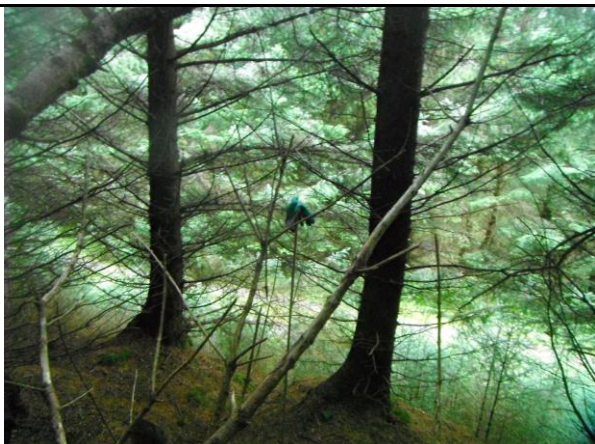
PROJECT		LOCATION		LANDMARK	
Pencloe		New Cumnock, Scotland		TR71	
Co-ords: X	260980	Y	607676	Ref	Grid position

CATEGORY			SCORE
Rainfall	1870	Moderate altitude, Moderate rainfall.	100
Moisture conditions	<input checked="" type="checkbox"/> Dry <input type="checkbox"/> Patchy <input type="checkbox"/> Part saturated <input type="checkbox"/> Saturated <input type="checkbox"/> Waterlogged Ditches: <input type="checkbox"/> No ditches <input checked="" type="checkbox"/> Dry <input type="checkbox"/> Flowing <input type="checkbox"/> Ponded		2
Substrata	<input type="checkbox"/> Peat <input type="checkbox"/> Clay <input type="checkbox"/> Sand/Gravel <input checked="" type="checkbox"/> Rock Strength (kPa): <input type="checkbox"/> <10 <input type="checkbox"/> 10-20 <input type="checkbox"/> 20-30 <input type="checkbox"/> 30-40 <input checked="" type="checkbox"/> >40		8
Strata details	Peat depth = 0.3 m	Probe depth = 0.3 m	2
	Layer 1, from ground level to 0.3 mBGL at 10-20 kPa Layer 2 not applicable Layer 3 not applicable		7

Location sensitivity	<input type="checkbox"/> Low <input checked="" type="checkbox"/> Medium <input type="checkbox"/> High <input type="checkbox"/> Very high Reason: track, 50 degree slope		3
OVERALL SCORE			175

<p align="center"><u>Vegetation</u></p> <p>Conifer: <input checked="" type="checkbox"/> Young <input type="checkbox"/> Semi-mature <input checked="" type="checkbox"/> Mature Deciduous: <input type="checkbox"/> Young <input type="checkbox"/> Semi-mature <input type="checkbox"/> Mature <input checked="" type="checkbox"/> Sphagnum moss <input type="checkbox"/> Staghorn moss <input type="checkbox"/> Other mosses <input type="checkbox"/> Cotton grass <input type="checkbox"/> Rushes <input checked="" type="checkbox"/> Other grasses <input type="checkbox"/> Heather <input type="checkbox"/> Fern <input type="checkbox"/> Shrubs <input checked="" type="checkbox"/> Leaf litter <input type="checkbox"/> Bracken Other:</p> <p>Terrain category: <input type="checkbox"/> One <input checked="" type="checkbox"/> Two <input type="checkbox"/> Three</p> <p>Notes:</p>

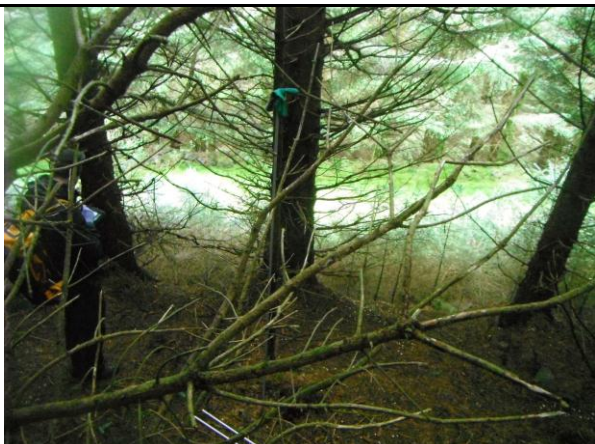
PROJECT		LOCATION		LANDMARK	
Pencloe		New Cumnock, Scotland		TR72	
Co-ords: X	260991	Y	607627	Ref	Grid position

CATEGORY			SCORE
Rainfall	1870	Moderate altitude, Moderate rainfall.	100
Moisture conditions	<input checked="" type="checkbox"/> Dry <input type="checkbox"/> Patchy <input type="checkbox"/> Part saturated <input type="checkbox"/> Saturated <input type="checkbox"/> Waterlogged Ditches: <input type="checkbox"/> No ditches <input checked="" type="checkbox"/> Dry <input type="checkbox"/> Flowing <input type="checkbox"/> Ponded		2
Substrata	<input type="checkbox"/> Peat <input type="checkbox"/> Clay <input type="checkbox"/> Sand/Gravel <input checked="" type="checkbox"/> Rock Strength (kPa): <input type="checkbox"/> <10 <input type="checkbox"/> 10-20 <input type="checkbox"/> 20-30 <input type="checkbox"/> 30-40 <input checked="" type="checkbox"/> >40		8
Strata details	Peat depth = 0.1 m		1
	Probe depth = 0.1 m		
	Layer 1, from ground level to 0.1 mBGL at 20-30 kPa Layer 2 not applicable Layer 3 not applicable		2

Location sensitivity	<input type="checkbox"/> Low <input checked="" type="checkbox"/> Medium <input type="checkbox"/> High <input type="checkbox"/> Very high Reason: track , 40 degree slope		3
OVERALL SCORE			103

<p><u>Vegetation</u></p> <p>Conifer: <input checked="" type="checkbox"/> Young <input type="checkbox"/> Semi-mature <input checked="" type="checkbox"/> Mature</p> <p>Deciduous: <input type="checkbox"/> Young <input type="checkbox"/> Semi-mature <input type="checkbox"/> Mature</p> <p><input checked="" type="checkbox"/> Sphagnum moss <input type="checkbox"/> Staghorn moss</p> <p><input type="checkbox"/> Other mosses <input type="checkbox"/> Cotton grass <input type="checkbox"/> Rushes</p> <p><input checked="" type="checkbox"/> Other grasses <input type="checkbox"/> Heather <input type="checkbox"/> Fern</p> <p><input checked="" type="checkbox"/> Shrubs <input checked="" type="checkbox"/> Leaf litter <input type="checkbox"/> Bracken</p> <p>Other:</p> <p>Terrain category: <input type="checkbox"/> One <input checked="" type="checkbox"/> Two <input type="checkbox"/> Three</p> <p>Notes:</p>

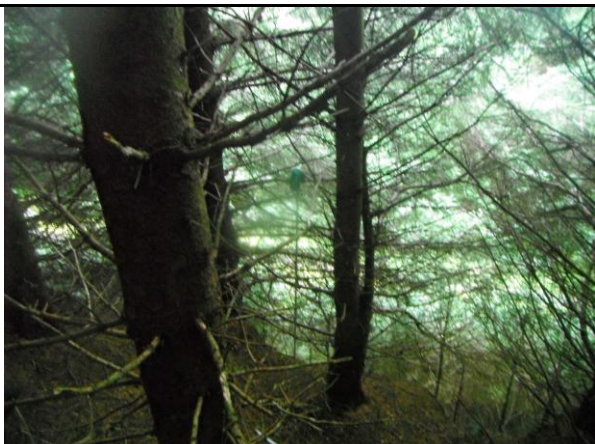
PROJECT		LOCATION		LANDMARK	
Pencloe		New Cumnock, Scotland		TR73	
Co-ords: X	261003	Y	607579	Ref	Grid position

CATEGORY			SCORE
Rainfall	1870	Moderate altitude, Moderate rainfall.	100
Moisture conditions	<input checked="" type="checkbox"/> Dry <input type="checkbox"/> Patchy <input type="checkbox"/> Part saturated <input type="checkbox"/> Saturated <input type="checkbox"/> Waterlogged Ditches: <input checked="" type="checkbox"/> No ditches <input type="checkbox"/> Dry <input type="checkbox"/> Flowing <input type="checkbox"/> Ponded		3
Substrata	<input type="checkbox"/> Peat <input type="checkbox"/> Clay <input type="checkbox"/> Sand/Gravel <input checked="" type="checkbox"/> Rock Strength (kPa): <input type="checkbox"/> <10 <input type="checkbox"/> 10-20 <input type="checkbox"/> 20-30 <input type="checkbox"/> 30-40 <input checked="" type="checkbox"/> >40		8
Strata details	Peat depth = 0.1 m	Probe depth = 0.1 m	1
	Layer 1, from ground level to 0.1 mBGL at 10-20 kPa Layer 2 not applicable Layer 3 not applicable		3

Location sensitivity	<input type="checkbox"/> Low <input checked="" type="checkbox"/> Medium <input type="checkbox"/> High <input type="checkbox"/> Very high Reason: track , 60 degree slope		3
OVERALL SCORE			105

<p align="center"><u>Vegetation</u></p> <p>Conifer: <input checked="" type="checkbox"/> Young <input type="checkbox"/> Semi-mature <input checked="" type="checkbox"/> Mature Deciduous: <input type="checkbox"/> Young <input type="checkbox"/> Semi-mature <input type="checkbox"/> Mature <input checked="" type="checkbox"/> Sphagnum moss <input type="checkbox"/> Staghorn moss <input type="checkbox"/> Other mosses <input type="checkbox"/> Cotton grass <input type="checkbox"/> Rushes <input checked="" type="checkbox"/> Other grasses <input type="checkbox"/> Heather <input type="checkbox"/> Fern <input checked="" type="checkbox"/> Shrubs <input checked="" type="checkbox"/> Leaf litter <input type="checkbox"/> Bracken Other:</p> <p>Terrain category: <input type="checkbox"/> One <input checked="" type="checkbox"/> Two <input type="checkbox"/> Three</p> <p>Notes:</p>

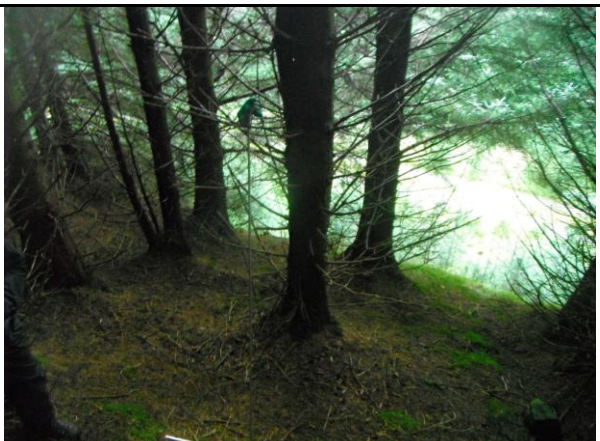
PROJECT		LOCATION		LANDMARK	
Pencloe		New Cumnock, Scotland		TR74	
Co-ords: X	261014	Y	607530	Ref	Grid position

CATEGORY			SCORE
Rainfall	1870	Moderate altitude, Moderate rainfall.	100
Moisture conditions	<input checked="" type="checkbox"/> Dry <input type="checkbox"/> Patchy <input type="checkbox"/> Part saturated <input type="checkbox"/> Saturated <input type="checkbox"/> Waterlogged Ditches: <input checked="" type="checkbox"/> No ditches <input type="checkbox"/> Dry <input type="checkbox"/> Flowing <input type="checkbox"/> Ponded		3
Substrata	<input type="checkbox"/> Peat <input type="checkbox"/> Clay <input checked="" type="checkbox"/> Sand/Gravel <input type="checkbox"/> Rock Strength (kPa): <input type="checkbox"/> <10 <input type="checkbox"/> 10-20 <input type="checkbox"/> 20-30 <input type="checkbox"/> 30-40 <input checked="" type="checkbox"/> >40		3
Strata details	Peat depth = 0.1 m		1
	Probe depth = 0.1 m		
	Layer 1, from ground level to 0.1 mBGL at 20-30 kPa Layer 2 not applicable Layer 3 not applicable		2

Location sensitivity	<input type="checkbox"/> Low <input checked="" type="checkbox"/> Medium <input type="checkbox"/> High <input type="checkbox"/> Very high Reason: track , 50 degree slope		3
OVERALL SCORE			99

<p><u>Vegetation</u></p> Conifer: <input checked="" type="checkbox"/> Young <input type="checkbox"/> Semi-mature <input checked="" type="checkbox"/> Mature Deciduous: <input type="checkbox"/> Young <input type="checkbox"/> Semi-mature <input type="checkbox"/> Mature <input checked="" type="checkbox"/> Sphagnum moss <input type="checkbox"/> Staghorn moss <input type="checkbox"/> Other mosses <input type="checkbox"/> Cotton grass <input type="checkbox"/> Rushes <input checked="" type="checkbox"/> Other grasses <input type="checkbox"/> Heather <input type="checkbox"/> Fern <input checked="" type="checkbox"/> Shrubs <input checked="" type="checkbox"/> Leaf litter <input type="checkbox"/> Bracken Other:

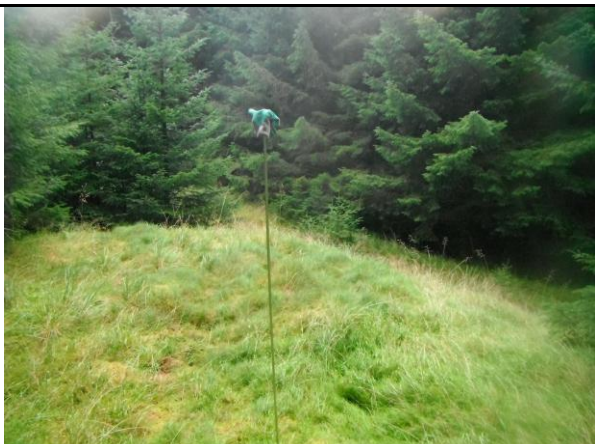
PROJECT		LOCATION		LANDMARK	
Pencloe		New Cumnock, Scotland		TR75	
Co-ords: X	261026	Y	607481	Ref	Grid position

CATEGORY			SCORE
Rainfall	1870	Moderate altitude, Moderate rainfall.	100
Moisture conditions	<input checked="" type="checkbox"/> Dry <input type="checkbox"/> Patchy <input type="checkbox"/> Part saturated <input type="checkbox"/> Saturated <input type="checkbox"/> Waterlogged Ditches: <input type="checkbox"/> No ditches <input type="checkbox"/> Dry <input checked="" type="checkbox"/> Flowing <input type="checkbox"/> Ponded		5
Substrata	<input type="checkbox"/> Peat <input type="checkbox"/> Clay <input checked="" type="checkbox"/> Sand/Gravel <input type="checkbox"/> Rock Strength (kPa): <input type="checkbox"/> <10 <input type="checkbox"/> 10-20 <input type="checkbox"/> 20-30 <input type="checkbox"/> 30-40 <input checked="" type="checkbox"/> >40		3
Strata details	Peat depth = 0.1 m	Probe depth = 0.1 m	1
	Layer 1, from ground level to 0.1 mBGL at 10-20 kPa Layer 2 not applicable Layer 3 not applicable		3

Location sensitivity	<input type="checkbox"/> Low <input checked="" type="checkbox"/> Medium <input type="checkbox"/> High <input type="checkbox"/> Very high Reason: track, 30 degree slope		3
OVERALL SCORE			102

<p align="center"><u>Vegetation</u></p> <p>Conifer: <input checked="" type="checkbox"/> Young <input type="checkbox"/> Semi-mature <input checked="" type="checkbox"/> Mature Deciduous: <input type="checkbox"/> Young <input type="checkbox"/> Semi-mature <input type="checkbox"/> Mature <input checked="" type="checkbox"/> Sphagnum moss <input type="checkbox"/> Staghorn moss <input type="checkbox"/> Other mosses <input type="checkbox"/> Cotton grass <input type="checkbox"/> Rushes <input checked="" type="checkbox"/> Other grasses <input type="checkbox"/> Heather <input type="checkbox"/> Fern <input type="checkbox"/> Shrubs <input checked="" type="checkbox"/> Leaf litter <input type="checkbox"/> Bracken Other:</p> <p>Terrain category: <input type="checkbox"/> One <input checked="" type="checkbox"/> Two <input type="checkbox"/> Three</p> <p>Notes:</p>

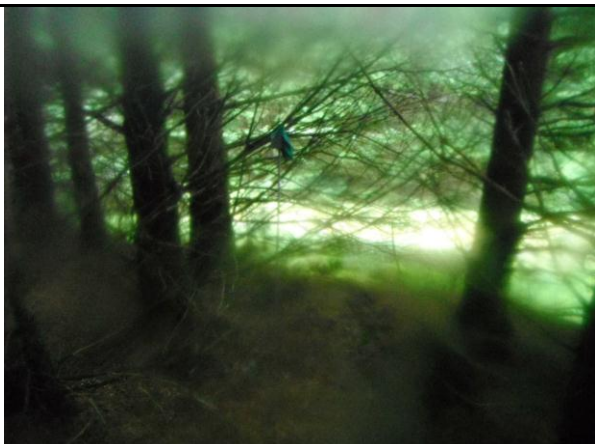
PROJECT		LOCATION		LANDMARK	
Pencloe		New Cumnock, Scotland		TR76	
Co-ords: X	261019	Y	607409	Ref	Grid position

CATEGORY			SCORE
Rainfall	1870	Moderate altitude, Moderate rainfall.	100
Moisture conditions	<input checked="" type="checkbox"/> Dry <input type="checkbox"/> Patchy <input type="checkbox"/> Part saturated <input type="checkbox"/> Saturated <input type="checkbox"/> Waterlogged Ditches: <input type="checkbox"/> No ditches <input type="checkbox"/> Dry <input checked="" type="checkbox"/> Flowing <input type="checkbox"/> Ponded		5
Substrata	<input type="checkbox"/> Peat <input type="checkbox"/> Clay <input type="checkbox"/> Sand/Gravel <input checked="" type="checkbox"/> Rock Strength (kPa): <input type="checkbox"/> <10 <input type="checkbox"/> 10-20 <input type="checkbox"/> 20-30 <input type="checkbox"/> 30-40 <input checked="" type="checkbox"/> >40		8
Strata details	Peat depth = 0.2 m	Probe depth = 0.2 m	1
	Layer 1, from ground level to 0.2 mBGL at 20-30 kPa Layer 2 not applicable Layer 3 not applicable		3

Location sensitivity	<input type="checkbox"/> Low <input checked="" type="checkbox"/> Medium <input type="checkbox"/> High <input type="checkbox"/> Very high Reason: track		3
OVERALL SCORE			107

<p align="center"><u>Vegetation</u></p> <p>Conifer: <input checked="" type="checkbox"/> Young <input type="checkbox"/> Semi-mature <input checked="" type="checkbox"/> Mature Deciduous: <input type="checkbox"/> Young <input type="checkbox"/> Semi-mature <input type="checkbox"/> Mature <input checked="" type="checkbox"/> Sphagnum moss <input type="checkbox"/> Staghorn moss <input type="checkbox"/> Other mosses <input type="checkbox"/> Cotton grass <input type="checkbox"/> Rushes <input checked="" type="checkbox"/> Other grasses <input type="checkbox"/> Heather <input type="checkbox"/> Fern <input type="checkbox"/> Shrubs <input checked="" type="checkbox"/> Leaf litter <input type="checkbox"/> Bracken Other:</p> <p>Terrain category: <input checked="" type="checkbox"/> One <input type="checkbox"/> Two <input type="checkbox"/> Three</p> <p>Notes:</p>

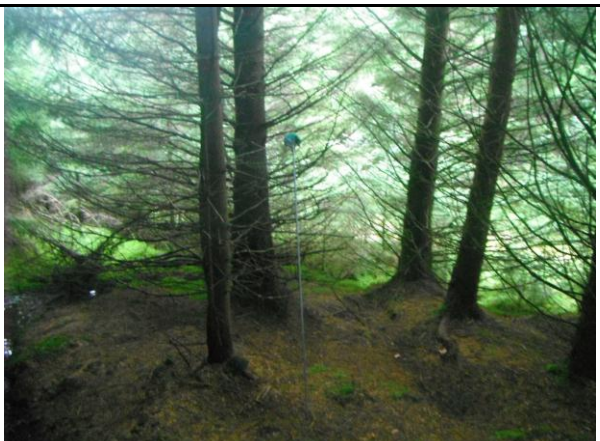
PROJECT		LOCATION		LANDMARK	
Pencloe		New Cumnock, Scotland		TR77	
Co-ords: X	260998	Y	607363	Ref	Grid position

CATEGORY			SCORE
Rainfall	1870	Moderate altitude, Moderate rainfall.	100
Moisture conditions	<input checked="" type="checkbox"/> Dry <input type="checkbox"/> Patchy <input type="checkbox"/> Part saturated <input type="checkbox"/> Saturated <input type="checkbox"/> Waterlogged Ditches: <input type="checkbox"/> No ditches <input type="checkbox"/> Dry <input checked="" type="checkbox"/> Flowing <input type="checkbox"/> Ponded		5
Substrata	<input type="checkbox"/> Peat <input type="checkbox"/> Clay <input type="checkbox"/> Sand/Gravel <input checked="" type="checkbox"/> Rock Strength (kPa): <input type="checkbox"/> <10 <input type="checkbox"/> 10-20 <input type="checkbox"/> 20-30 <input type="checkbox"/> 30-40 <input checked="" type="checkbox"/> >40		8
Strata details	Peat depth = 0.1 m		1
	Probe depth = 0.1 m		
	Layer 1, from ground level to 0.1 mBGL at 10-20 kPa Layer 2 not applicable Layer 3 not applicable		3

Location sensitivity	<input type="checkbox"/> Low <input checked="" type="checkbox"/> Medium <input type="checkbox"/> High <input type="checkbox"/> Very high Reason: track		3
OVERALL SCORE			107

<p align="center"><u>Vegetation</u></p> <p>Conifer: <input checked="" type="checkbox"/> Young <input type="checkbox"/> Semi-mature <input checked="" type="checkbox"/> Mature Deciduous: <input type="checkbox"/> Young <input type="checkbox"/> Semi-mature <input type="checkbox"/> Mature <input checked="" type="checkbox"/> Sphagnum moss <input type="checkbox"/> Staghorn moss <input type="checkbox"/> Other mosses <input type="checkbox"/> Cotton grass <input type="checkbox"/> Rushes <input checked="" type="checkbox"/> Other grasses <input type="checkbox"/> Heather <input type="checkbox"/> Fern <input type="checkbox"/> Shrubs <input checked="" type="checkbox"/> Leaf litter <input type="checkbox"/> Bracken Other:</p>

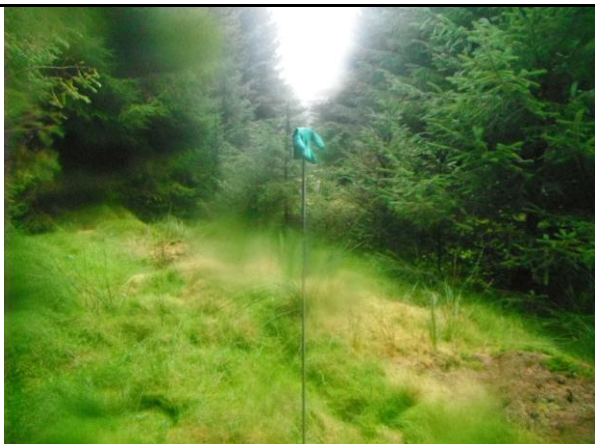
PROJECT		LOCATION		LANDMARK	
Pencloe		New Cumnock, Scotland		TR78	
Co-ords: X	260945	Y	607312	Ref	Grid position

CATEGORY			SCORE
Rainfall	1870	Moderate altitude, Moderate rainfall.	100
Moisture conditions	<input type="checkbox"/> Dry <input type="checkbox"/> Patchy <input type="checkbox"/> Part saturated <input checked="" type="checkbox"/> Saturated <input type="checkbox"/> Waterlogged Ditches: <input type="checkbox"/> No ditches <input type="checkbox"/> Dry <input checked="" type="checkbox"/> Flowing <input type="checkbox"/> Ponded		13
Substrata	<input type="checkbox"/> Peat <input type="checkbox"/> Clay <input checked="" type="checkbox"/> Sand/Gravel <input type="checkbox"/> Rock Strength (kPa): <input type="checkbox"/> <10 <input type="checkbox"/> 10-20 <input type="checkbox"/> 20-30 <input type="checkbox"/> 30-40 <input checked="" type="checkbox"/> >40		3
Strata details	Peat depth = 0.2 m		1
	Probe depth = 0.2 m		
	Layer 1, from ground level to 0.2 mBGL at 20-30 kPa Layer 2 not applicable Layer 3 not applicable		3

Location sensitivity	<input type="checkbox"/> Low <input checked="" type="checkbox"/> Medium <input type="checkbox"/> High <input type="checkbox"/> Very high Reason: track		3
OVERALL SCORE			87

<p align="center"><u>Vegetation</u></p> <p>Conifer: <input checked="" type="checkbox"/> Young <input type="checkbox"/> Semi-mature <input checked="" type="checkbox"/> Mature Deciduous: <input type="checkbox"/> Young <input type="checkbox"/> Semi-mature <input type="checkbox"/> Mature <input checked="" type="checkbox"/> Sphagnum moss <input type="checkbox"/> Staghorn moss <input type="checkbox"/> Other mosses <input type="checkbox"/> Cotton grass <input checked="" type="checkbox"/> Rushes <input checked="" type="checkbox"/> Other grasses <input type="checkbox"/> Heather <input type="checkbox"/> Fern <input type="checkbox"/> Shrubs <input checked="" type="checkbox"/> Leaf litter <input type="checkbox"/> Bracken Other:</p> <p>Terrain category: <input checked="" type="checkbox"/> One <input type="checkbox"/> Two <input type="checkbox"/> Three</p> <p>Notes:</p>

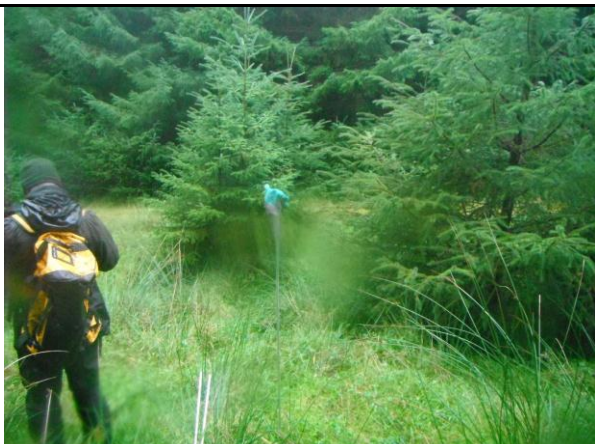
PROJECT		LOCATION		LANDMARK	
Pencloe		New Cumnock, Scotland		TR79	
Co-ords: X	260986	Y	607337	Ref	Grid position

CATEGORY			SCORE
Rainfall	1870	Moderate altitude, Moderate rainfall.	100
Moisture conditions	<input type="checkbox"/> Dry <input type="checkbox"/> Patchy <input type="checkbox"/> Part saturated <input checked="" type="checkbox"/> Saturated <input type="checkbox"/> Waterlogged Ditches: <input type="checkbox"/> No ditches <input type="checkbox"/> Dry <input checked="" type="checkbox"/> Flowing <input type="checkbox"/> Ponded		25
Substrata	<input type="checkbox"/> Peat <input type="checkbox"/> Clay <input type="checkbox"/> Sand/Gravel <input checked="" type="checkbox"/> Rock Strength (kPa): <input type="checkbox"/> <10 <input type="checkbox"/> 10-20 <input type="checkbox"/> 20-30 <input type="checkbox"/> 30-40 <input checked="" type="checkbox"/> >40		15
Strata details	Peat depth = 0.8 m	Probe depth = 0.8 m	2
	Layer 1, from ground level to 0.8 mBGL at 10-20 kPa Layer 2 not applicable Layer 3 not applicable		17

Location sensitivity	<input type="checkbox"/> Low <input checked="" type="checkbox"/> Medium <input type="checkbox"/> High <input type="checkbox"/> Very high Reason: track		9
OVERALL SCORE			212

<p align="center"><u>Vegetation</u></p> <p>Conifer: <input checked="" type="checkbox"/> Young <input type="checkbox"/> Semi-mature <input checked="" type="checkbox"/> Mature</p> <p>Deciduous: <input type="checkbox"/> Young <input type="checkbox"/> Semi-mature <input type="checkbox"/> Mature</p> <p><input checked="" type="checkbox"/> Sphagnum moss <input type="checkbox"/> Staghorn moss</p> <p><input type="checkbox"/> Other mosses <input type="checkbox"/> Cotton grass <input checked="" type="checkbox"/> Rushes</p> <p><input checked="" type="checkbox"/> Other grasses <input type="checkbox"/> Heather <input type="checkbox"/> Fern</p> <p><input type="checkbox"/> Shrubs <input checked="" type="checkbox"/> Leaf litter <input type="checkbox"/> Bracken</p> <p>Other:</p> <p>Terrain category: <input checked="" type="checkbox"/> One <input type="checkbox"/> Two <input type="checkbox"/> Three</p> <p>Notes:</p>
